# PRIEST FARM FEASIBILITY REPORT & CONCEPT PLAN

TOWN OF SOUTH WINDSOR, CT  
1407 SULLIVAN AVE, SOUTH WINDSOR, CT

MAY 16, 2016

Re: Priest Farm Structural Condition Assessment - Final

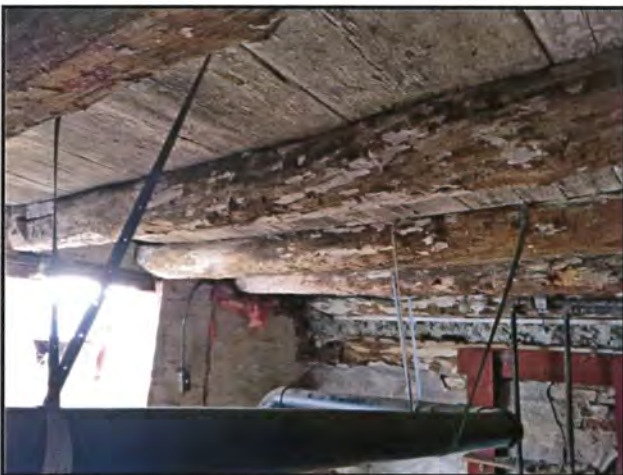
**Photo P02:** Log joists and plank floor at west end of Ell. Attempt at finishing stone walls with plaster at south side walk-out exit door.

1. Remove superficial plaster on walls and reset loose stones. Add mortar pointing to limit water entry and to contribute to strength and stability of wall.
2. Sister flat-top joists with sawn timber to achieve 40psf 1<sup>st</sup>-floor load capacity. (6 joists).

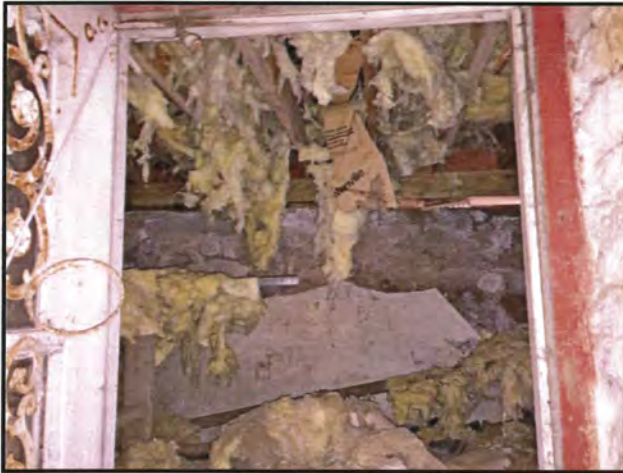
**Photo P03:** Foundation for modern south greenhouse addition. 1<sup>st</sup> floor framed with 2x8 at 16 inches on-center. Fiberglass insulation is sagging and torn. Daylight shows around pressure-treated sill.

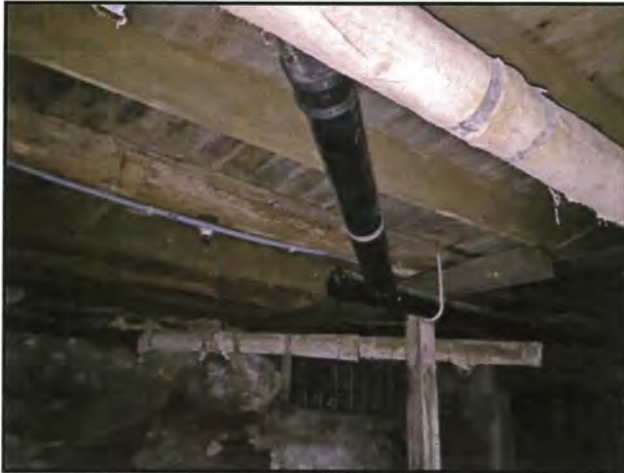
**Photo P06:** Flat-top log joists mixed with modern 2x8 joists plus tongue-and-groove decking. Some timber shoring beams and wood shoring posts added due to sagging floors from over-spanned joist conditions.

1. Sister log and modern joists with LVLs or rough sawn timbers to achieve 40psf 1<sup>st</sup>-floor load capacity.
2. Remove temporary shoring beams and posts.
3. Clean old plaster off of masonry foundation walls.

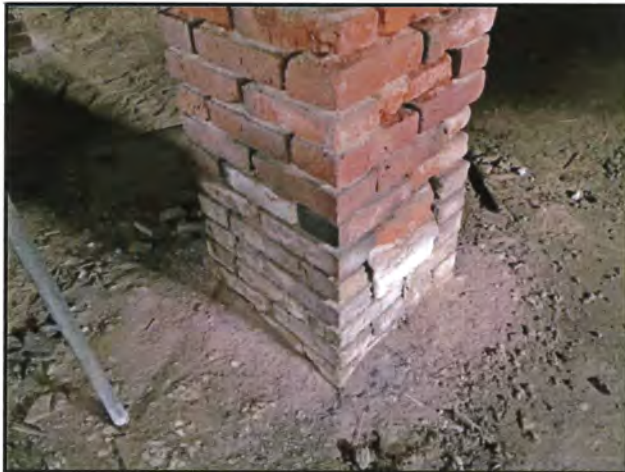
**Photo P07:** Brick masonry chimney base with loose lime mortar in joints and deterioration of some soft brick due to excess dampness at the basement level.

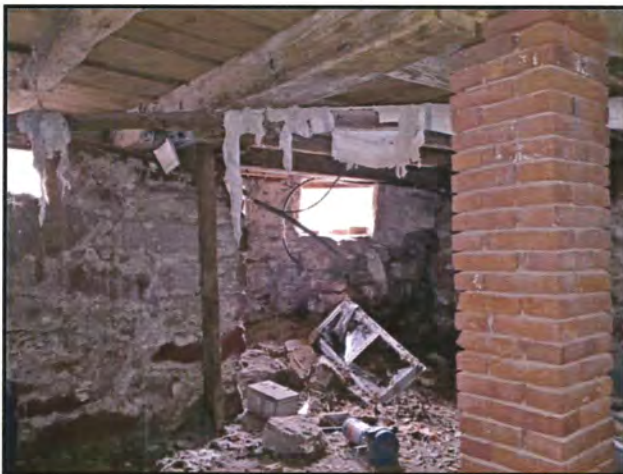
**Photo P09:** Southwest area of basement and 1<sup>st</sup> floor framing with bay window basement walls at the south side. Past plaster and over-mortared joints in foundation walls.

1. Sister joists with rough sawn lumber to achieve a 40psf 1<sup>st</sup> floor load capacity.
2. Clean loose plaster/mortar off of foundation walls and repoint masonry where necessary.

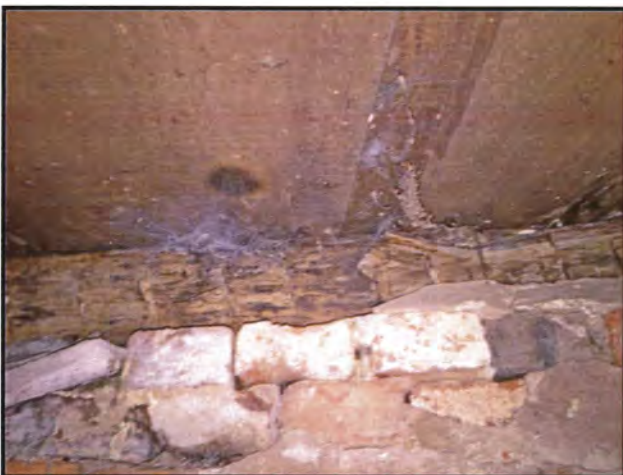
**Photo P10:** Front timber sill with some infestation damage visible from the interior. Upper foundation bricks with mortar in joints deteriorated.

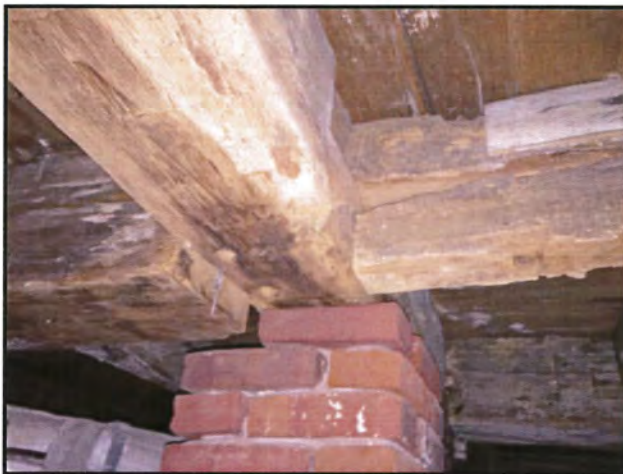
**Photo P12:** South side joist end split at dapped end into girder mortise.

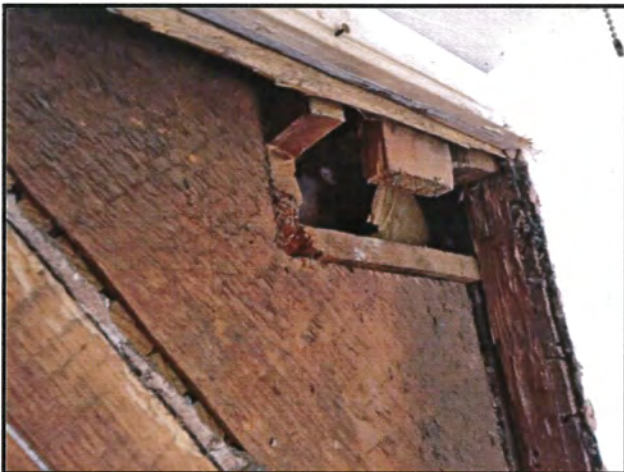
**Photo P19:** Trimmer for stairs from second floor to attic is undersized for 30psf live load.

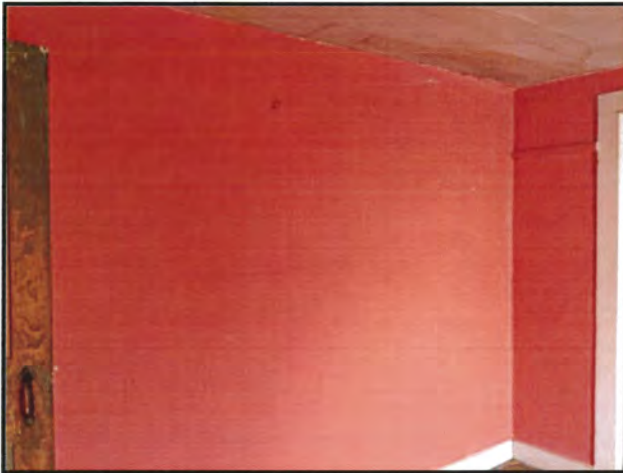
**Photo P21:** Tension cracks in central wall of second floor.

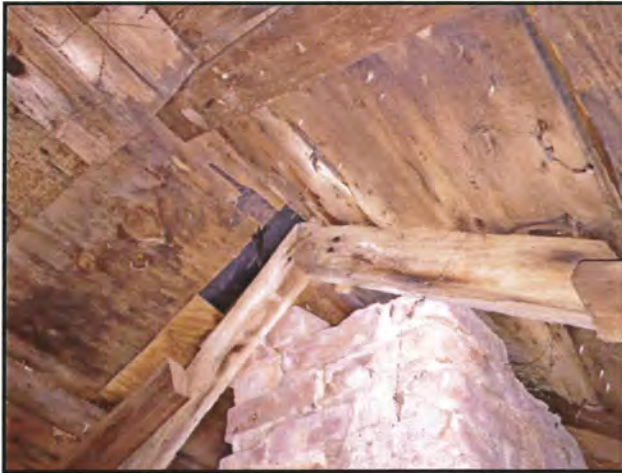
**Photo P24:** Top of chimney masonry no longer penetrates roof. Opening is enclosed with plywood and sisters scabbed onto rafters. Five-side ridge beam has no support where penetration is enclosed.

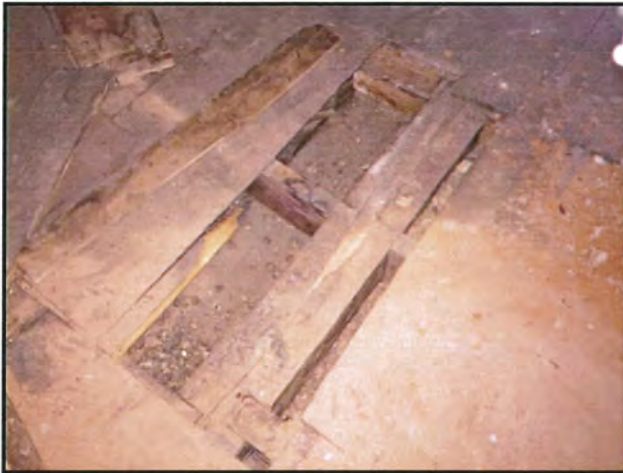
**Photo P26:** Attic plank pulled up to observe attic framing around chimney.

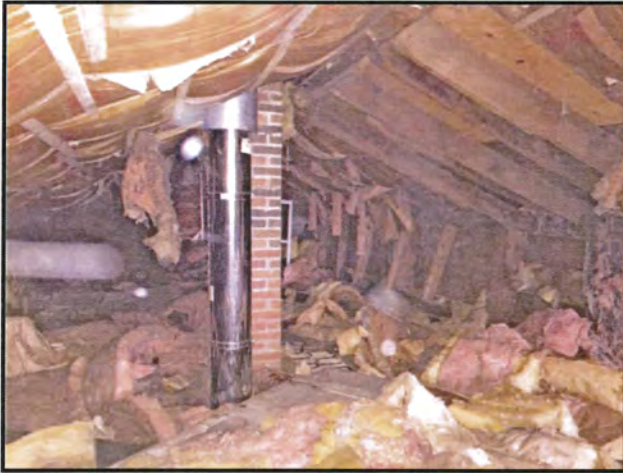
**Photo P28:** Ell framing looking towards Main House.

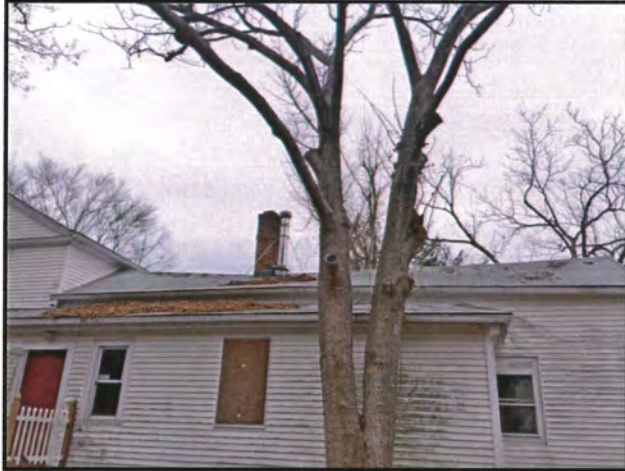
The Ell roof is in poor condition and is severely deflected. The attic half-story projects approximately 4 feet above the attic to the roof top plate which is not tied. The lack of tying allowed the roof to thrust outward at the eaves and the ridge to severely drop. The roof rafters are 2 ¾ inches x 3 ½ inches at 36 inches on-center and are adequately sized to support the required 30psf snow load. To correct this lack of tying, the roof sheathing and roofing should be removed and the roof framing be repositioned and straightened as much as possible. The top plates should be tied with seven, evenly spaced steel rods to tie them together. The existing roof decking can be reused or replaced and the roofing should be replaced.

**Photo E01:** Severe deflections in Ell roof.

- 1. Re-plumb and reinforce roof framing per previous recommendations to provide a straighter and more stable roof.*

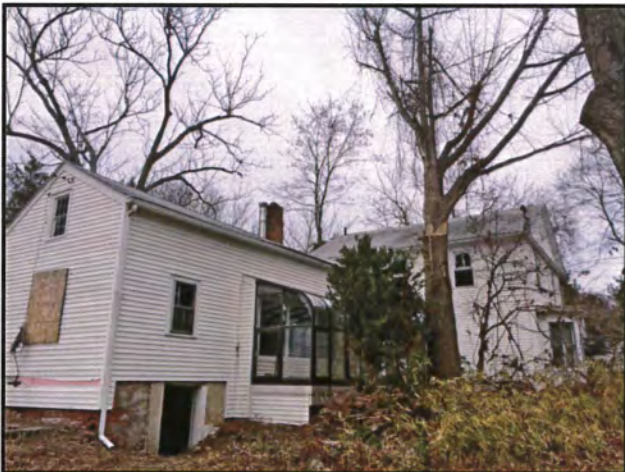
**Photo E02:** South exterior of Ell.

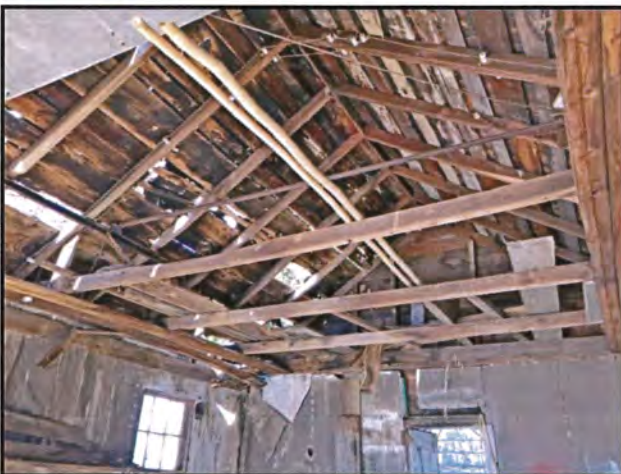
**Photo P1.3:** Deflected 2"x4" rafters at 30"oc, mostly without rafter ties. North and west walls covered with finishes. East wall (not pictured) consists of 2"x4" studs at 32"oc.

1. Reinforce rafters with 2"x6" RSL sisters. At rafters supporting garage door, reinforce with (2) 2"x4" sisters.
2. Provide 2"x6" RSL ties at each rafter.
3. Reinforce connection of wall studs to underside of top plate using Simpson A35 framing clips.

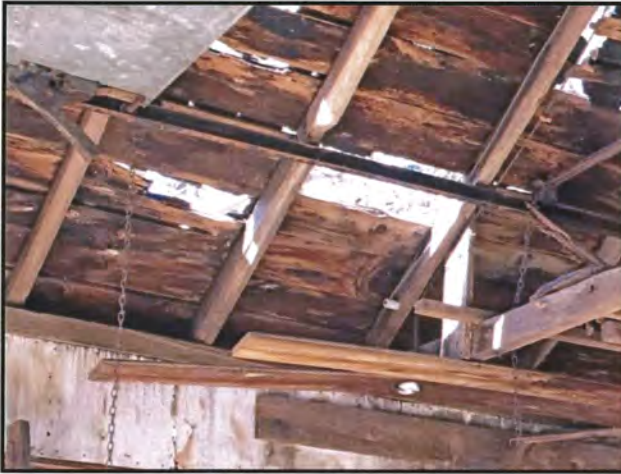
**Photo P1.4:** Damaged roof skip sheathing and decking at west side of Outbuilding along with deep notches in rafters for garage door anchorage.

1. Remove roofing materials, damaged skip sheathing, and decking. Replace sheathing and decking in kind.
2. Anchor reinforced rafters to top plates with Simpson A35 framing clips.
3. Garage door will need to be temporarily removed to allow installation of rafter sisters. Reinstall garage door at reinforced rafters. Do not notch new rafter sisters.
4. East and west eaves may require reconstruction due to water damage and staining observed at interior.

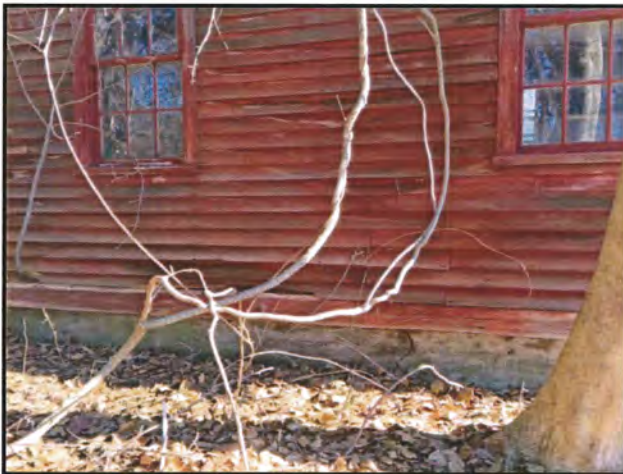
**Photo P1.5:** West exterior showing clapboards and concrete foundations. Thin crack in foundation was observed but appears to be due to expansion, not settlement.

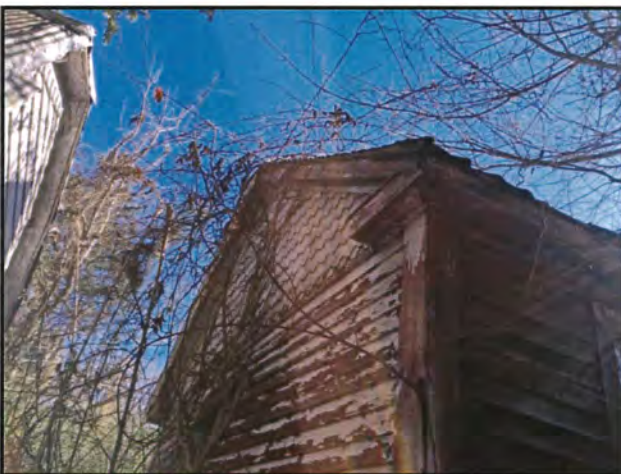
**Photo P1.7:** North gable showing rake and rake return.

1. Address base of wall per previous recommendations in Photo P1.6.

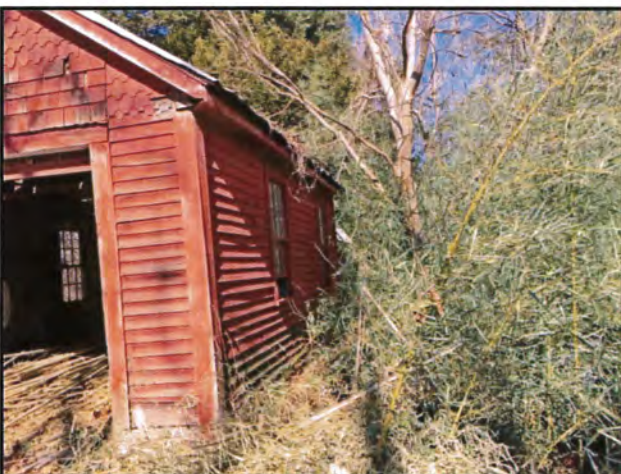
**Photo P1.8:** East exterior appears to be plumb. Top plate has mild deterioration due to water infiltration and insect activity.

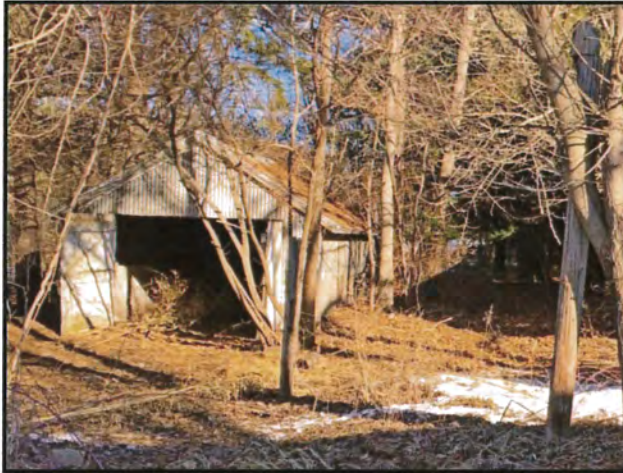
**Photo P2.1:** South gable exterior with double doors.

1. Anchor sill plates to CMU providing  $\frac{1}{2}$ " threaded rods x 1'-4" embed at 24" c (and ends of each wall), and grouting cells solid at anchor points. (Applies to all walls)
2. Repair damaged CMU per recommendations in P2.7.

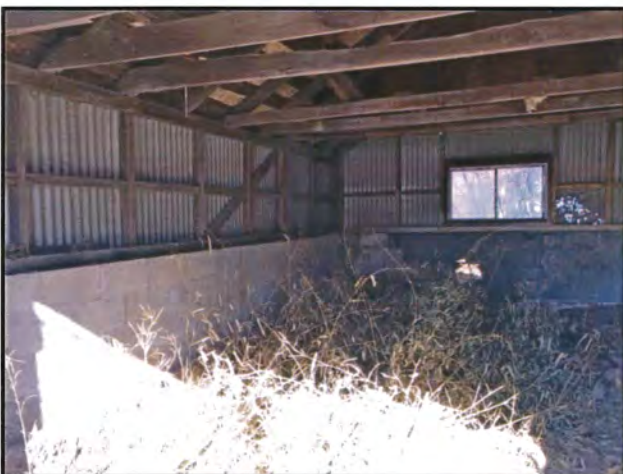
**Photo P2.3:** Northwest corner of outbuilding.

1. Provide Simpson A35 framing clips from rafters to top plate.

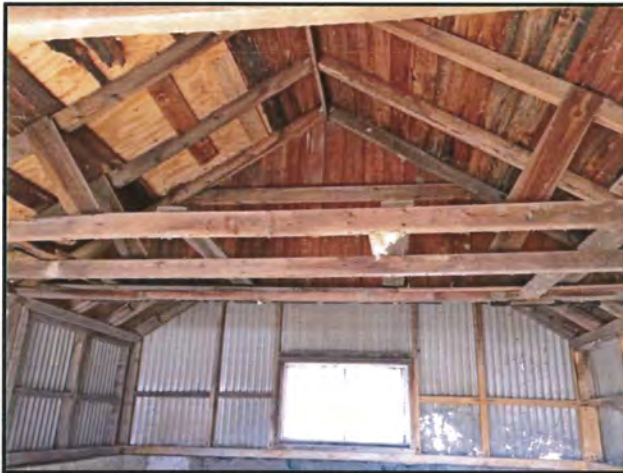
**Photo P2.4:** 2" x 4" roof rafters with 2"x6" ties at 24"oc and original north gable along with plywood sheathing over original roof decking. Attempt to reinforce roof rafters by installing 1x6 kickers are overstressing ties.

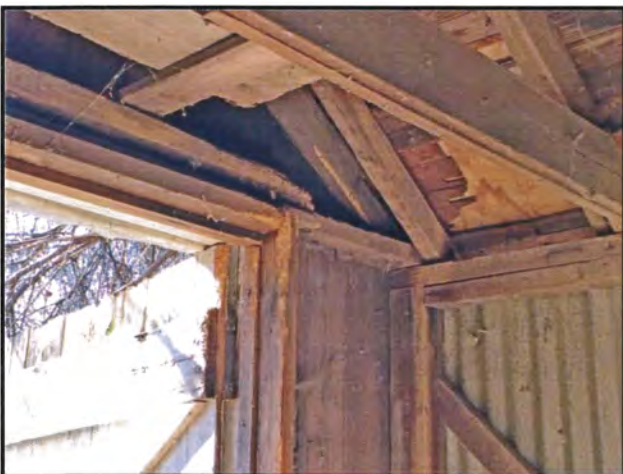
**Photo P2.6:** Door framing with evidence of squirrel damage. End of top member of door header is deteriorated.

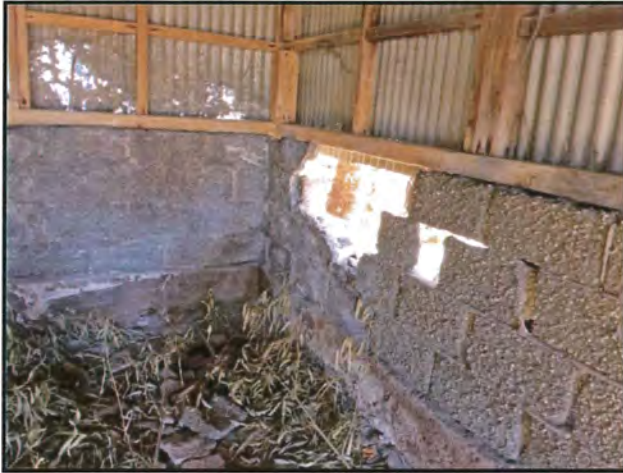
**Photo P2.7:** Damaged CMU foundation wall at northeast corner.

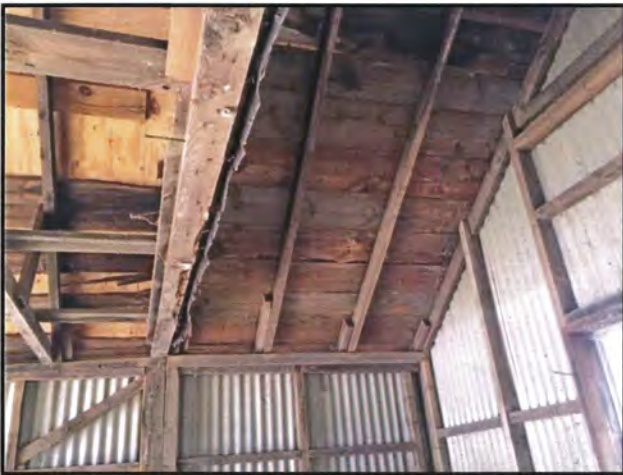
**Photo P2.8:** Transition in framing showing untied roof rafters and different roof decking at north side of outbuilding.

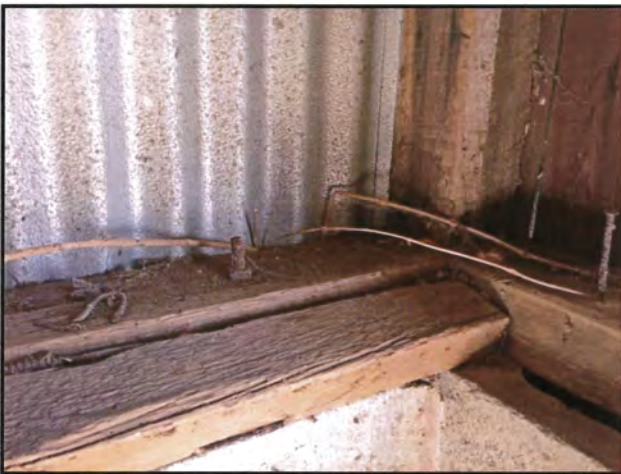
**Photo P2.10:** Sill in acceptable condition with  $\frac{1}{4}$ " threaded rod holddown at southeast corner.

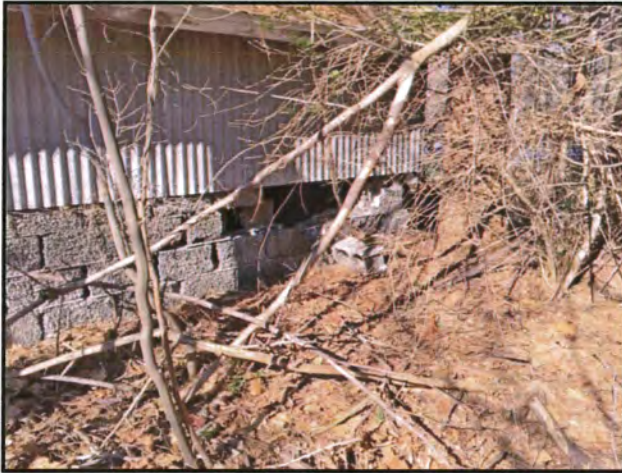
**Photo P2.12:** East exterior showing damaged CMU foundation wall.

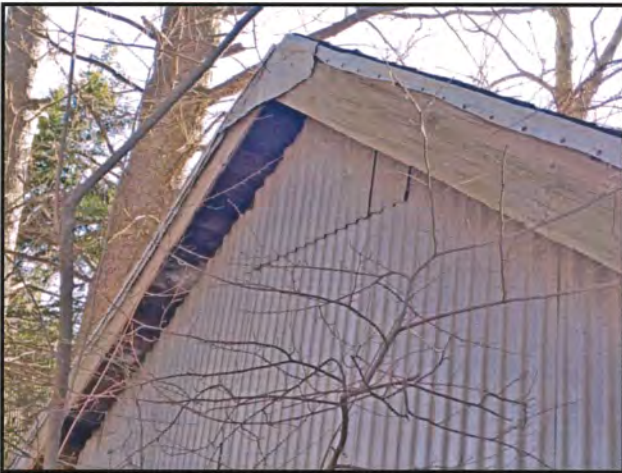
**Photo P2.13:** North gable and rake overhang.

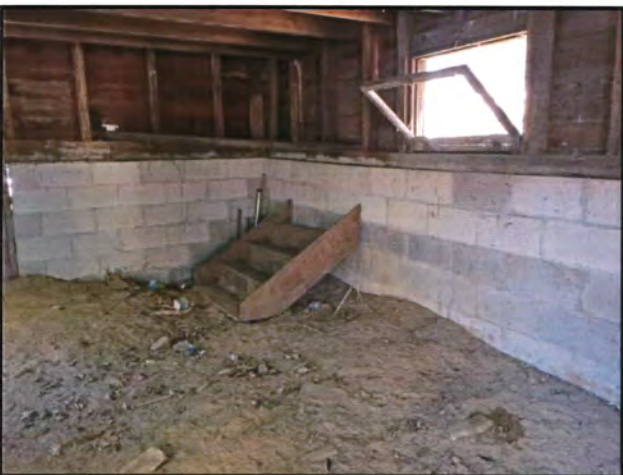
**Photo P3.3:** Southwest corner of outbuilding

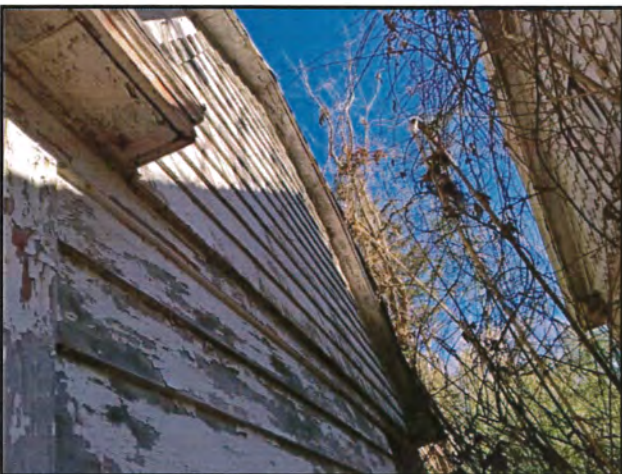
**Photo P3.9:** South gambrel rake and rake return.

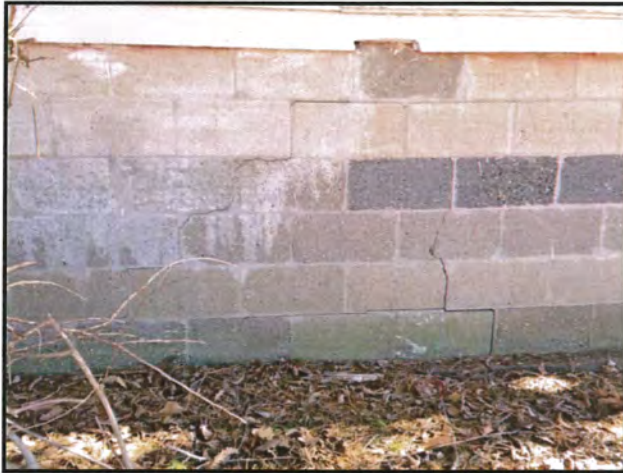
**Photo P3.10:** Settlement crack in foundation at west exterior.

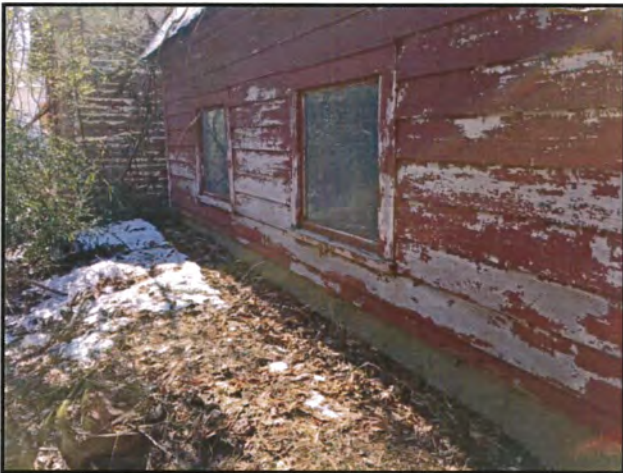
**Photo P3.11:** East exterior with low CMU foundation wall.

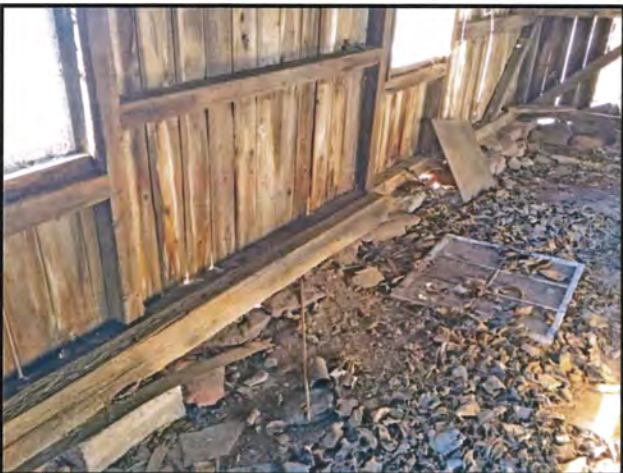
**Photo P4.3:** Masonry foundation is deteriorated and is no longer providing support for sill plates.

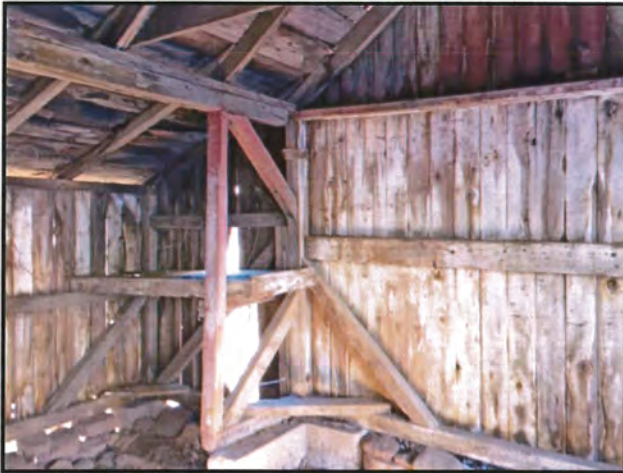
**Photo P4.4:** Southeast corner of outbuilding

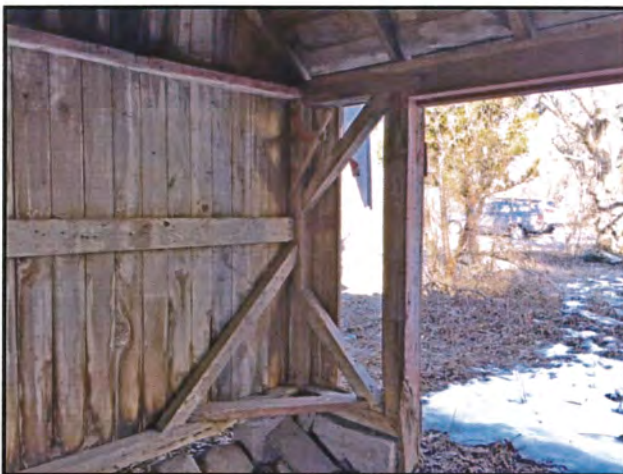
**Photo P4.5:** Northwest corner of outbuilding showing one of four concrete corner foundations.

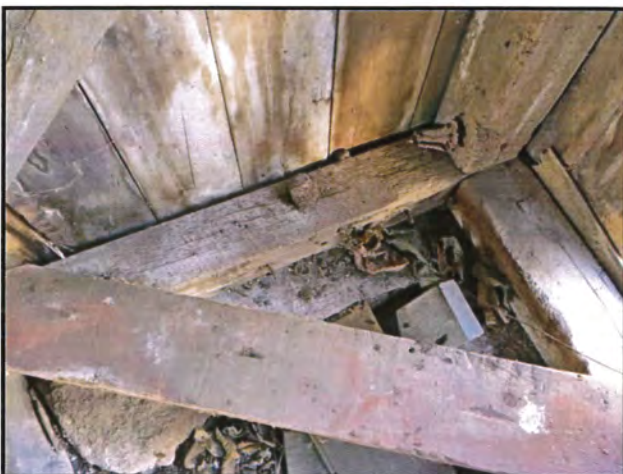
**Photo P4.6:**  $\frac{3}{4}$ " dia. threaded rod holddown at concrete corner foundation.

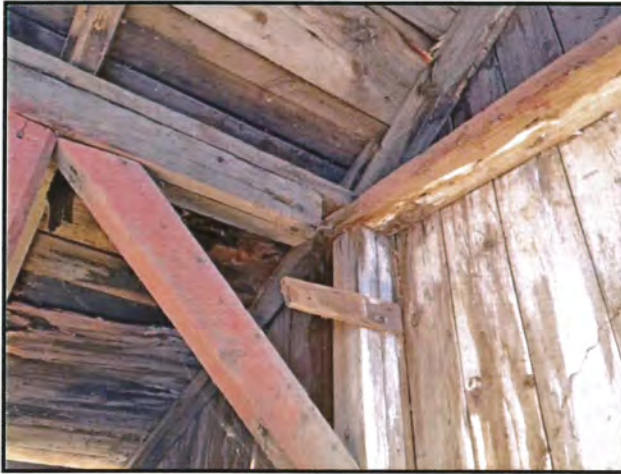
**Photo P4.10:** End of girder supporting gable/shed rafters deeply notched at top plate.

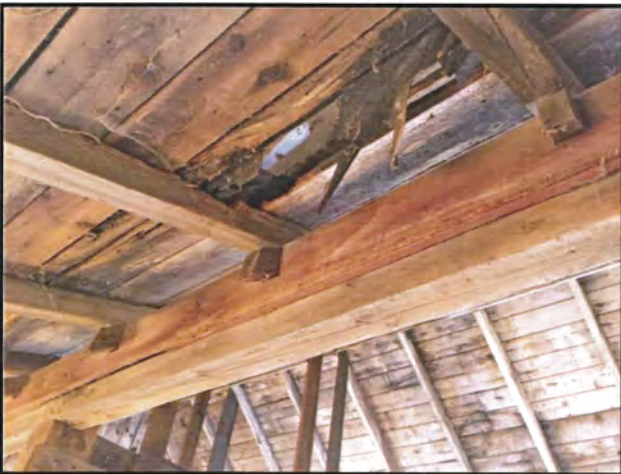
**Photo P4.12:** Girder supporting gable and shed rafters and damage roof decking.

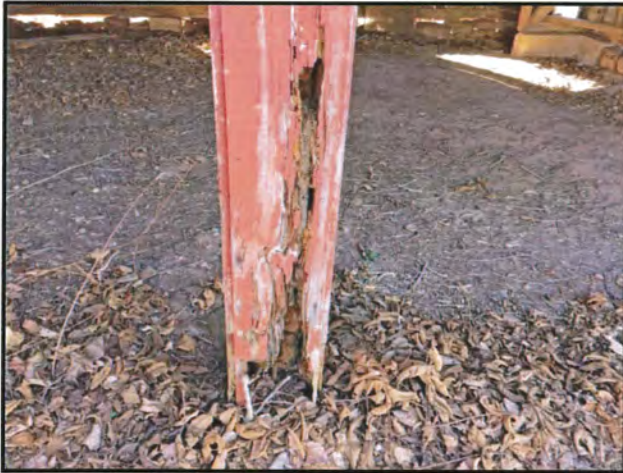
**Photo P4.13:** Center post at north wall with door openings completely deteriorated at bottom 2'-6".

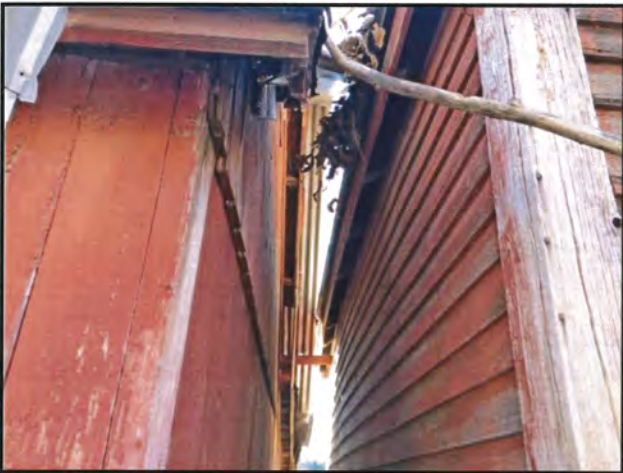
**Photo P4.14:** West exterior of outbuilding (next to Outbuilding No. 5) with rake overhang.

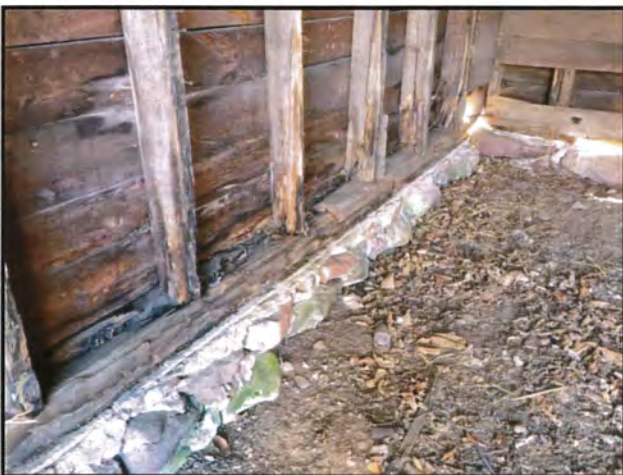
**Photo P5.3:** East wall base showing deteriorate 2"x6" stud bases, exterior sheathing, and sill plate with attempted repairs.

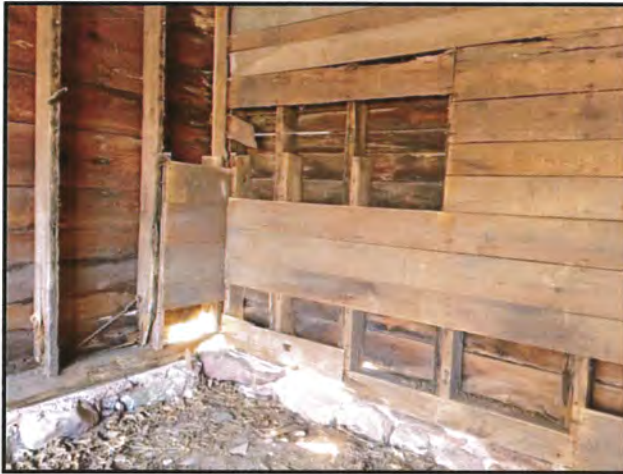
**Photo P5.4:** South stud wall with sisters at stud bases and attempted sill repair.

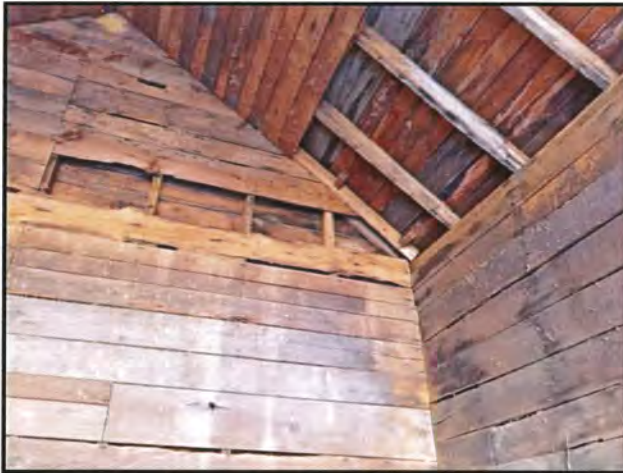
**Photo P5.6:** Southwest corner of outbuilding showing 2"x5" roof rafters at 22"oc and south gable stud wall framing. Outriggers for south rake are visible and do not extend back to adjacent rafter.

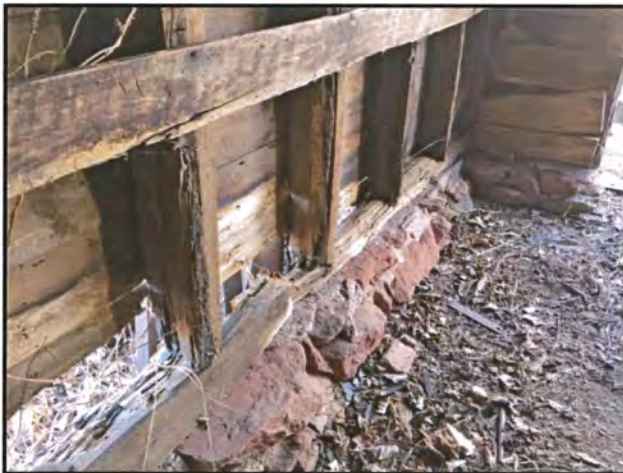
**Photo P5.7:** Deteriorated stud bases, interior and exterior sheathing, and sill along west wall.

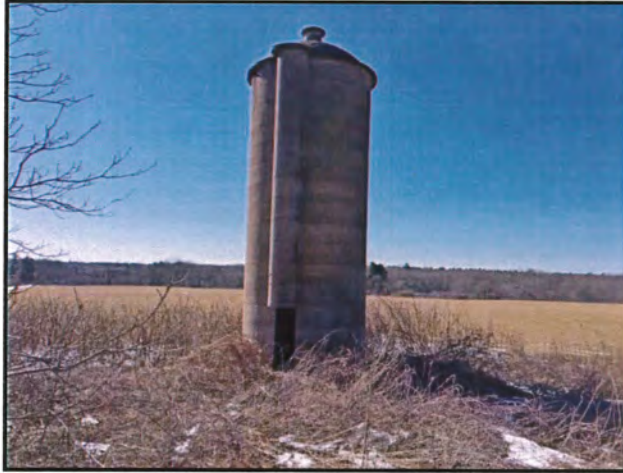
**Photo PS.1:** East exterior of silo showing silage tube bump-out, entrance, and roof.

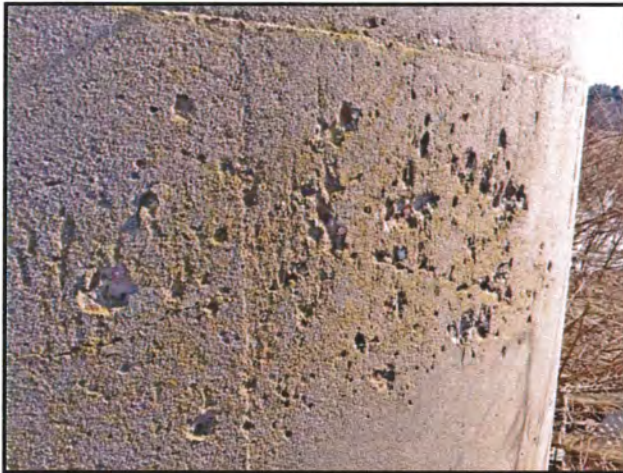
**Photo PS.4:** Visibly empty void spaces at the surface, commonly known as bugholes, and organic growth at southwest side of exterior.

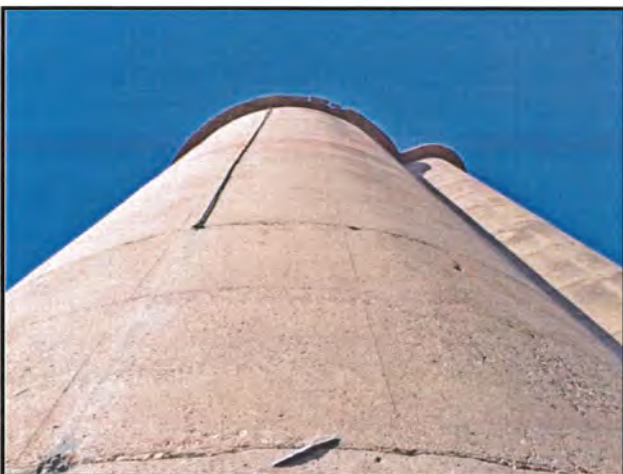
**Photo PS.6:** South roof overhang deteriorated.

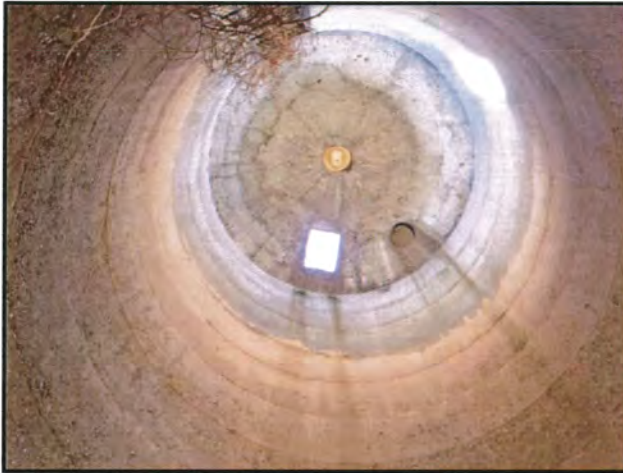
**Photo PS.10:** Roof of silo from inside showing possible evidence of water damage and previous attempts at patching.

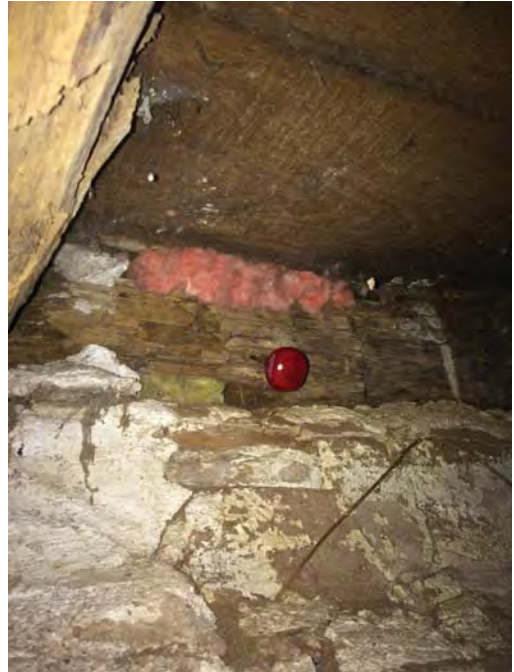
Awl pushed into deteriorated stretch of timber sill.  
**Photo No. 5**

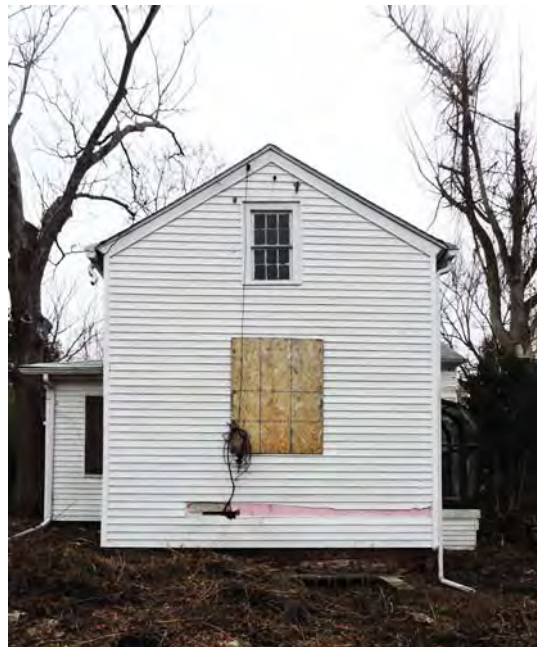
Hole in wall at West elevation  
**Photo No. 6**

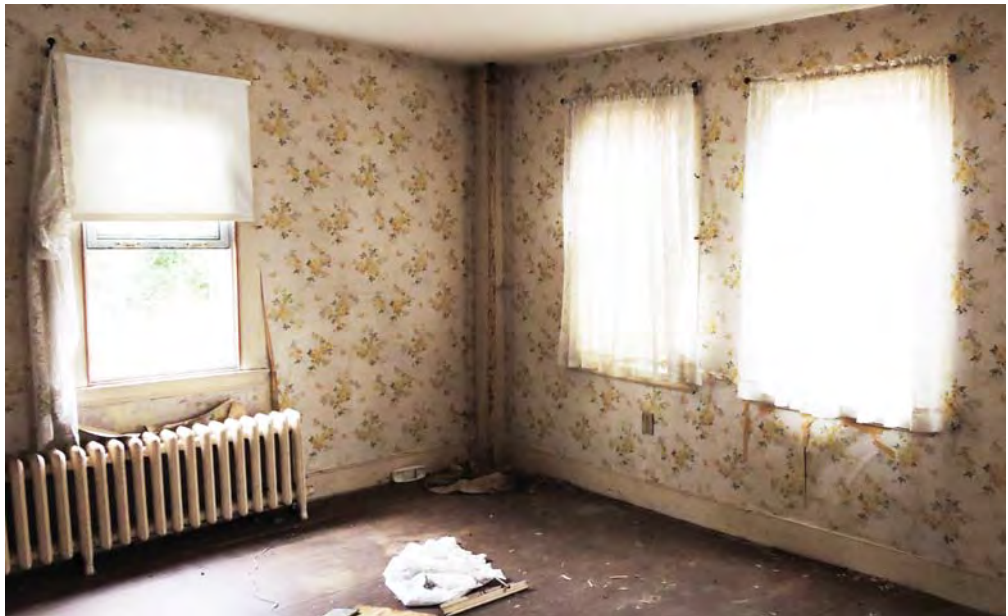
Front Parlor. Evidence of water infiltration below windows.  
**Photo No. 7**

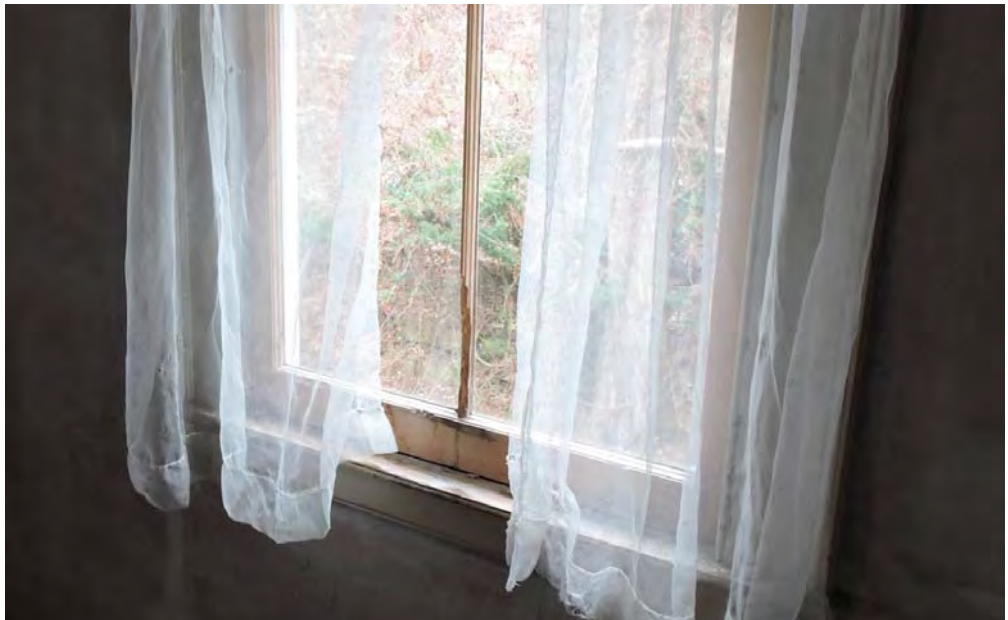
Squirrel damage at window muntin. Note 2nd floor windows are not painted on the interior..  
**Photo No. 8**

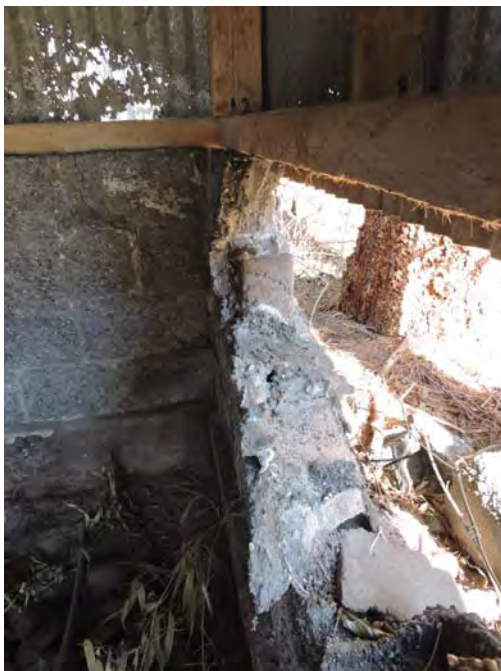
Building No. 2 at NE corner.  
Noted pitted metal siding, damaged foundation.  
**Photo No. 25**

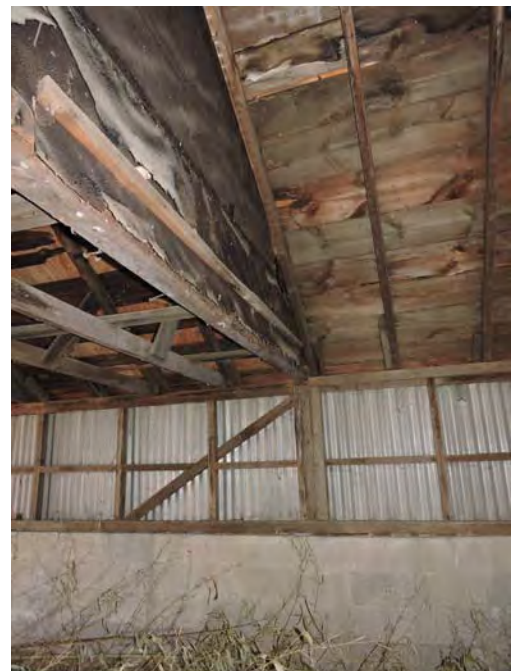
Building No. 2 - interior 'gable end' suggesting the roof  
structure may have been salvaged from another building.  
**Photo No. 26**

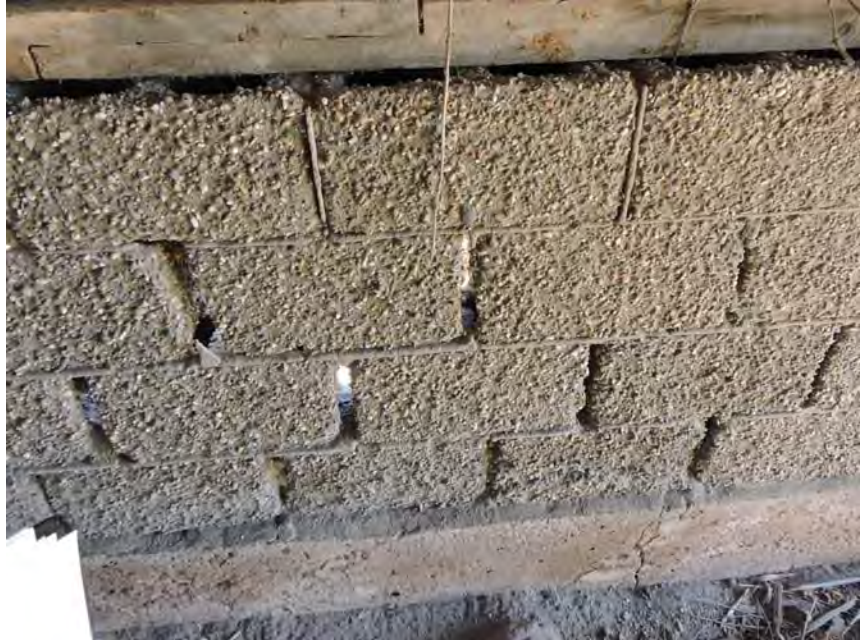
Building No. 2 - Erosion at concrete block foundation walls.  
**Photo No. 27**

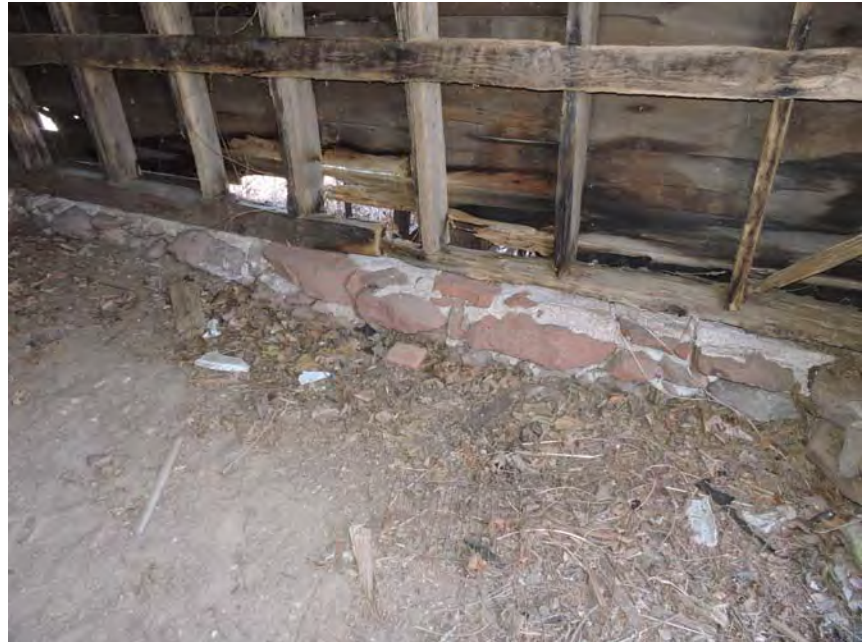
Building No. 5 - Note condition of timber sills.  
**Photo No. 35**

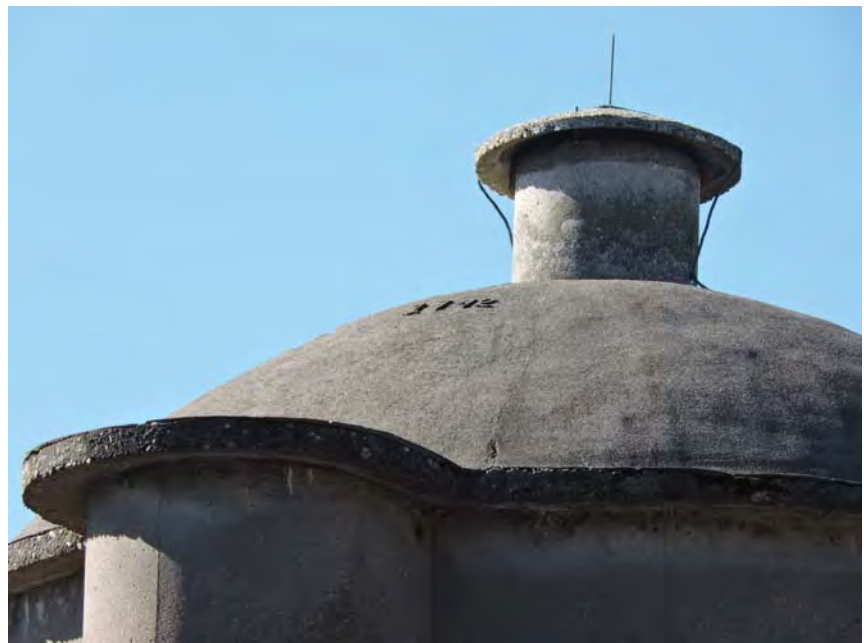
Silo roof dome. Note crack to the right of the date, as well as existing lightning protection system.  
**Photo No. 38**

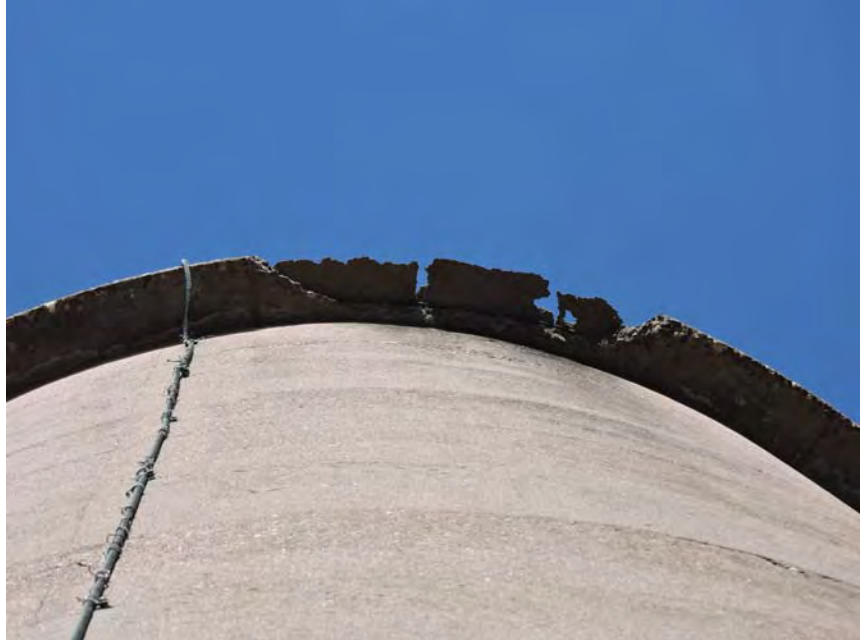
Silo - spalling at the roof overhang.  
**Photo No. 39**
