Confidential Inspection Report

1407 Sullivan Ave
South Windsor, CT 06074

Prepared for: John Folger
The Town Of South Windsor CT

Prepared by: Sherwood Inspection Services, LLC

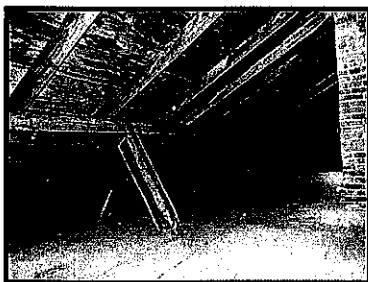
main attic overview

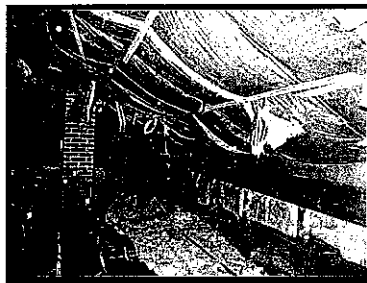
REPAIR(LOWER ATTIC): The framing in the attic over the one story section of the house in need of further evaluation and repairs: The following conditions were observed. There is considerable sagging of the ridge line, notably toward the chimney penetration, this appears to be due to improper or poorly attempted repairs where some rafters have been replaced and the ridge not properly supported on either side of the chimney opening. The left side upper wall (when facing the front of the house) is leaning outward which may be due to outward pressure from the rafters, there is damage to the bottom of a couple of vertical posts and the beam below in the rear right attic area. The full extend of damage is unknown due to limitations of flooring and debris on floor.

lower attic- insulation covering rafters

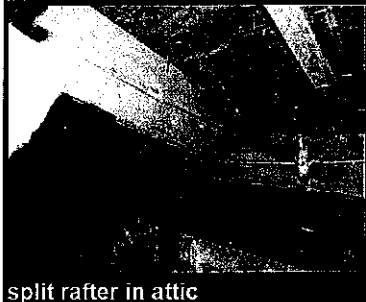
split rafter in attic

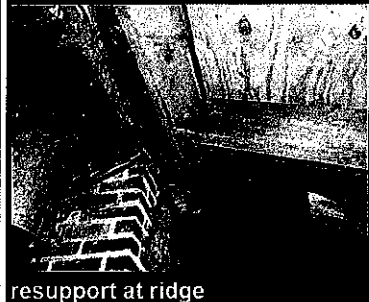
UPPER ATTIC: The overall condition of the roof framing in the main attic (two story section of house) appears to be in good condition for the age of the home. The wood framing members and their connections (mortise and tenon and wooden pegs) were in tact and functional. There is one section of resupporting that was done to connect two opposing rafters where the chimney has been removed. This area needs improvement to ensure better connection of the rafters.

resupport at ridge

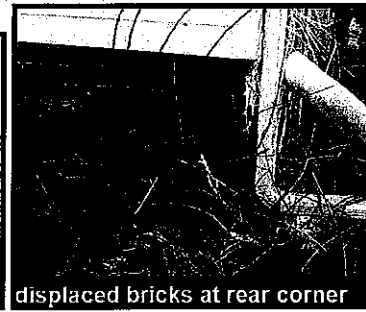
REPAIR: There are areas of loose, damaged and displaced brick visible from the exterior, notably at the left side bump out and the rear corner of the one story section of the house, the condition of the brick below grade is likely to be in similar or in worse condition. The stone foundation appears to bow inward at the left side of the house (facing front of house), there are loose stones and cracks in the parge coating over the foundation in the basement which indicates settlement/movement in multiple areas. There is wide spread deterioration of the mortar throughout the foundation (stone and brick). I recommend a qualified structural engineer further evaluate and determine full scope of repairs needed and develop a repair plan to know the full scope of work and impact on budget.

displaced bricks at rear corner

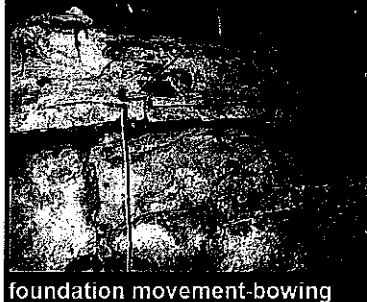
foundation movement-bowing

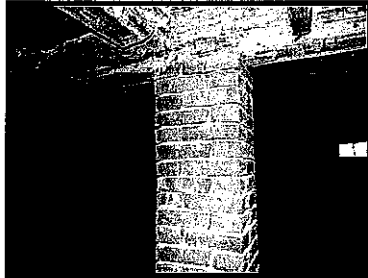
REPAIR: This are significant repairs needed to the structural components (wood framing and support piers/columns). The following conditions were observed to the structure in the basement: There is extensive wood destroying insect damage observed to multiple sections of the sill beams and to joist ends, There is significant sagging to beams and joists in multiple areas, Splits, cracks and/or large checks that extend through the joists were observed, Some degree of separation of the mortise and tenon joints at joist to beam connections, The masonry/brick piers all have extensive wear to the mortar joints and some of the bricks have compressed, There are temporary type repairs or resupporting efforts that have been made such as telescoping jack screw columns, and non standard wooden floor support beams. The structural components in the basement are vulnerable to and subject to further movement and deterioration. I recommend a qualified structural engineer fully assess the structural framing and supports in the basement (it makes sense to have this done in conjunction with the foundation, so that the structure as a whole is evaluated) to determine the full scope of repairs needed and develop a repair plan to know the full scope of work and impact on budget.

brick piers deteriorated mortar

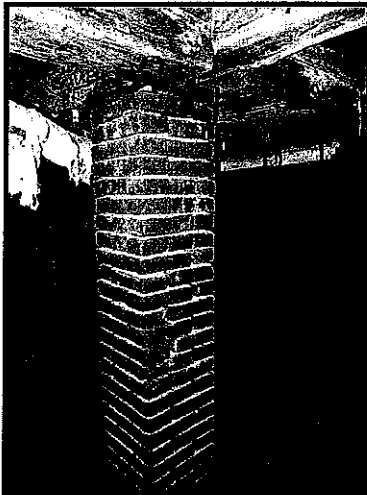
brick pier

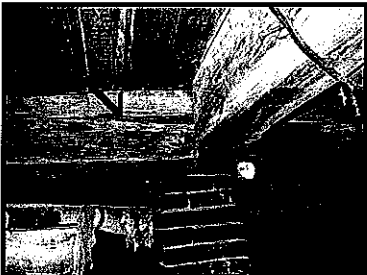
crack-check at beam end

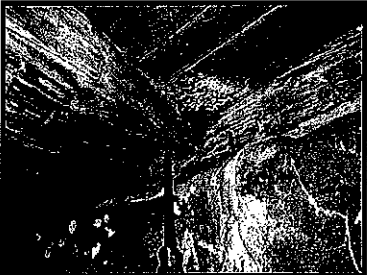
insect damage to beam/joist end
