December 15, 2023

**RE: SOILS INVESTIGATION REPORT**  
8 Collins Lane, South Windsor, CT

*REMA Job No.: 23-2664-SWN125*

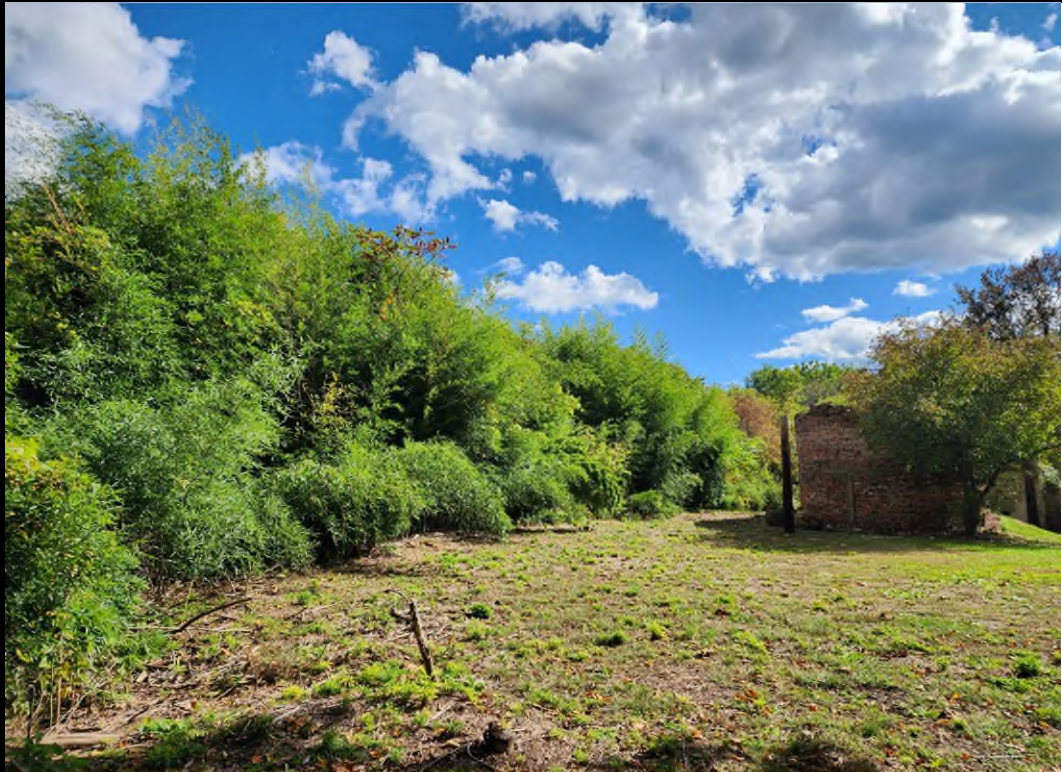
<b>SITE/LOCATION:</b> 8 Collins Lane South Windsor, CT	REMA JOB NO.: 23-2664-SWN125	<b>ANNOTATED PHOTO LOG</b>
	<b>INVESTIGATOR(S):</b> George T. Logan, MS, PWS, CSE		
<b>DATE:</b> October 9, 2023	<b>FACING:</b> SOUTHERLY	<b>PHOTO NO.:</b> 1

<b>Comments:</b> <i>Northeasterly portion of property; area of old structures associated with farmstead</i>

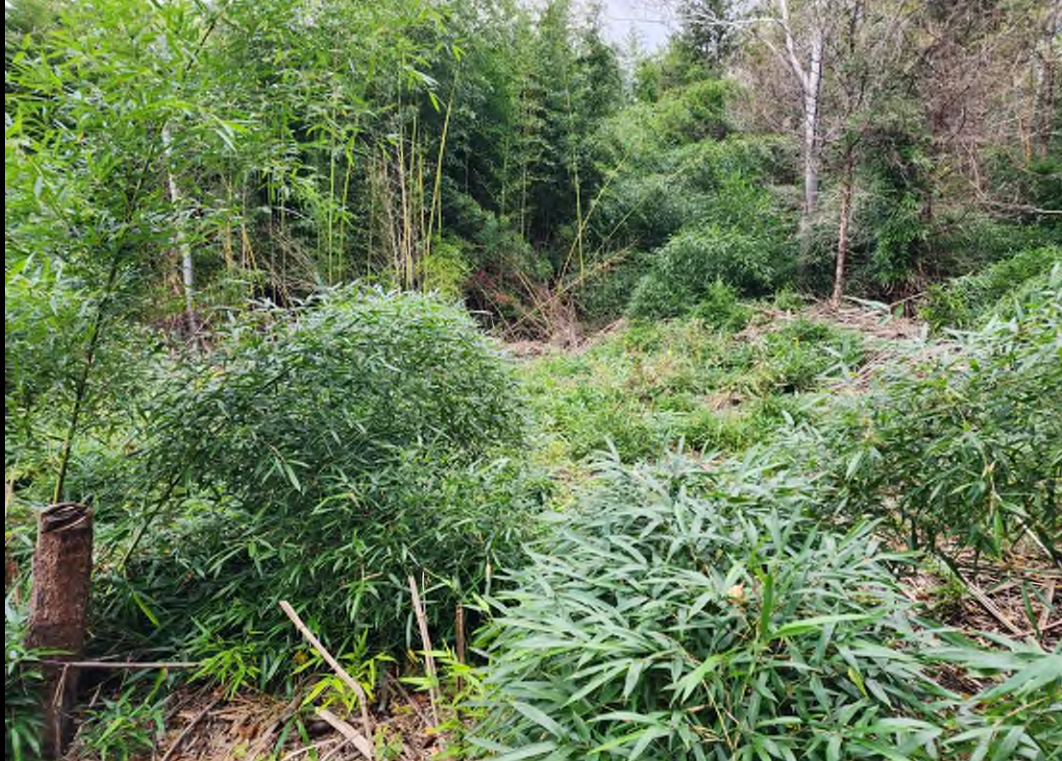
<b>DATE:</b> October 9, 2023	<b>FACING:</b> NORTHEASTERLY	<b>PHOTO NO.:</b> 2

<b>Comments:</b> <i>Fishpole bamboo (Phyllostachys aurea) stand; an aggressive colonizer (not listed as invasive), occupies roughly 15,000 sq. ft. of property</i>

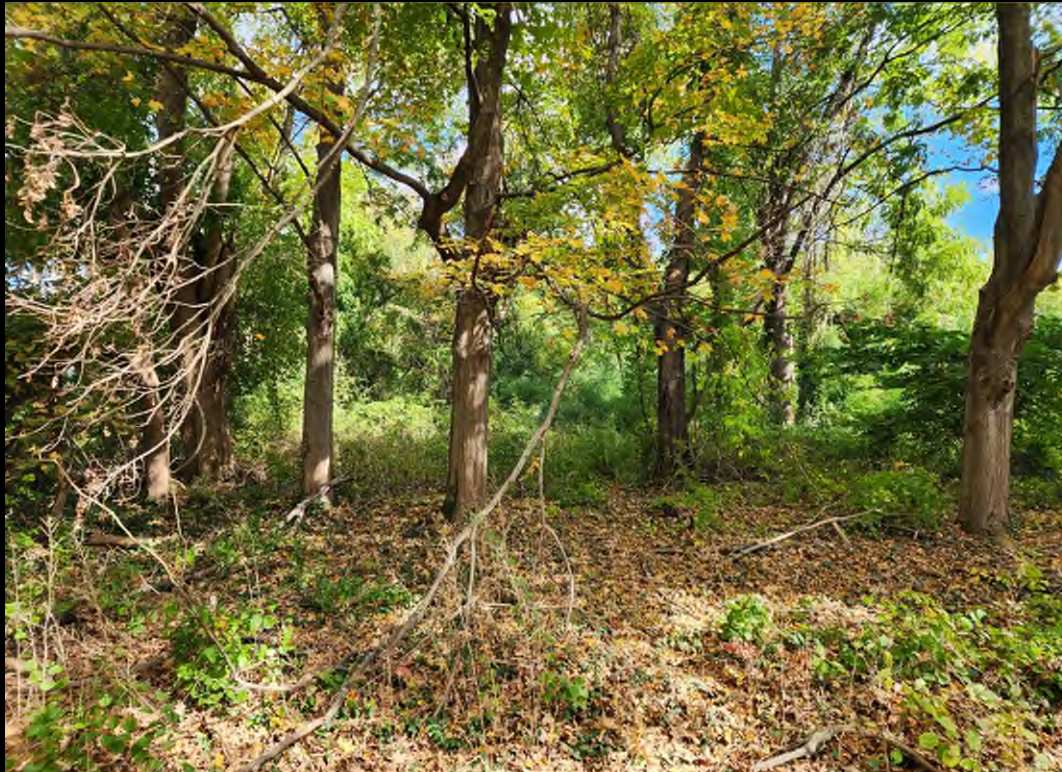
<b>SITE/LOCATION:</b> 8 Collins Lane South Windsor, CT	REMA JOB NO.: 23-2664-SWN125	<b>ANNOTATED PHOTO LOG</b>
	<b>INVESTIGATOR(S):</b> George T. Logan, MS, PWS, CSE		
<b>DATE:</b> October 9, 2023	<b>FACING:</b> SOUTHEASTERLY	<b>PHOTO NO.:</b> 3

<b>Comments:</b> Ruderal woods in northern portion of property (4-acre parcel); once a plowed field

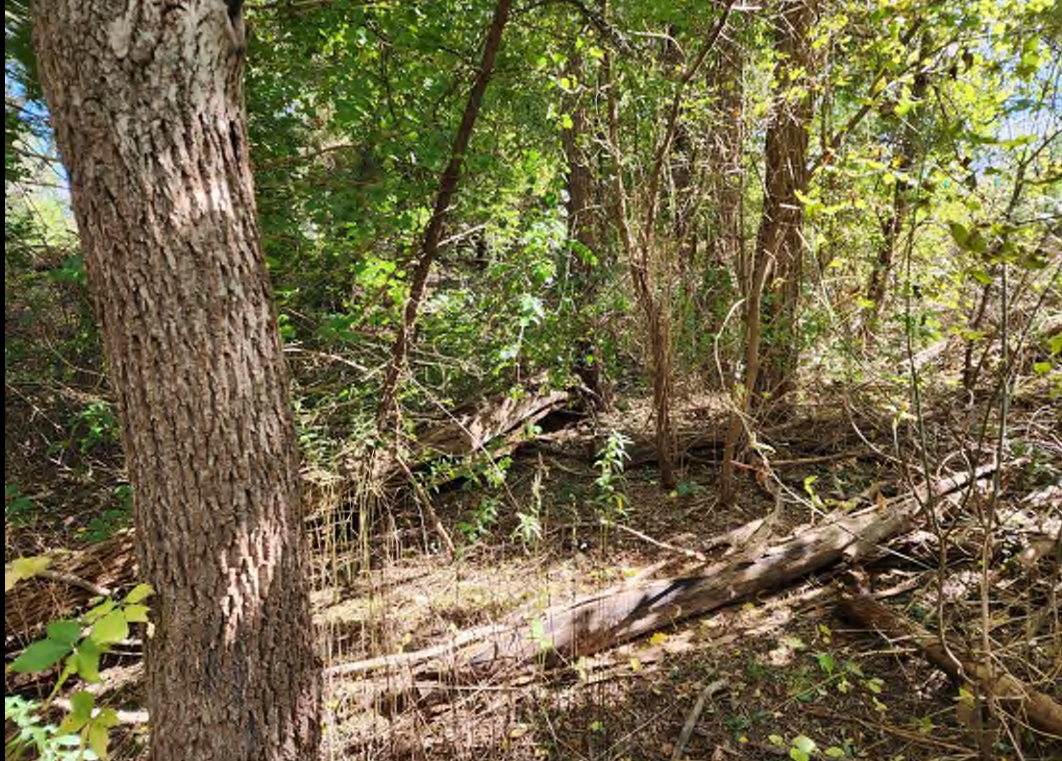
<b>DATE:</b> October 9, 2023	<b>FACING:</b> SOUTHERLY	<b>PHOTO NO.:</b> 4

<b>Comments:</b> 0.68-acre "triangel" parcel, between Collins Lane Sullivan Avenue; once a tree nursery
