Identification of Architecturally, Culturally, Economically, Politically or Socially Significant Structures Contained within the South Windsor Town Center

Presented by the Demolition Delay Committee

January 29, 2015

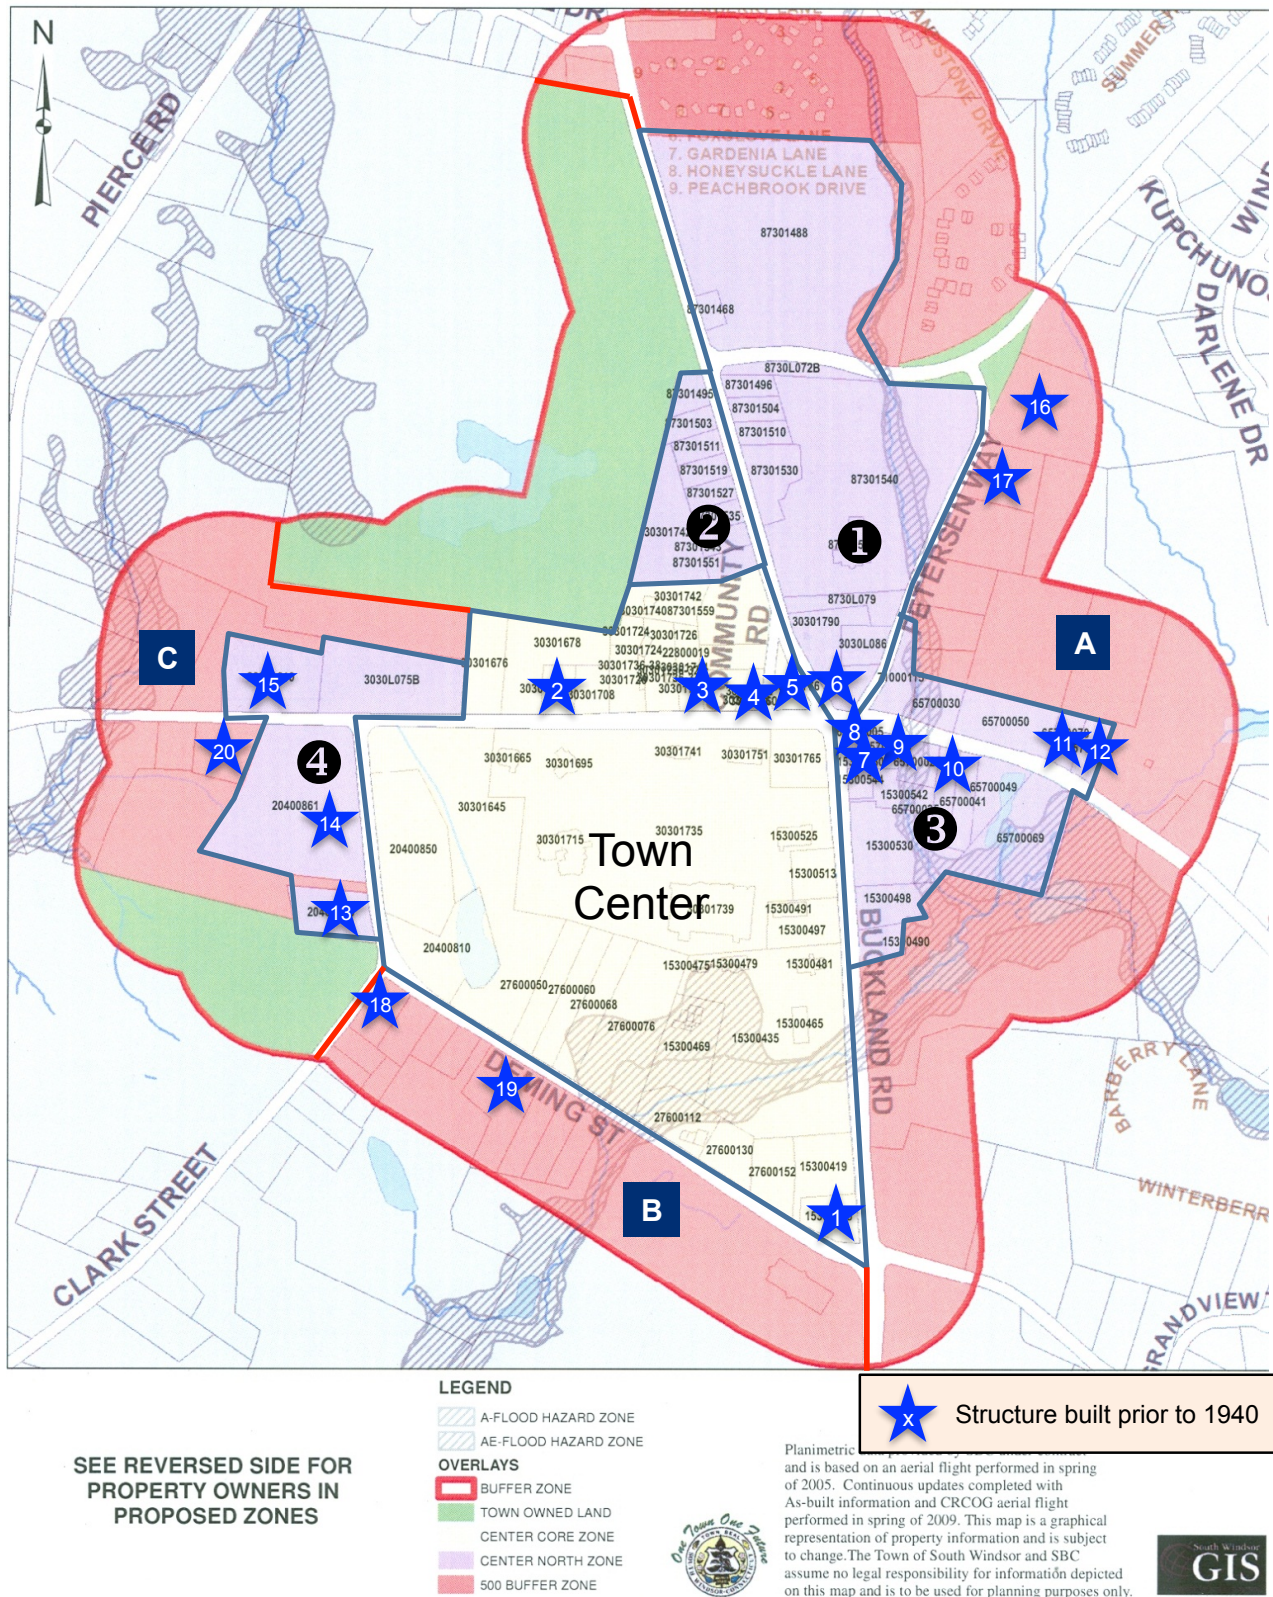
Figure 1
Significant Structures within Proposed Town Center Re-Development Area

Class I - Parcels with structures listed as being 75 years or older as of January, 2015
(Denoted in figure 1 with a blue star)

Structures meeting the 75 year threshold situated in class I are highlighted in Figure 1 with a blue numbered star to visually understand the frequency and density of historic properties within each zone. Detailed information on selected properties were retrieved from South Windsor architectural surveys, volumes 1 and 2 and are assembled in Appendix A.

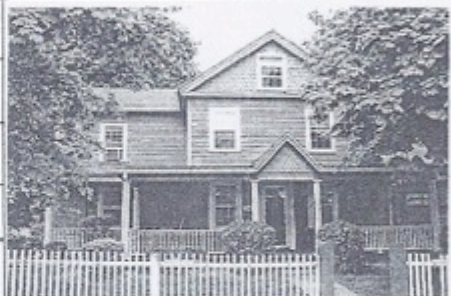
11. NUMBER OF STORIES 2.5		APPROXIMATE DIMENSIONS 24 x 18			
	12. CONDITION (Structural) (Exterior)					
	<input type="checkbox"/> Excellent <input checked="" type="checkbox"/> Good <input type="checkbox"/> Fair <input type="checkbox"/> Deteriorated <input type="checkbox"/> Excellent <input type="checkbox"/> Good <input checked="" type="checkbox"/> Fair <input type="checkbox"/> Deteriorated

DESCRIPTION (continued)	17. OTHER NOTABLE FEATURES OF BUILDING OR SITE (Interior and/or exterior)	
	<p>395 BUCKLAND ROAD is a two-and-one-half-story vernacular style house. The main block of the house is oriented with the ridge parallel to the street. The plan of the house is complex with a gabled projection facing the street as well. At the intersection of the ell and the main block is a chamfered brick chimney. The gabled end is pedimented and features a single window. The eaves and rake are lined with wide cornice moldings. The gable end facing the street is filled with fish-scale shingles. A wrap-around porch supported by tapered posts spans the front elevation. A gabled projection marks the main entrance. This projection is also infilled with fish-scale shingles. Openings are 6/6 double-hung sash with wide trim. The porch railing features turned balusters and the house is clad in wooden clapboards. There is a two-story gabled extension on the - elevation which features a tall brick chimney located centrally along the ridge. This house is currently a business and is located on a busy intersection.</p>

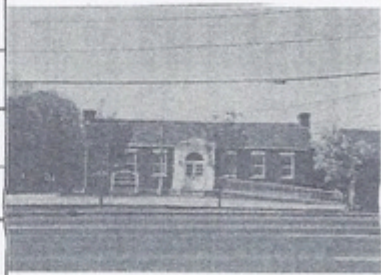
11. NUMBER OF STORIES		APPROXIMATE DIMENSIONS			
1.5		58x92			
12. CONDITION (Structural)		(Exterior)			
<input checked="" type="checkbox"/> Excellent <input type="checkbox"/> Good <input type="checkbox"/> Fair <input type="checkbox"/> Deteriorated		<input checked="" type="checkbox"/> Excellent <input type="checkbox"/> Good <input type="checkbox"/> Fair <input type="checkbox"/> Deteriorated

DESCRIPTION (continued)	17. OTHER NOTABLE FEATURES OF BUILDING OR SITE (Interior and/or exterior)	
	<p>The Wapping Community House is a one-and-one-half story Colonial Revival building. The building is marked by symmetry. Chimneys are centered in each end gable, and a small frontispiece marks the center of the building. Both the chimneys and the entry are centered between windows, with one on each side to the chimneys and three on each side of the entry. The corners are marked by brick quoins. Decorative elements are executed in concrete (CHECK), with the shoulders of the chimneys, the the flat arch window heads and their keystones, and the foundation all created from this material. The frontispiece includes a small projecting gable, pilasters flanking the entry, and a double leaf door under a a blank demi-lune window.</p>	
SIGNIFICANCE	18. ARCHITECT Turner and Sellow (Middletown, CT)	BUILDER Arvid Sieburg (Manchester, CT)

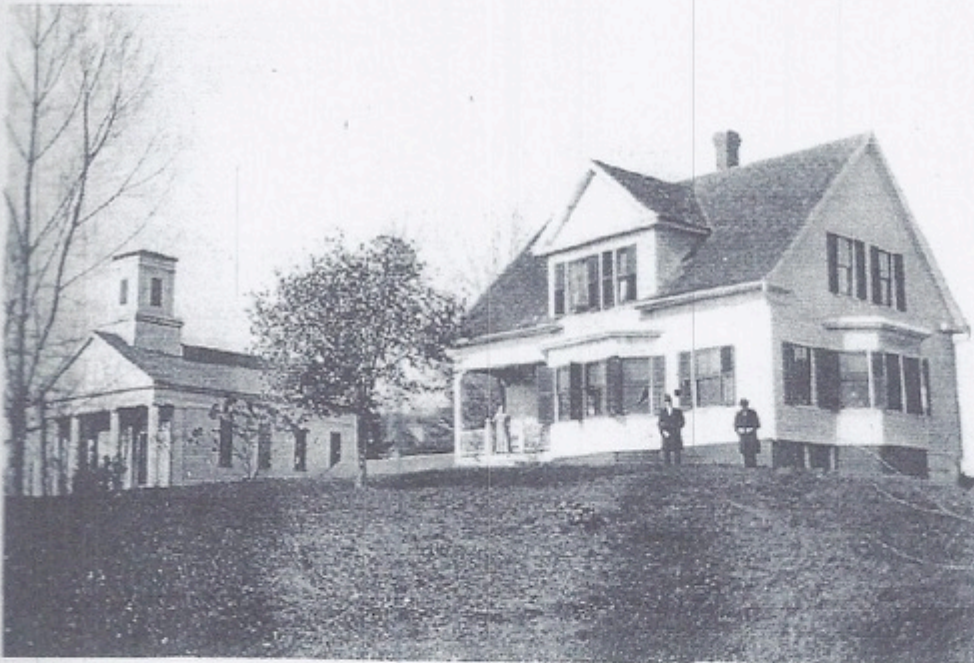
Shows Wapping Community Church with parsonage (now demolished) in foreground.

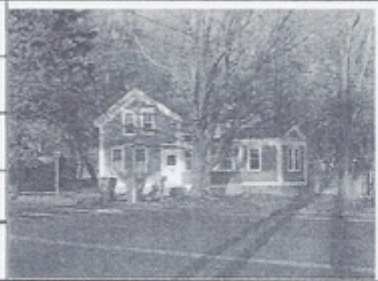
11. NUMBER OF STORIES 1.5		APPROXIMATE DIMENSIONS 36'x20'; 14'x5'; 10'x9'; 11'x5'; 14'x14'			
12. CONDITION (Structural)					
<input type="checkbox"/> Excellent <input checked="" type="checkbox"/> Good <input type="checkbox"/> Fair <input type="checkbox"/> Deteriorated (Exterior) <input type="checkbox"/> Excellent <input checked="" type="checkbox"/> Good <input type="checkbox"/> Fair <input type="checkbox"/> Deteriorated

DESCRIPTION (continued)	17. OTHER NOTABLE FEATURES OF BUILDING OR SITE (Interior and/or exterior)	
	550 Buckland Road one-and-one-half story, three bay gable-front-and-wing Greek Revival style building with a side hall plan. The building has a deep frieze and corner pilasters on the main block which are echoed in smaller scale on the wing. The inside corner between the main block and wing is now filled with an enclosed porch with a hip roof.	
SIGNIFICANCE	18. ARCHITECT	BUILDER

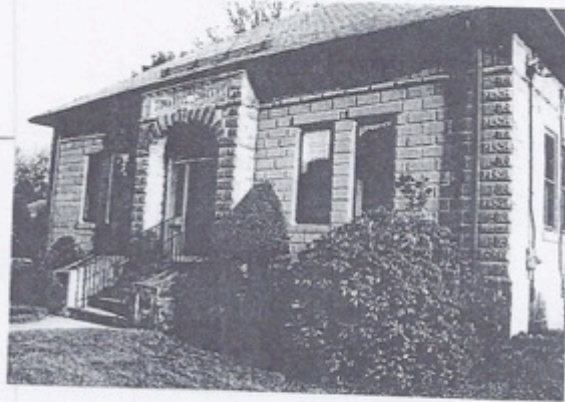
11. NUMBER OF STORIES					
1					
APPROXIMATE DIMENSIONS					
24 x 36					
12. CONDITION (Structural)					
<input type="checkbox"/> Excellent <input checked="" type="checkbox"/> Good <input type="checkbox"/> Fair <input type="checkbox"/> Deteriorated (Exterior) <input type="checkbox"/> Excellent <input checked="" type="checkbox"/> Good <input type="checkbox"/> Fair <input type="checkbox"/> Deteriorated

PHOTO	PHOTOGRAPHER	DATE	Nancy Gardner	11/2004	VIEW	SE	NEGATIVE ON FILE		Wood Library	COMPILED BY	NAME	DATE	Stacey S. Vairo	1/2006	ORGANIZATION		Fitzgerald & Halliday, Inc.			ADDRESS			72 Cedar Street, Hartford, CT 06106
PHOTO	PHOTOGRAPHER	DATE																								
	Nancy Gardner	11/2004																								
VIEW	SE	NEGATIVE ON FILE																								
		Wood Library																								
COMPILED BY	NAME	DATE																								
	Stacey S. Vairo	1/2006																								
	ORGANIZATION																									
	Fitzgerald & Halliday, Inc.																									
	ADDRESS																									
	72 Cedar Street, Hartford, CT 06106

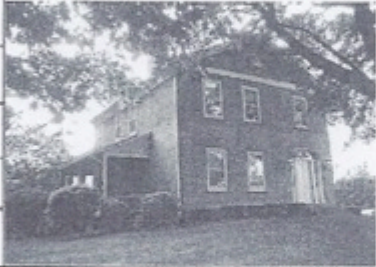
11. NUMBER OF STORIES		APPROXIMATE DIMENSIONS			
2.5		26' x 76'			
12. CONDITION (Structural)		(Exterior)			
<input type="checkbox"/> Excellent <input checked="" type="checkbox"/> Good <input type="checkbox"/> Fair <input type="checkbox"/> Deteriorated		<input type="checkbox"/> Excellent <input checked="" type="checkbox"/> Good <input type="checkbox"/> Fair <input type="checkbox"/> Deteriorated

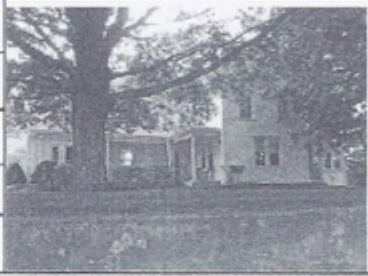
11. NUMBER OF STORIES		APPROXIMATE DIMENSIONS	
2.5		109' x 59'	
12. CONDITION (Structural)		(Exterior)	
<input type="checkbox"/> Excellent <input checked="" type="checkbox"/> Good <input type="checkbox"/> Fair <input type="checkbox"/> Deteriorated		<input type="checkbox"/> Excellent <input checked="" type="checkbox"/> Good <input type="checkbox"/> Fair <input type="checkbox"/> Deteriorated

DESCRIPTION (continued)	17. OTHER NOTABLE FEATURES OF BUILDING OR SITE (Interior and/or exterior)	
	<p>651 Clark Street is a two-and-one-half story, vernacular building from the late nineteenth century. Over the years its original L-shaped plan has grown into a complex building shaped somewhat like the upper part of a question mark and housing three separate apartments.</p>	
SIGNIFICANCE	18. ARCHITECT	BUILDER

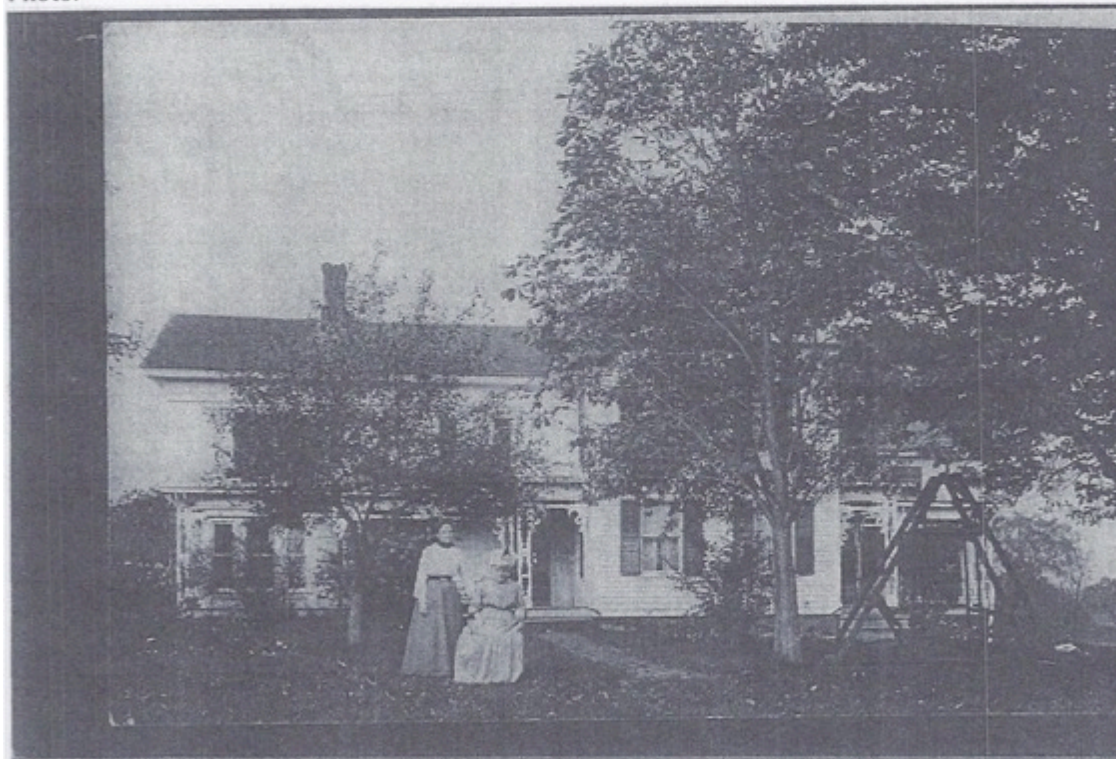
Oliver Clark House (Waldron's) on Clark Street, Opposite Post Office
1880's

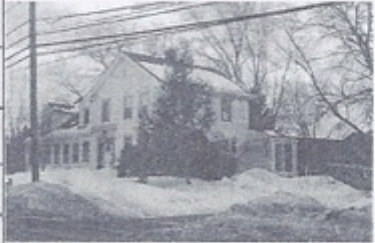
11. NUMBER OF STORIES		APPROXIMATE DIMENSIONS	
2.5		24' x 53'	
12. CONDITION (Structural)		(Exterior)	
<input type="checkbox"/> Excellent <input type="checkbox"/> Good <input checked="" type="checkbox"/> Fair <input type="checkbox"/> Deteriorated		<input type="checkbox"/> Excellent <input type="checkbox"/> Good <input checked="" type="checkbox"/> Fair <input type="checkbox"/> Deteriorated

DESCRIPTION (continued)	17. OTHER NOTABLE FEATURES OF BUILDING OR SITE (Interior and/or exterior)	
	<p>1581 Ellington Road is a two-and-one-half, three bay, gable-front-and-wing Greek Revival style house with a an enclosed porch on the wing. The wing has two peak-roofed dormers and there is a two part ell that angles off of the southwest corner of the building.</p>	
SIGNIFICANCE	18. ARCHITECT	BUILDER
