JMM WETLAND CONSULTING SERVICES, LLC

March 14, 2023

RE: ***SITE REVIEW OF PREVIOUSLY DELINEATED WETLAND***
444 Nutmeg Road North, South Windsor, Connecticut

JMM Job # 22-3133-SWN-4

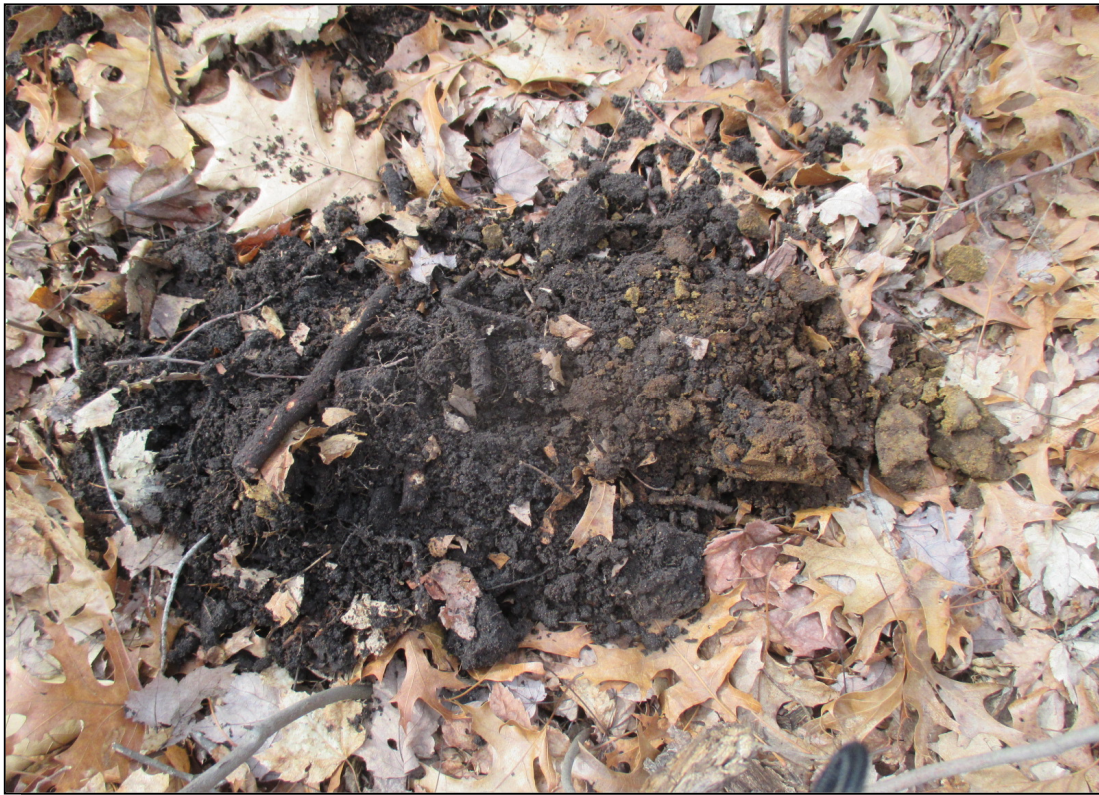
It was determined that the soil matrix chroma within 20-inches, at in each of the shallow pits, was above a chroma 2, which indicates the soil profiles are not a poorly drained soils, and therefore, not a regulated wetland area. As you may recall, in order to meet the criteria of poorly drained and/or very poorly drained regulated soil, the chroma within 20-inches must have a chroma 2 or less and a value of 4 or higher. In our shallow soil test pits, the Munsell soil colors were either 7.5YR 4/3 (brown) or 10YR 5/4 (yellowish brown). All matrix chromas were observed to be above 2 and with the values 4 or greater.

*Photo 1: View of typical profile within the previously delineated wetland
(JMM photo taken 2/16/2023)*

In conclusion, it is JMM's opinion that the area previously flagged as a regulated wetland is not a wetland, but rather a non-regulated, moderately well drained upland area.

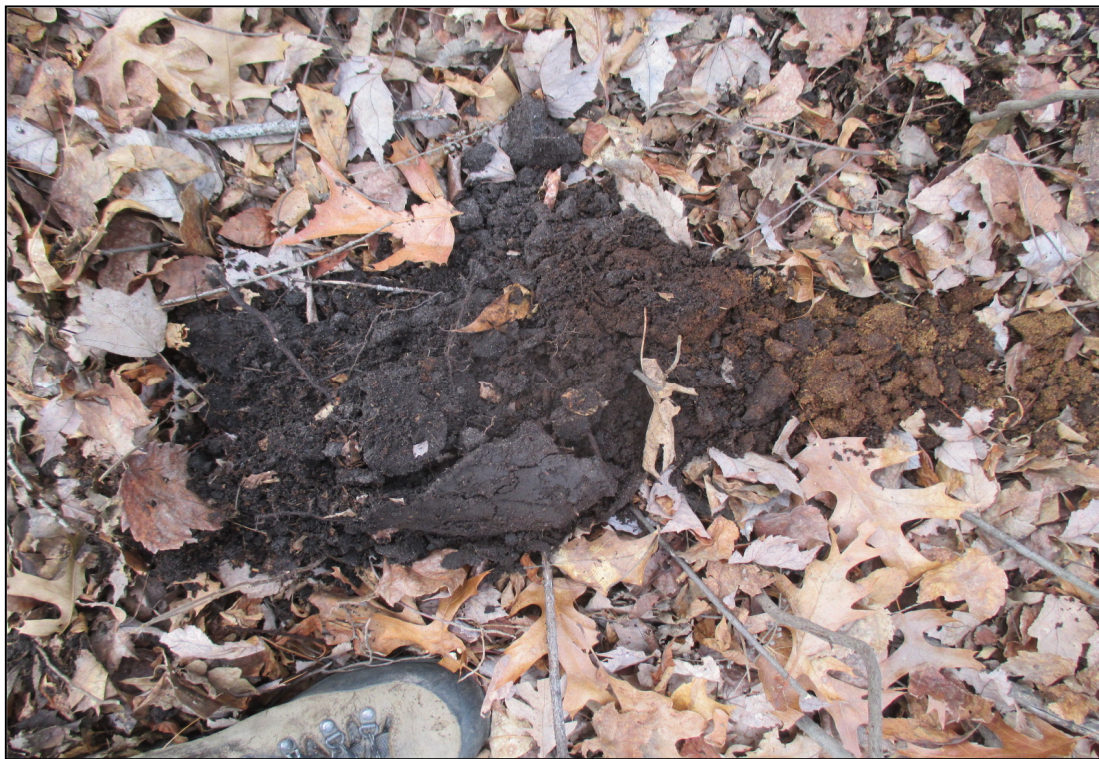
*Photo 2: View of typical profile within the previously delineated wetland
(JMM photo taken 2/16/2023)*
