Technical Memorandum

Project No. 141.20442.00001

**RE: 240 Deming Street – Additional Soil Investigations
South Windsor, Connecticut**

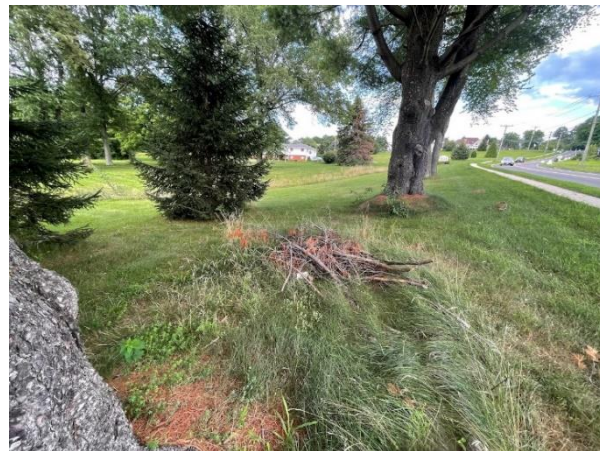
A portion of the southwestern property along Deming Street was identified due to Natural Resources Conservation Service (NRCS) Web Soil Survey mapping. The NRCS map depicts a hydric soil unit (12 – Raypol silt loam) extending north across Deming Street, with a small portion of the polygon (<0.1 acre) displayed onsite. In this area, vegetation consists of manicured lawn with scattered Eastern white pine (*Pinus strobus*), Norway spruce (*Picea abies*), and arborvitae (*Thuja* sp.) trees, sloping north from Deming Street and the adjacent sidewalk.

Southwestern Area of Investigation (Facing East)

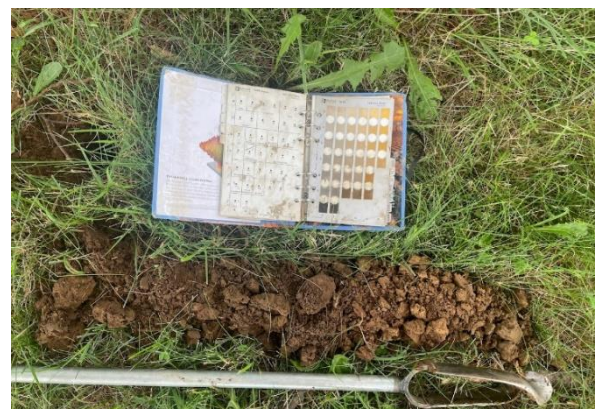
A Dutch auger was used to observe the color and morphology of soils from 0 to 24 inches in depth. A soil core was taken near the center of the NRCS-mapped Raypol area. From 0 to 18 inches, the very friable silt loam soil was identified as 10YR 3/3 in hue. From 18 to 24 inches, a silt loam of similar texture was identified as 10Y/R 4/4 in hue, with some faint concentrations (7/5YR 4/6) and few faint depletions (10YR 2/1). No water table or saturation was encountered; no surface water was observed. Based on these results, this soil was classified as non-hydric.

Soil Core within Southwestern Area of Investigation

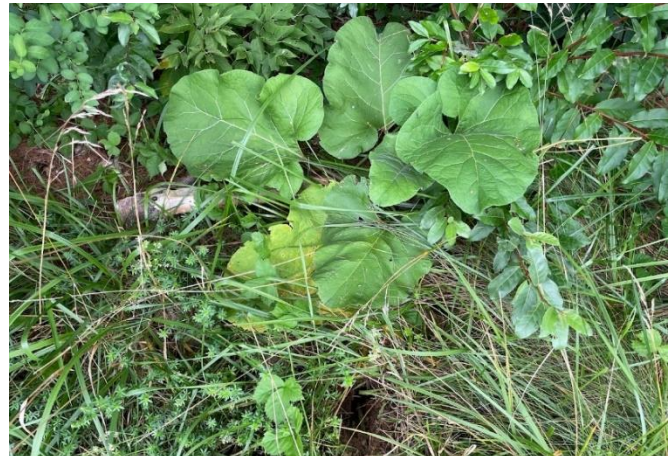
A second area of investigation was identified within an alley of eastern white pines in the western/central portion of the property. This area was identified due to a reported observation of an obligate wetland plant species – skunk cabbage (*Symplocarpus foetidus*). No skunk cabbage was found in this area; it is likely that the observer mistakenly identified common burdock (*Arctium minus*), a similarly-looking facultative upland species, for skunk cabbage. Common burdock was observed in multiple locations along the white pine alley, which also consists of autumn olive (*Elaeagnus umbellata*), northern catalpa (*Catalpa speciosa*), white mulberry (*Morus alba*), Asiatic bittersweet (*Celastrus orbiculatus*), poison ivy (*Toxicodendron radicans*), Virginia creeper (*Parthenocissus quinquefolia*), American pokeweed (*Phytolacca americana*), white clover (*Trifolium repens*), bedstraw (*Galium* sp.), and various grasses. Of the identified species, none are classified as facultative wetland or obligate wetland species in this region by the U.S. Army Corps of Engineers (USACE).

Common Burdock Likely Mistaken for Skunk Cabbage

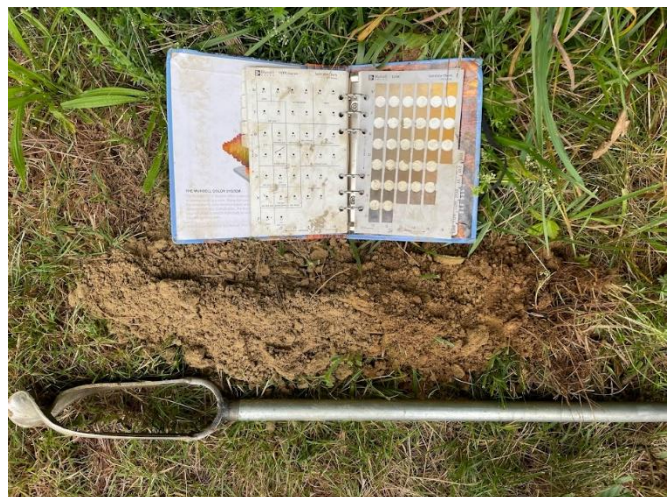
A soil core was taken in the area identified, near a large burdock. Soil morphology was able to be observed to approximately 20-inches in depth before encountering a restrictive layer of compacted soil. From 0 to 2 inches, the silt loam soil contained many roots, no redoximorphic features, and was identified as 10YR 3/6 in hue. From 2 to 12 inches, it contained few roots, no redoximorphic features, and was identified as 10YR 4/6 in hue. From 12 to 20 inches, no roots were observed and few faint concentrations (7.5YR 4/6) were observed. The dominant matrix color was 10YR 5/4. The soil was loose and friable throughout, with no water table or saturation encountered within 20 inches. Based on these results, this soil is classified as non-hydric.

Soil Core within Central Area of Investigation

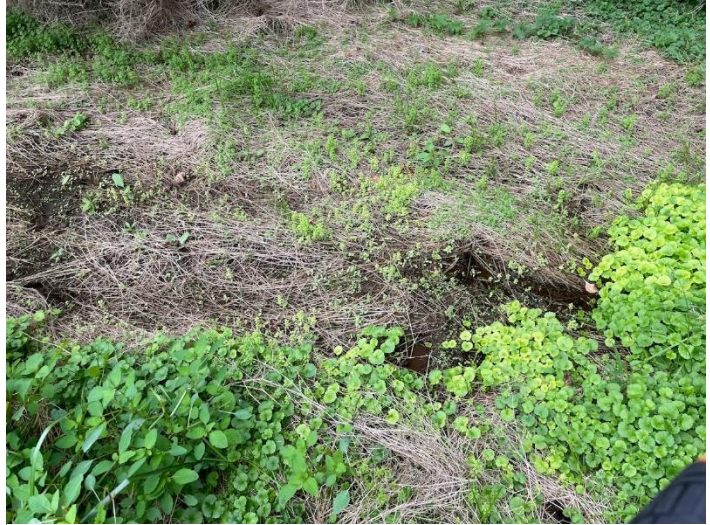
On the day of investigation, surface water lacking a channel was observed up to approximately 6 feet beyond the final intermittent watercourse flag. Dissipation through infiltration and evaporation occurs in the non-hydric soils within the area of investigation. No additional wetland and/or watercourse resources were delineated on site. Again, the area does not meet the statutory definition of an intermittent watercourse and the occasional presence of water in this area is typical of its landscape position.

Dissipation Occurring within Northern Area of Investigation
