# Wetland and Watercourse Delineation and Impact Assessment

**240 Deming Street, South Windsor, Connecticut**

## **The Metro Realty Group, Ltd.**

June 28, 2023

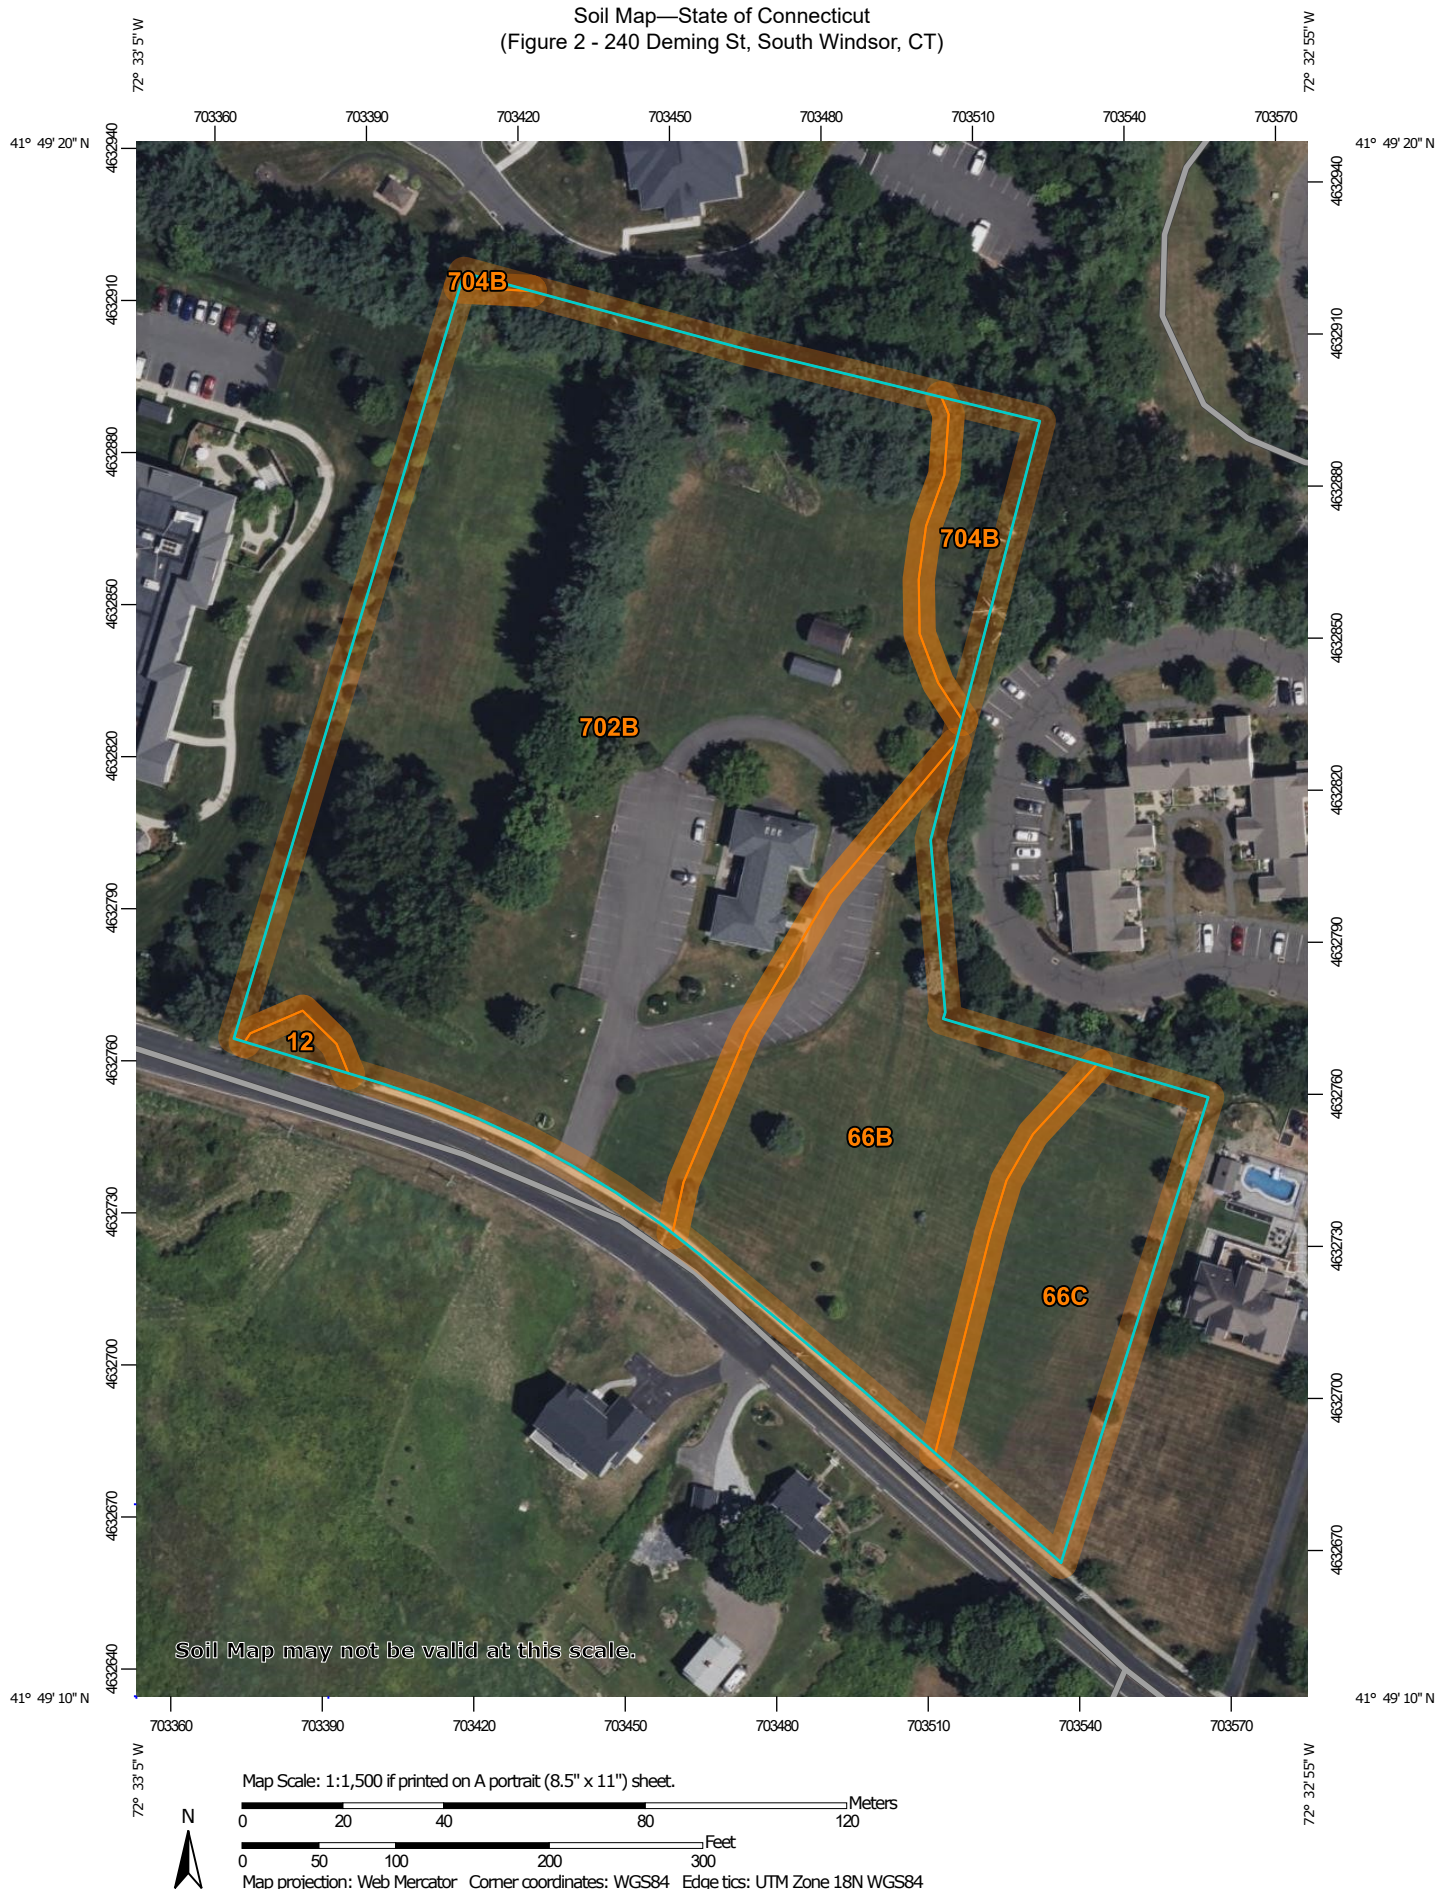
Soil Map—State of Connecticut  
(Figure 2 - 240 Deming St, South Windsor, CT)

Geospatial data were accessed via the USDA – Natural Resources Conservation Service (USDA-NRCS) web soil survey mapping. The soil survey mapping is appended (**Figure 3**). The survey identifies the following soil mapping units with associated NRCS map number in the project area (**Table 1**):

Soils were examined using a Dutch auger. Field investigations confirmed NRCS mapping; however, the poorly drained Raypol silt loam mapped in the southwestern portion of the site was not encountered. The area in which this soil unit is mapped by NRCS is comprised of upland manicured lawn with scattered white pine and arborvitae; no evidence of wetland hydrology, soils, or vegetation were observed. No poorly drained or very poorly drained soils were encountered onsite. Please note that SLR did not fully delineate upland soil types within the subject site.

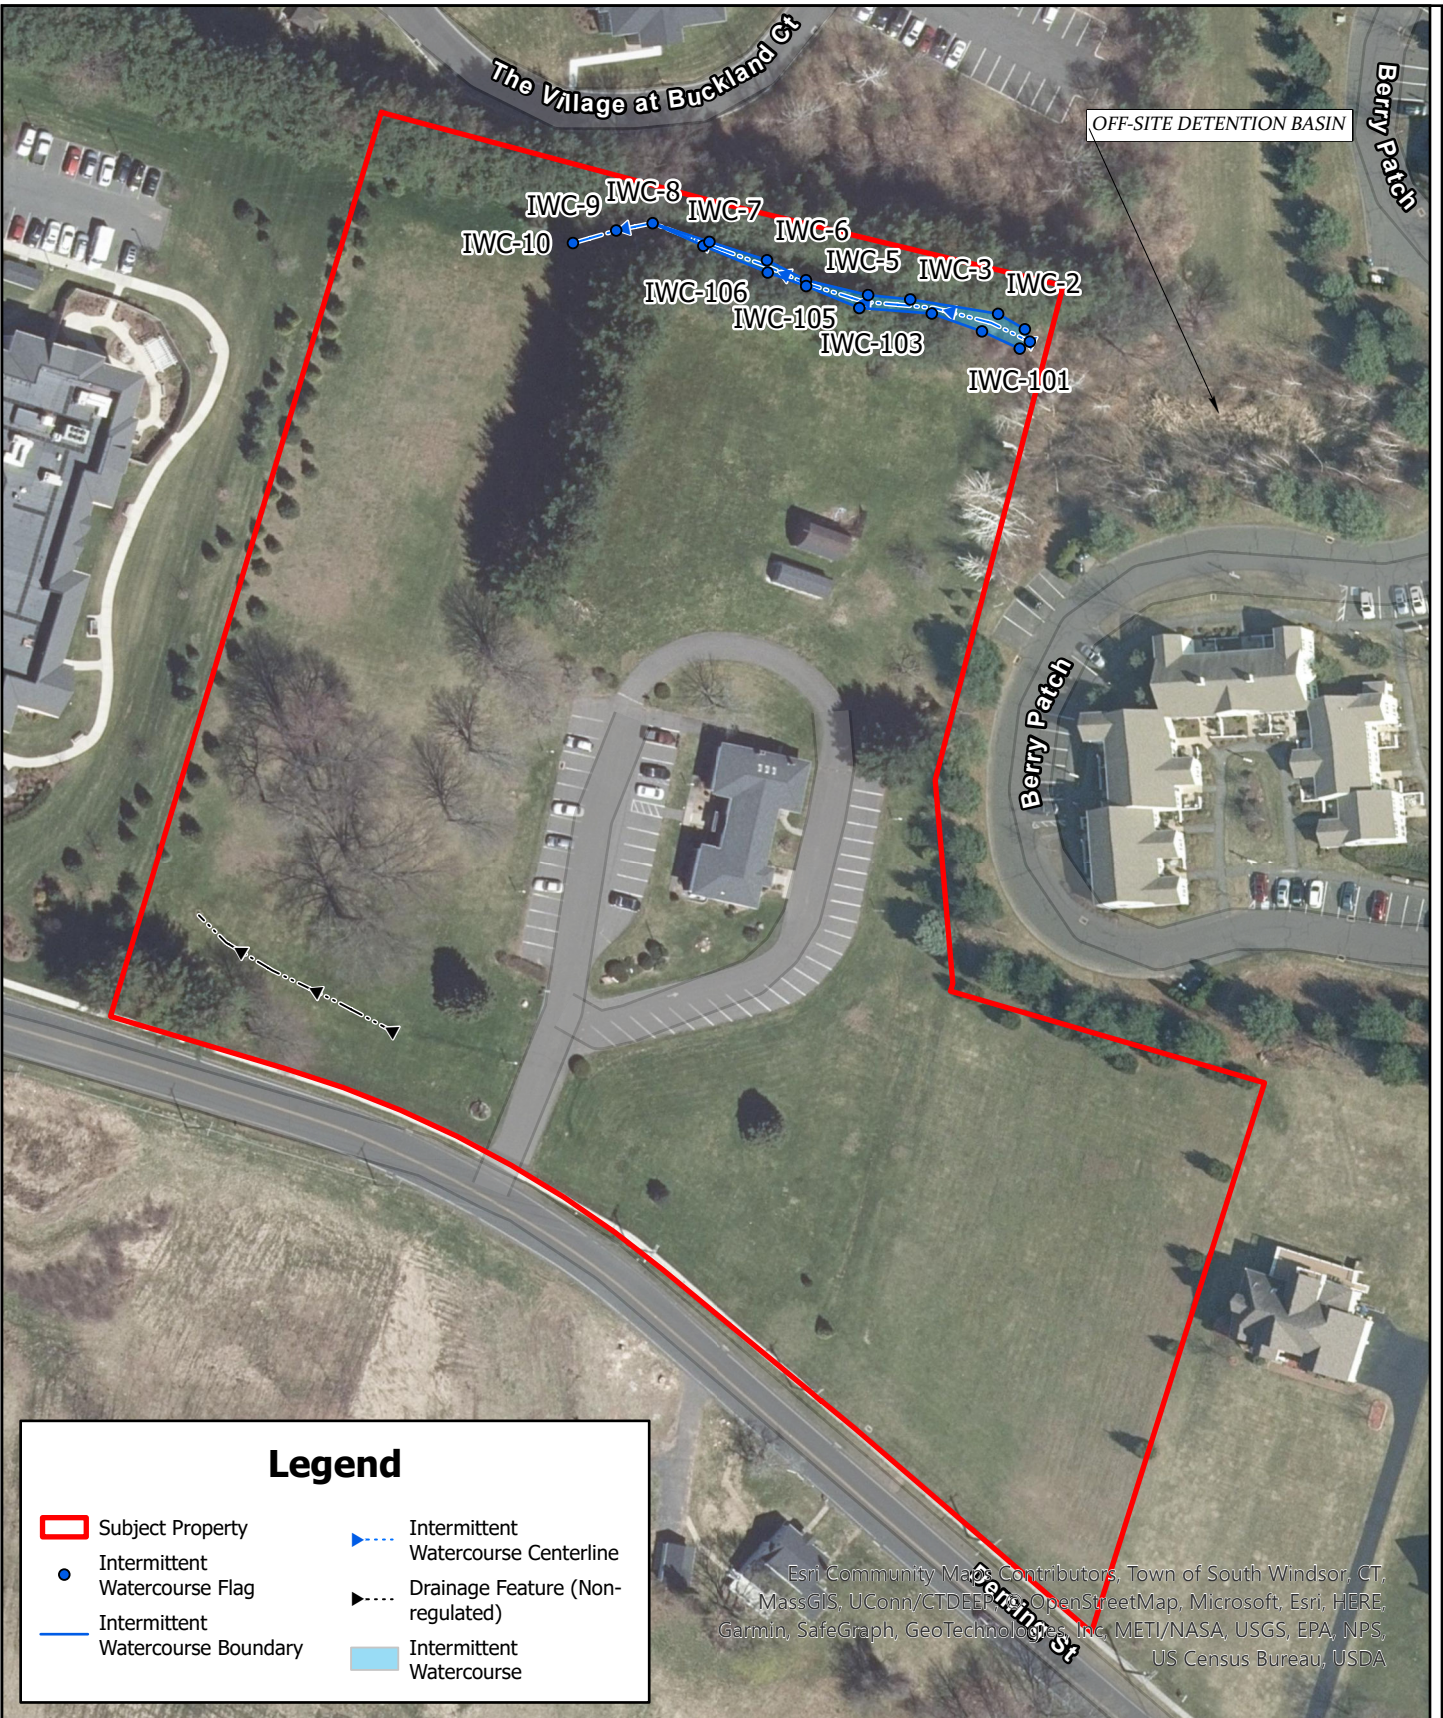
FIG. 3

Regulated resources onsite consist of one approximately 260-LF intermittent watercourse. The watercourse originates from a pipe in the northeastern portion of the site and flows west through a vegetated corridor before dissipating via evaporation and infiltration in the north-central portion of the site. The watercourse itself occupies approximately 1,350 square feet (SF), which represents approximately 0.5 percent of the 6.3-acre property. Land within 100 feet of the watercourse, regulated by the Town of South Windsor as URA, occupies 45,650 SF onsite, or approximately 16.6 percent of the subject property.

SLR Registered Soil Scientist and Professional Wetland Scientist Megan B. Raymond, and Environmental Scientist Meaghan Fogarty, delineated the intermittent watercourse in May 2023. Classification of the intermittent watercourse was determined based on the presence of a defined channel with bed and banks, evidence of scour, the presence of flowing water for a duration longer than a particular storm incident (no storm events were noted in the area within the two days prior to the delineation), and the presence of hydrophytic vegetation. The terminus of the watercourse was determined based on the lack of a defined channel, which occurs at flag IWC-10. On the day of investigation, water was observed in the channel.

## WATERCOURSE DELINEATION

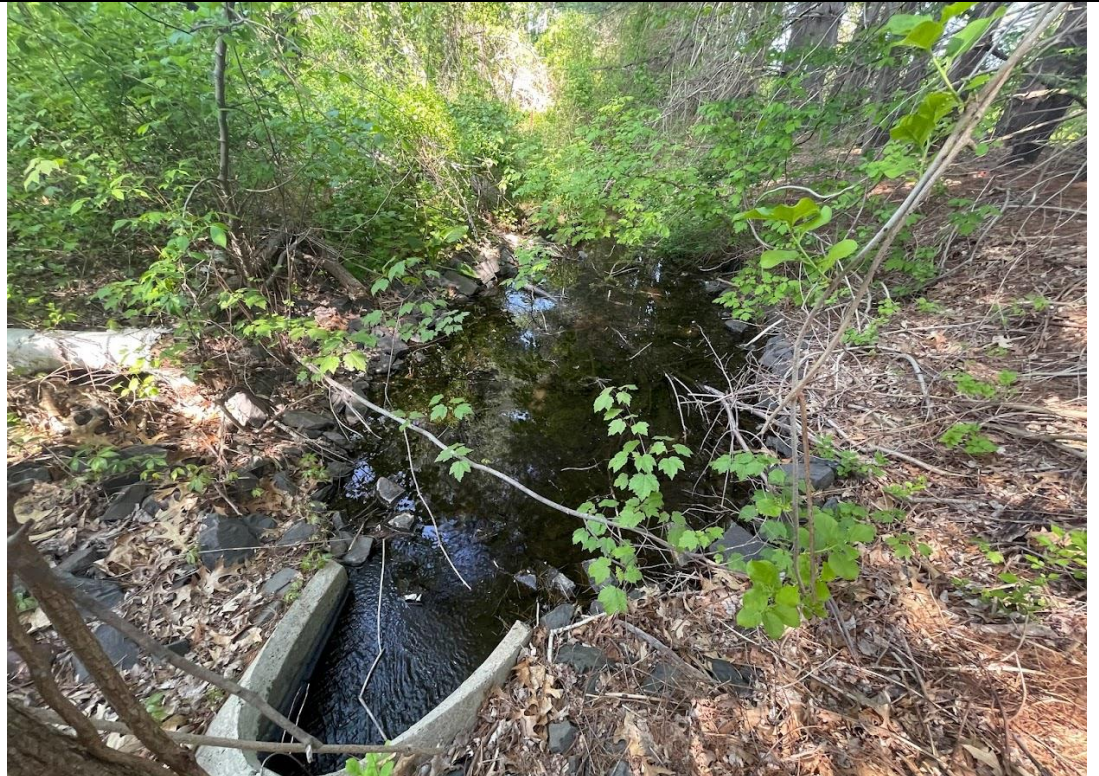
**Photo No.**  
1

The intermittent watercourse is engineered and originates from an off-site constructed stormwater basin, approximately 10 feet from the eastern property boundary (**Appendix A, Figure 3, Appendix B**). At the outlet, the flared-end concrete pipe is stabilized with riprap. The watercourse is approximately 10-feet-wide at the pipe outlet and narrows to approximately 3-feet-wide near flag IWC-8, before dissipating into a lawn area at its downstream (western) extent. The channel is low-gradient with substrate primarily comprised of fine sand, silt, and leaf litter. An upland canopy, dominated by an allee of white pine, shades the watercourse. On the day of the site evaluation, the intermittent watercourse conveyed water ranging from approximately 0 to 5 inches in depth, decreasing in depth from upstream to downstream. Woody debris and dense vegetation cover portions of the watercourse, primarily in the downstream portion. Much of the woody debris is derived from limbs of the adjacent pine trees. In addition to

**Description:**  
Outlet pipe of the off-site detention basin, originating the intermittent watercourse.

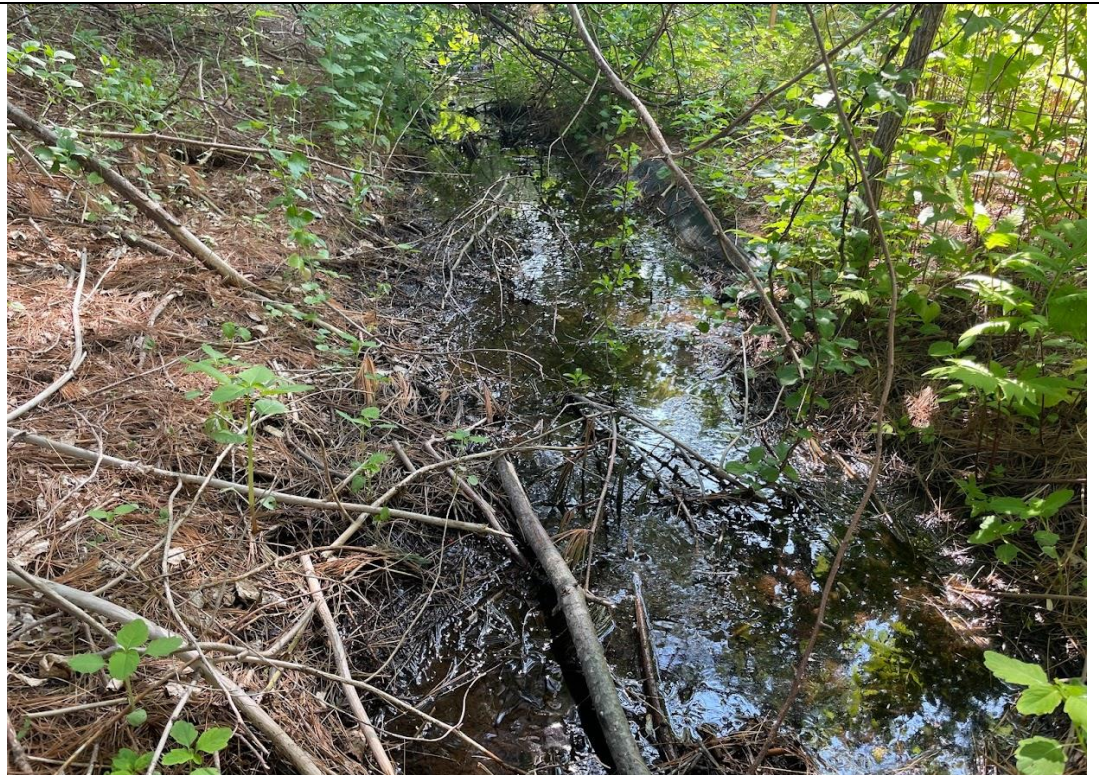
**Photo No.**  
2

**Description:**  
Intermittent watercourse from near flag IWC-3, facing upstream.

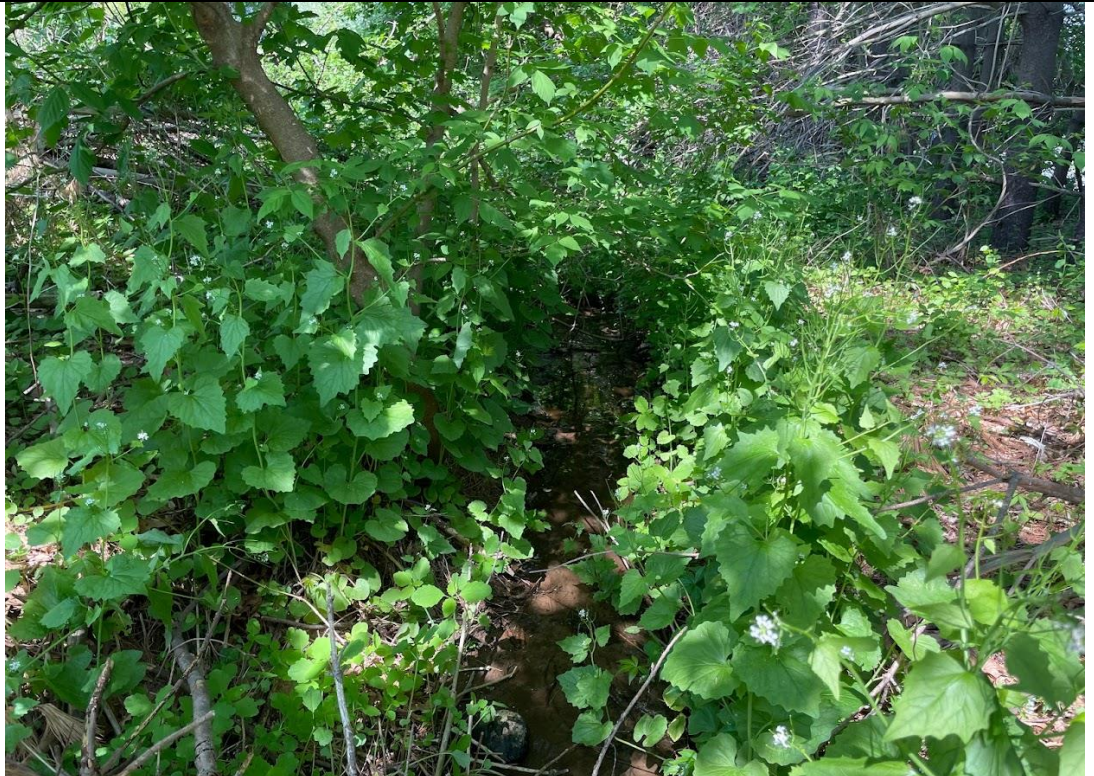
**Photo No.**  
3

**Description:**  
Intermittent watercourse  
from near flag IWC-9, facing  
upstream.

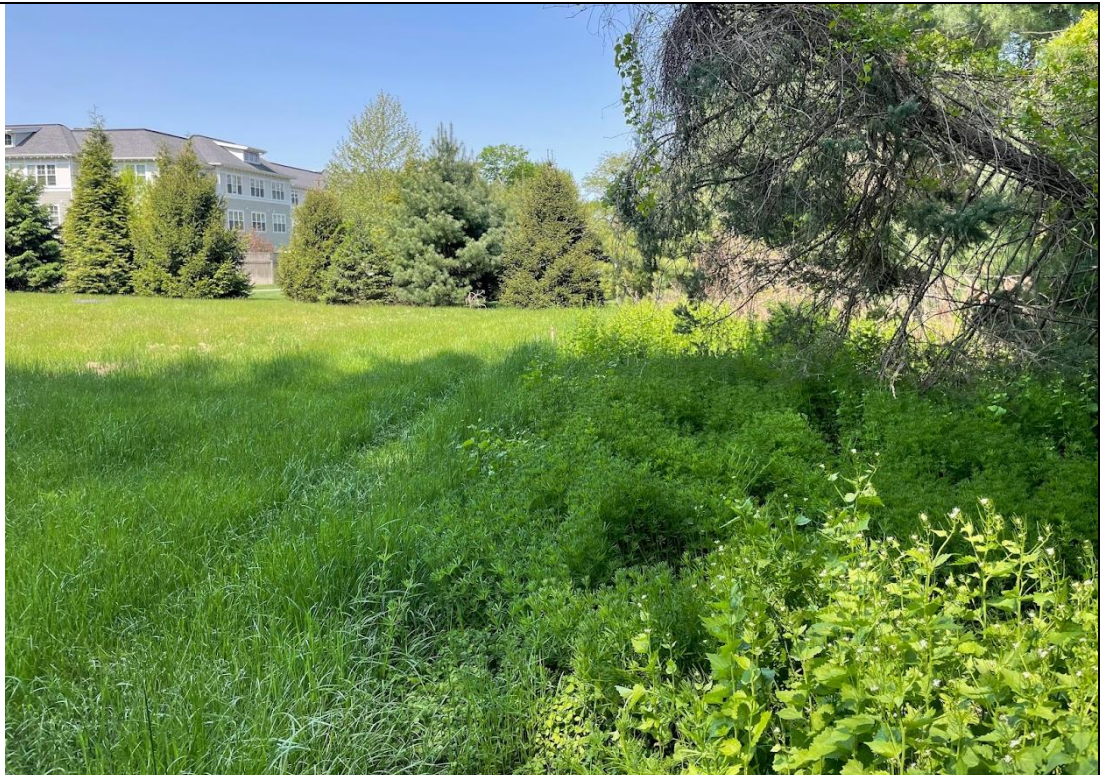
**Photo No.**  
4

**Description:**  
Terminus of intermittent  
watercourse, where flow  
dissipates into a mowed  
field.

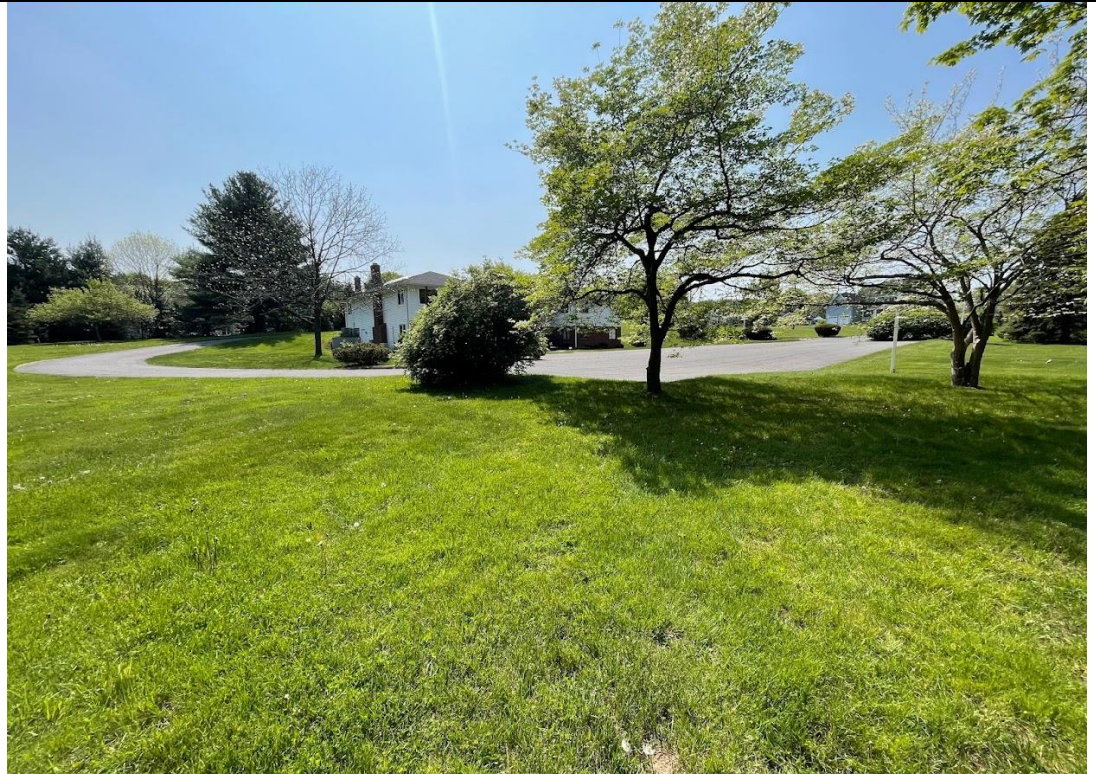
**Photo No.**  
5

**Description:**  
Existing development.

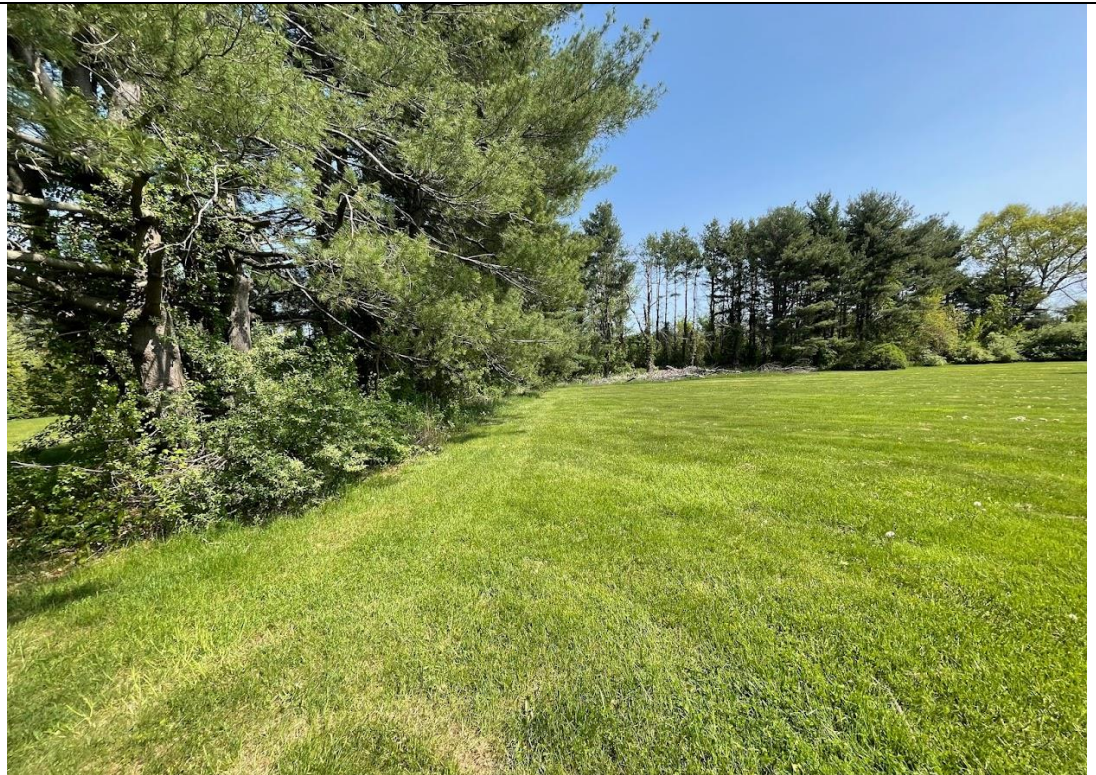
**Photo No.**  
6

**Description:**  
Existing site. Perpendicular arrangement of eastern white pines is visible.
