**RE: 3<sup>RD</sup> PARTY VERIFICATION OF WETLANDS/WATERCOURSES**

5 & 25 Talbot Road, 475 & 551 Governor's Highway, South Windsor, CT

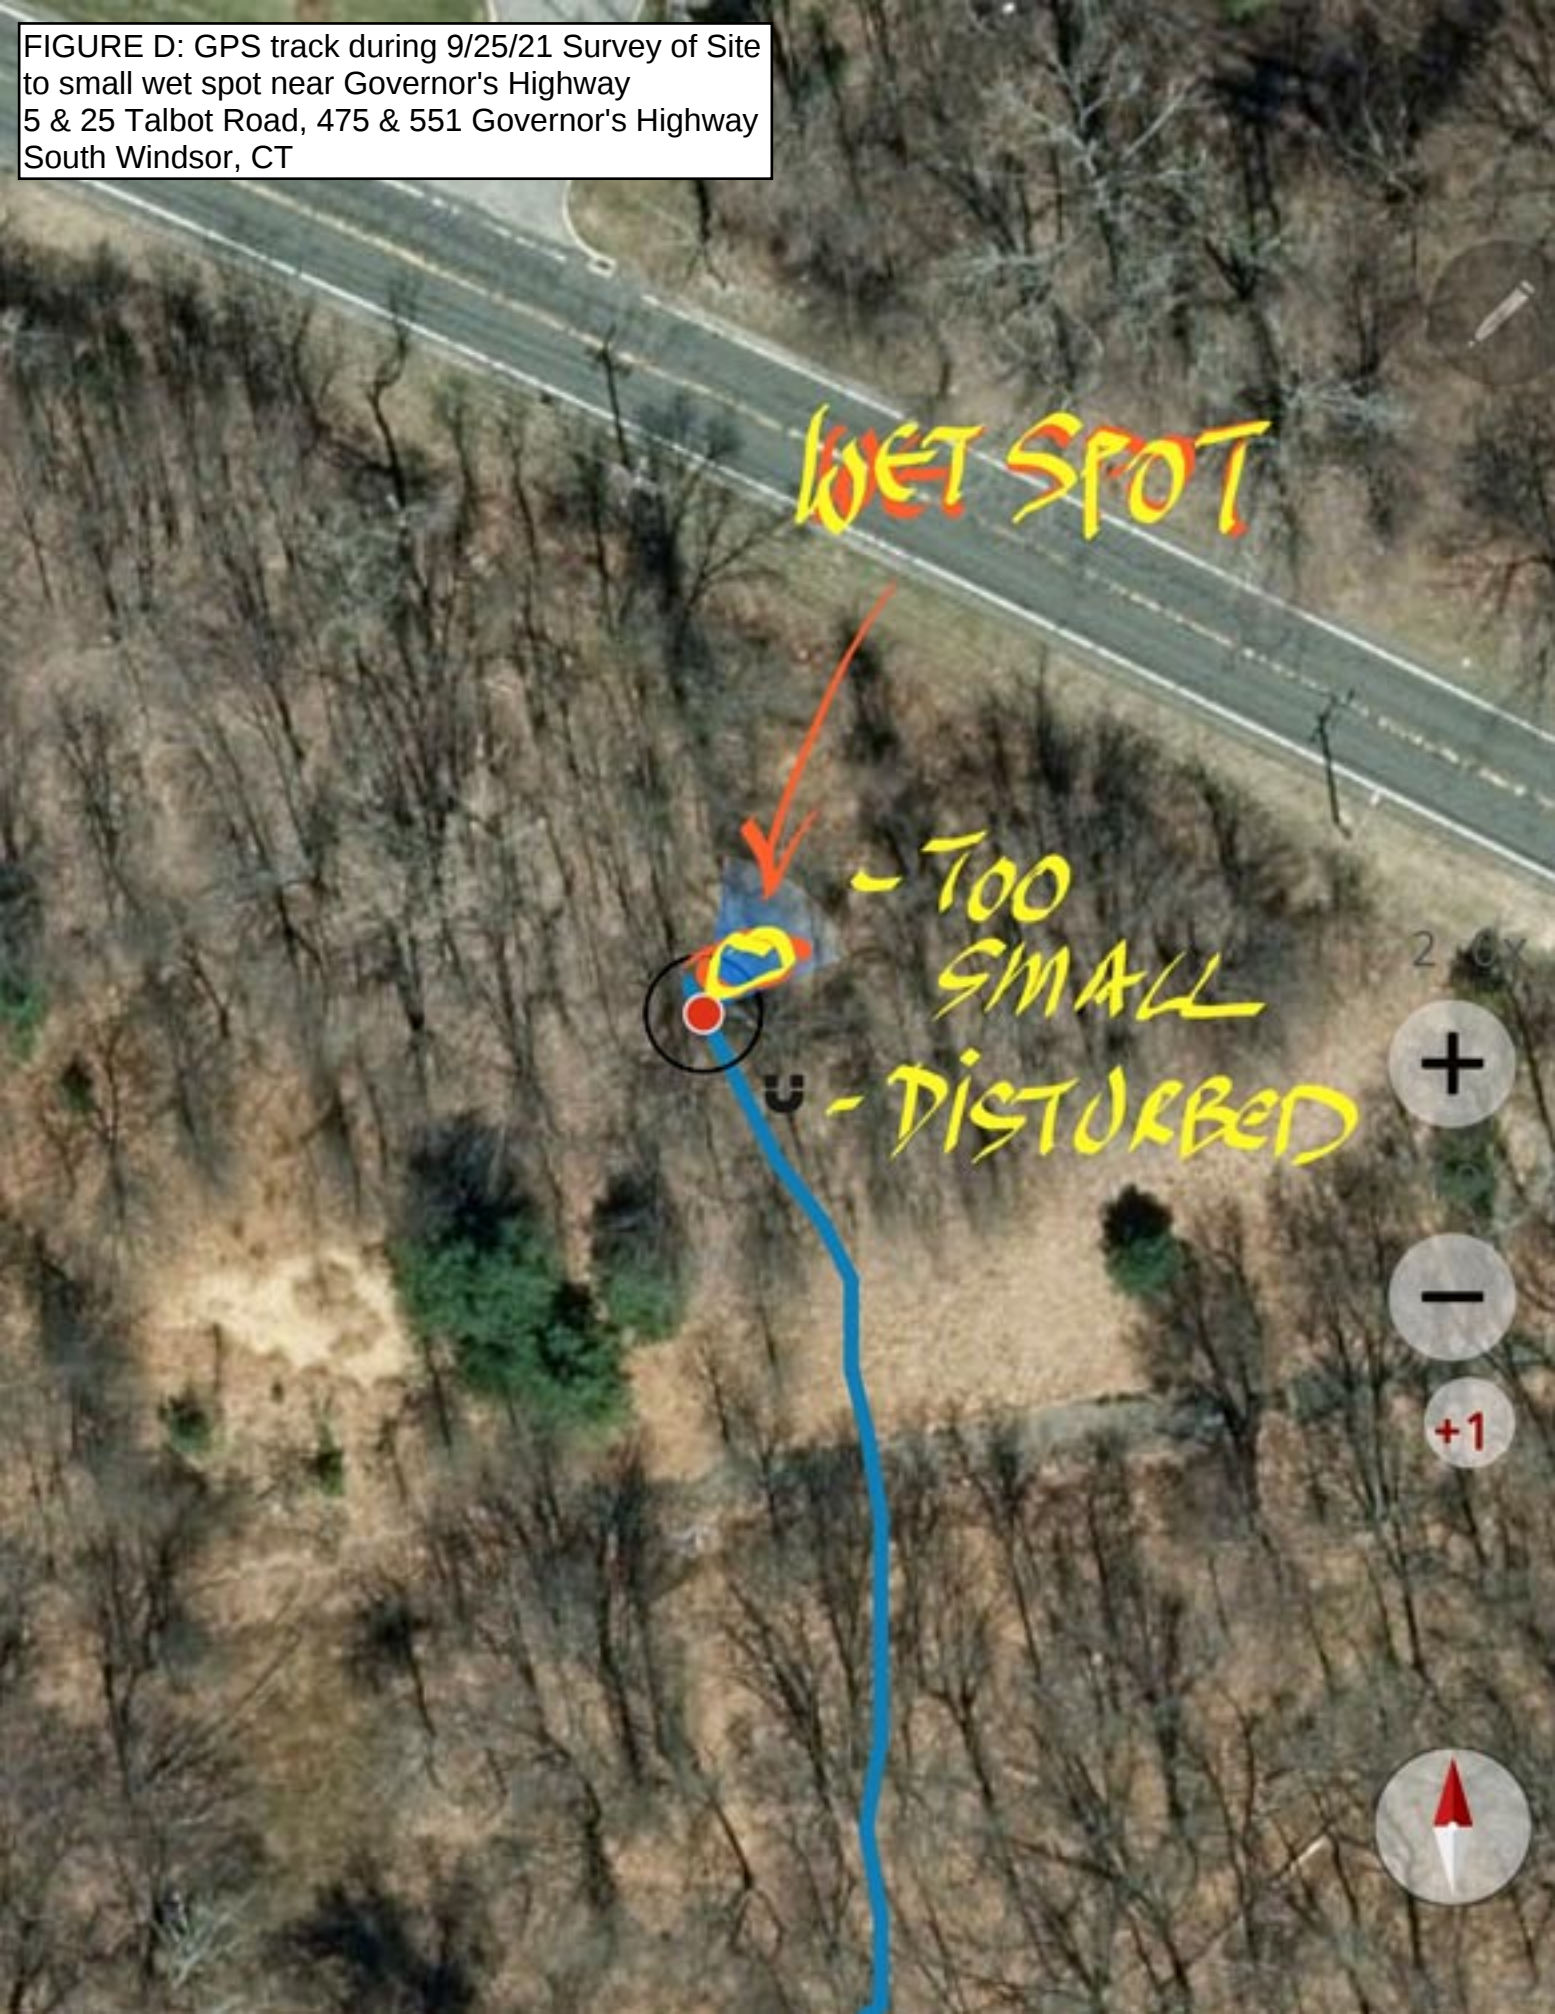
FIGURE D: GPS track during 9/25/21 Survey of Site to small wet spot near Governor's Highway 5 & 25 Talbot Road, 475 & 551 Governor's Highway South Windsor, CT

3. All of the "areas of concern" shown on the figure included in the letter by Dr. Danzer, did not contain poorly drained wetland soil profiles.
4. A small, excavated wet depression was observed in the northern portion of the site, but was determined to be too small to be delineated.

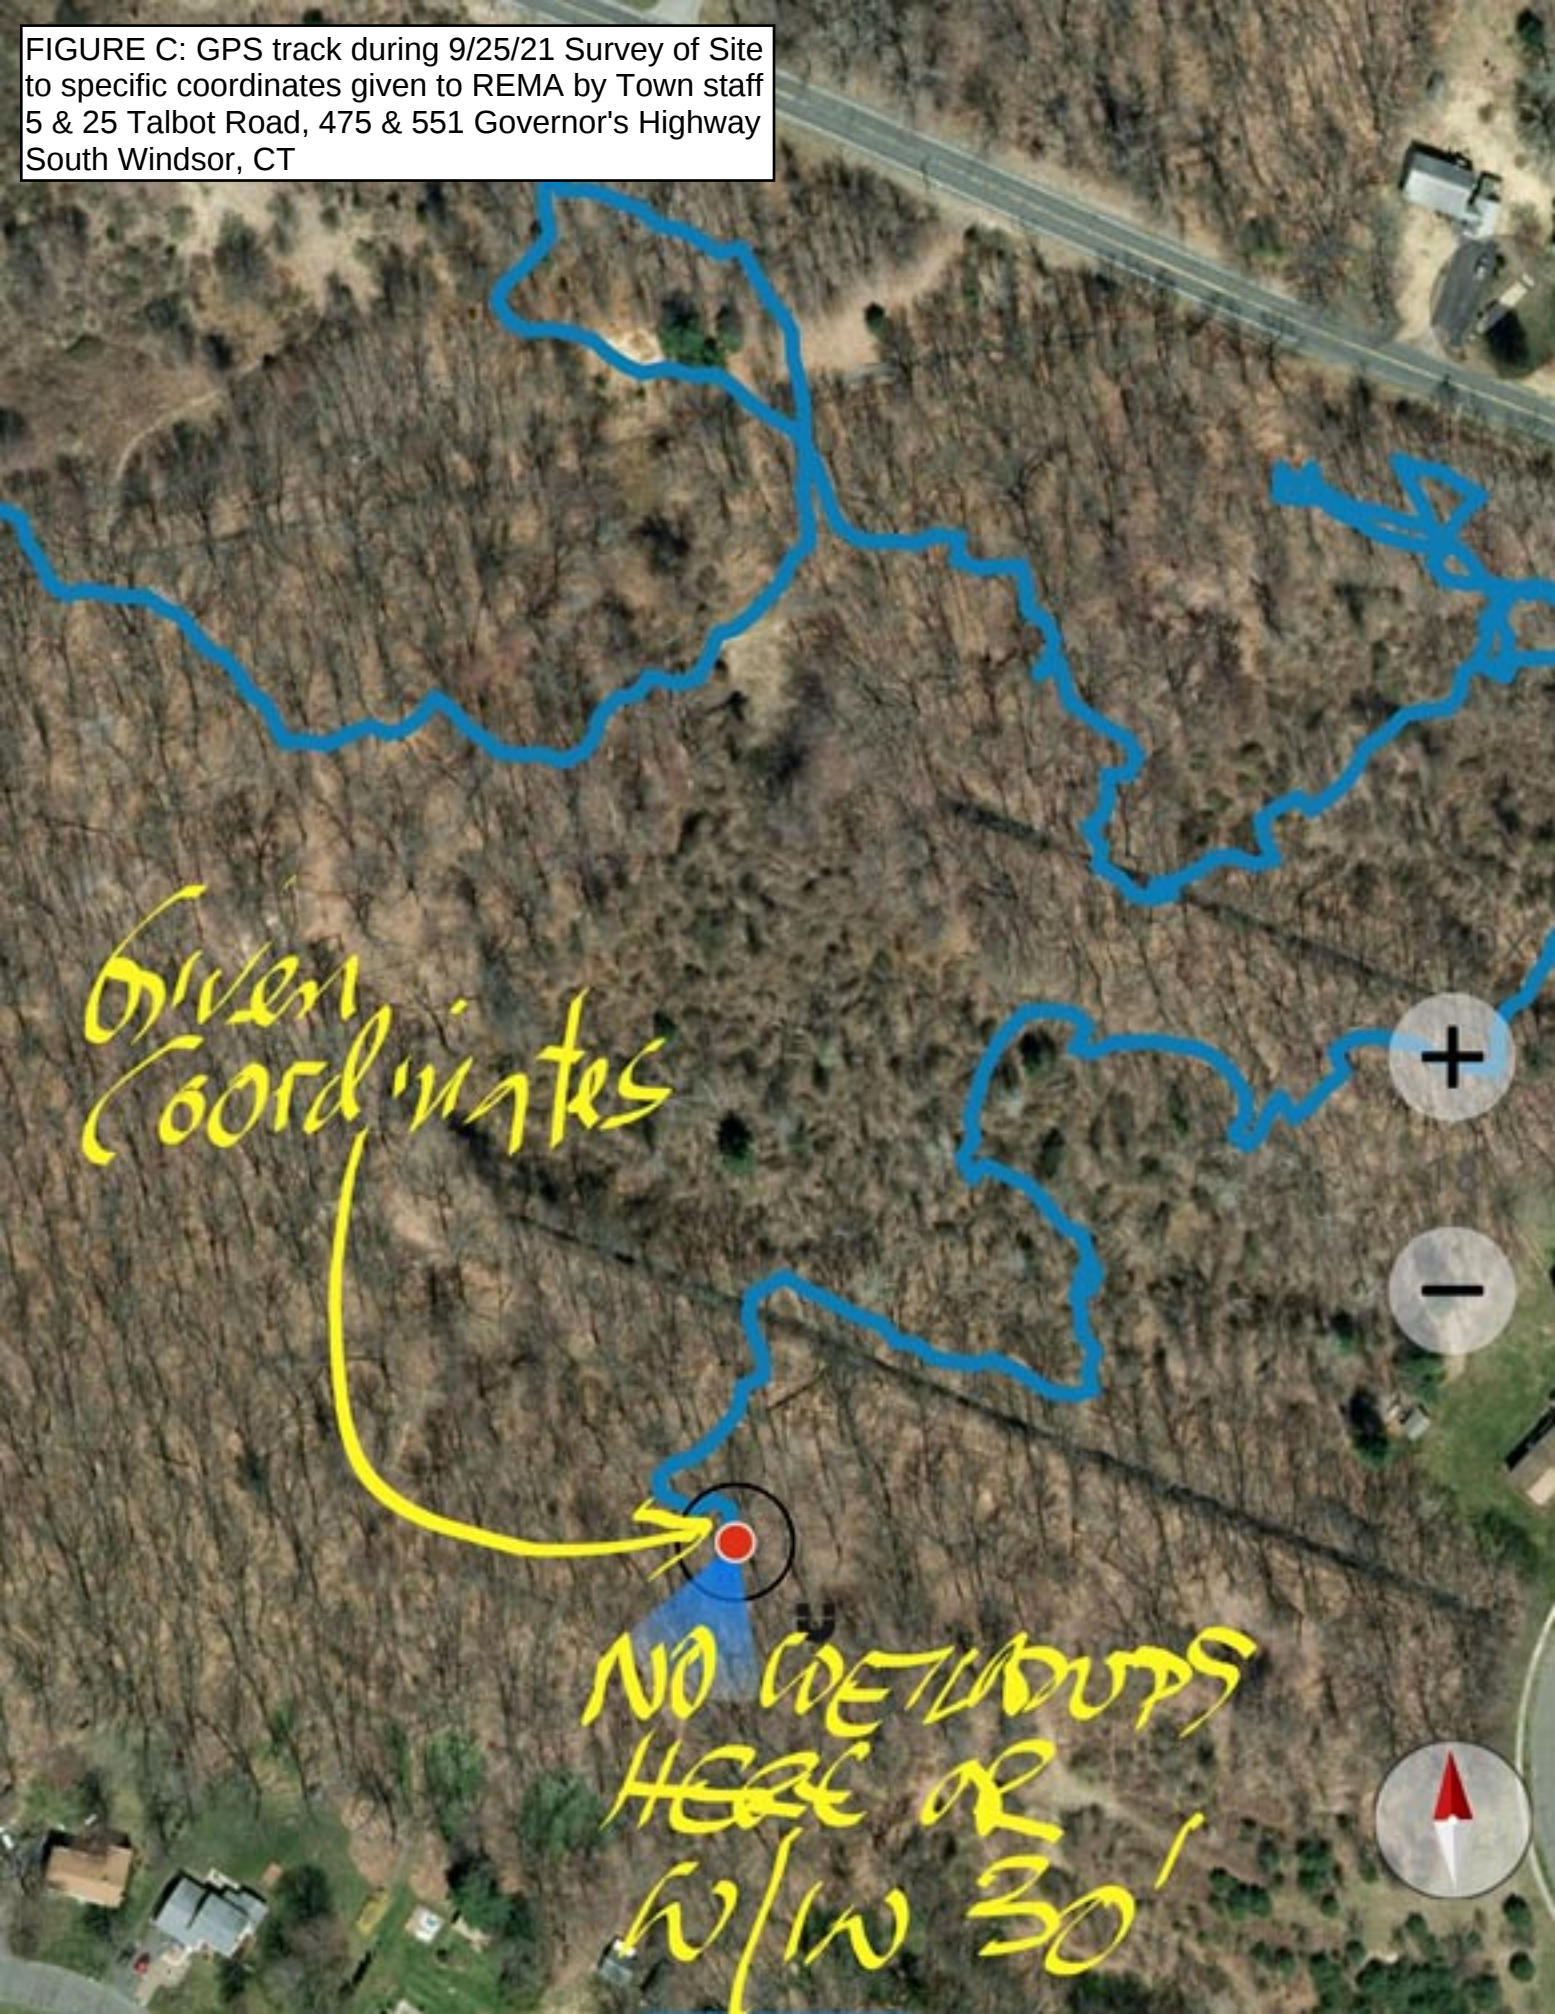
FIGURE C: GPS track during 9/25/21 Survey of Site to specific coordinates given to REMA by Town staff 5 & 25 Talbot Road, 475 & 551 Governor's Highway South Windsor, CT

6. We investigated an area at specific coordinates (i.e., latitude and longitude) provided to us by Town staff. No poorly drained wetland soil profiles were observed at this location or within 30 feet.

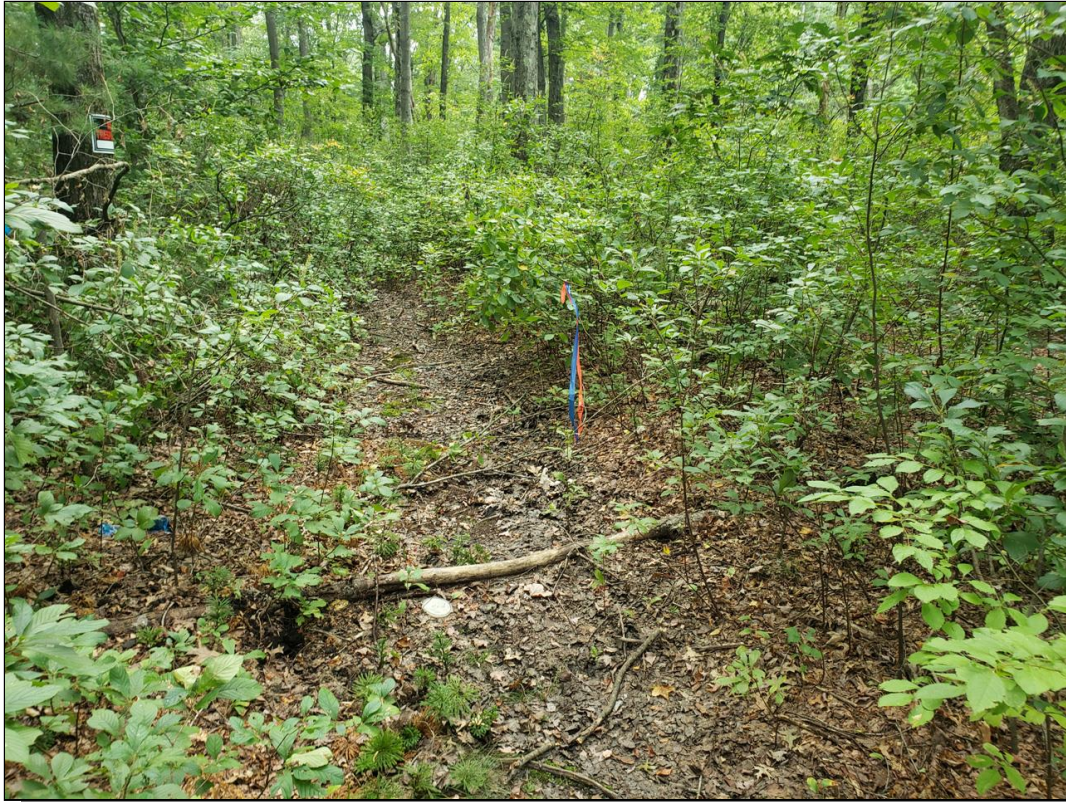
*Photo 1:* Typical wetland boundary flag by JMM Wetland Consulting Services, LLC; western portion of site near Talbot Road, facing southerly

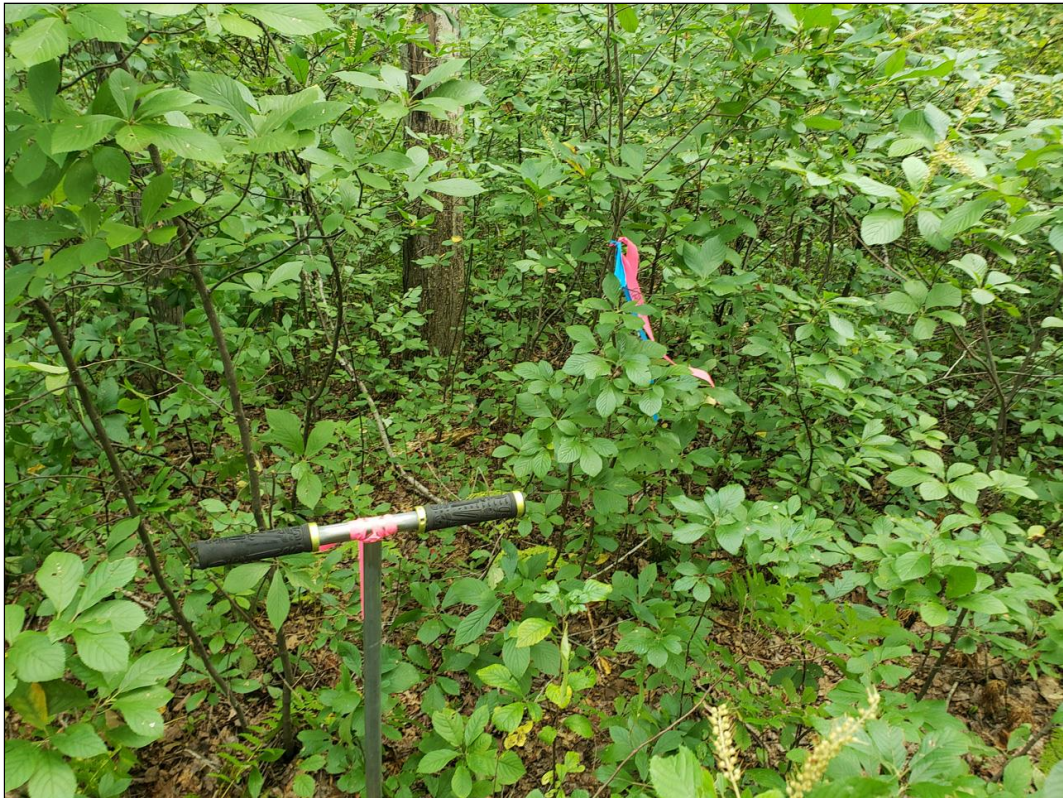
*Photo 2:* One of several “new” wetland boundary markers by REMA associated with westerly forested wetland near Talbot Road; facing southwesterly

1. Four additional wetland boundary markers (i.e., RES-100 to RES-103) were placed in the field, and were associated with the westerly forested wetland by Talbot Road. During our October 4<sup>th</sup>, 2021 joint site visit, we (REMA), after further investigations with Mr. McManus, agreed that RES-100 and RES-103, would remain, while the others would be taken down.

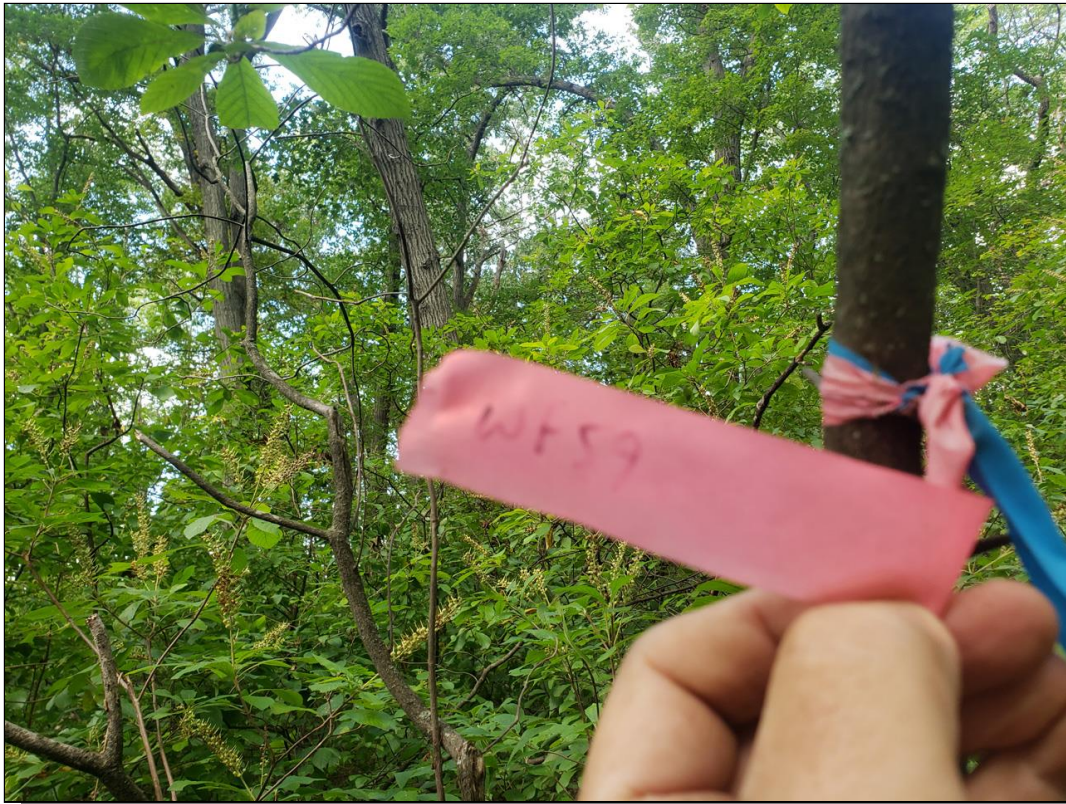
Photo 3: Many older wetland boundary flags were located, and soils investigations were conducted immediately downgradient of them

5. Several dozen old wetland boundary markers (not flags by John Ianni) were observed, especially in the areas to the south of the southerly ditched watercourse/wetland. These appear to be at least 8-10 years old. Thorough investigations took place below these flags. In all cases no poorly drained wetland soil profiles were observed.

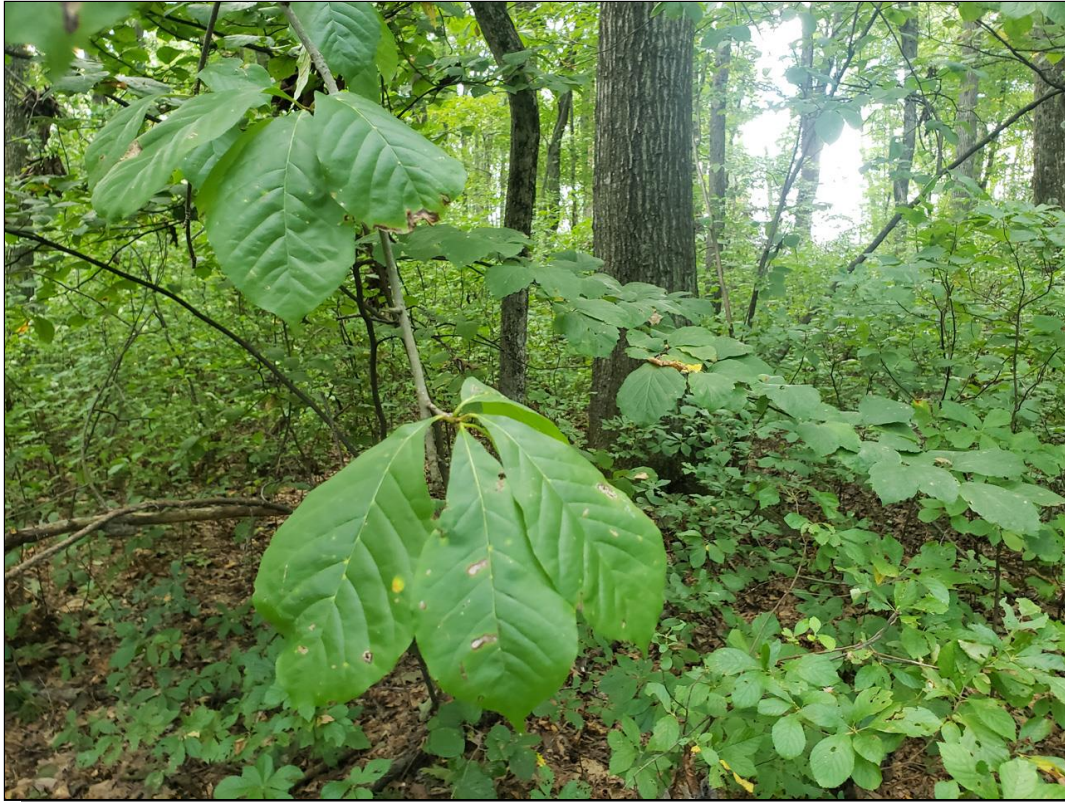
*Photo 5:* The presence of “moist habit” dense vegetation, such black gum (tree) and sweet pepperbush (shrub) necessitated thorough exploration of soils.

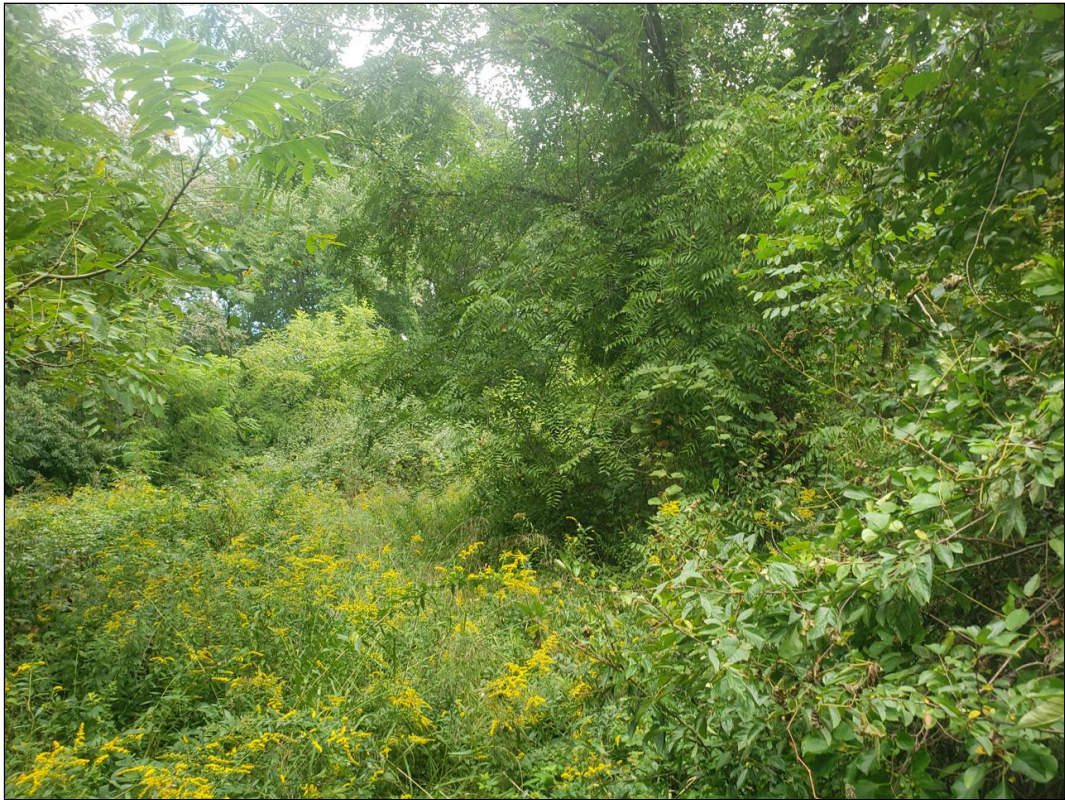
*Photo 6:* Areas investigated included post-agricultural areas, such as this meadow and scrub shrub area at the southeastern section of the site.

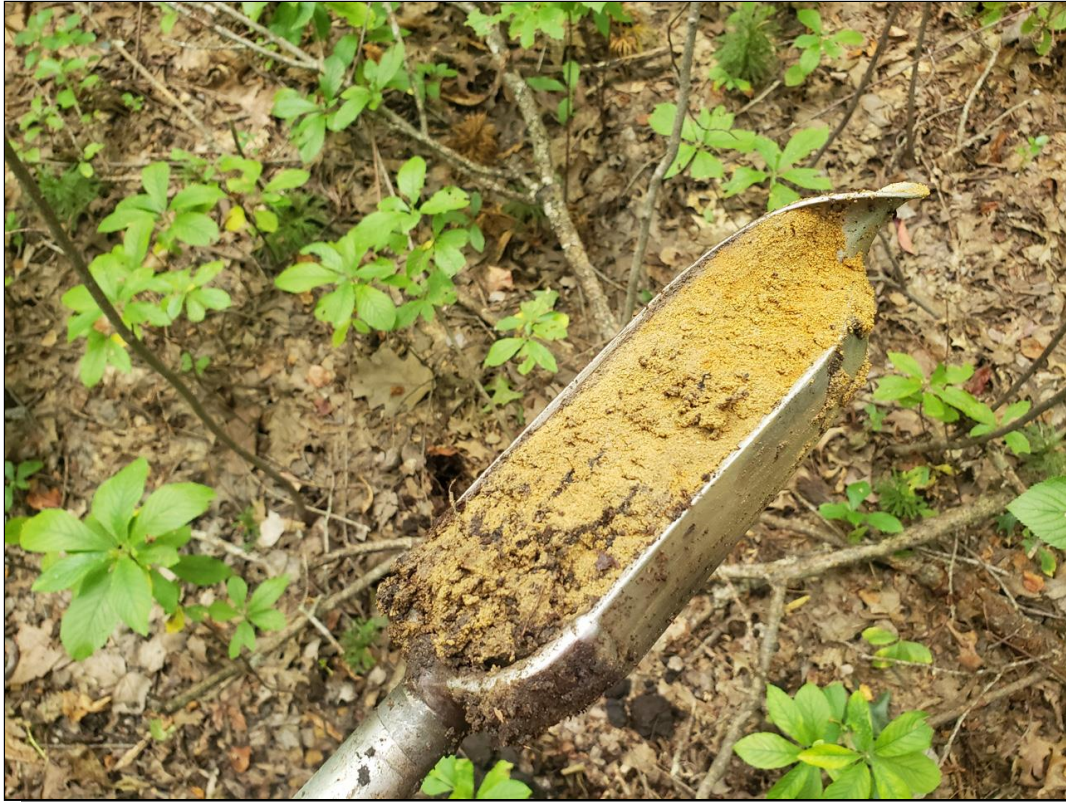
*Photo 7:* A soil auger was used to depths of at least 20 inches from the top of the mineral horizon (i.e., topsoil)

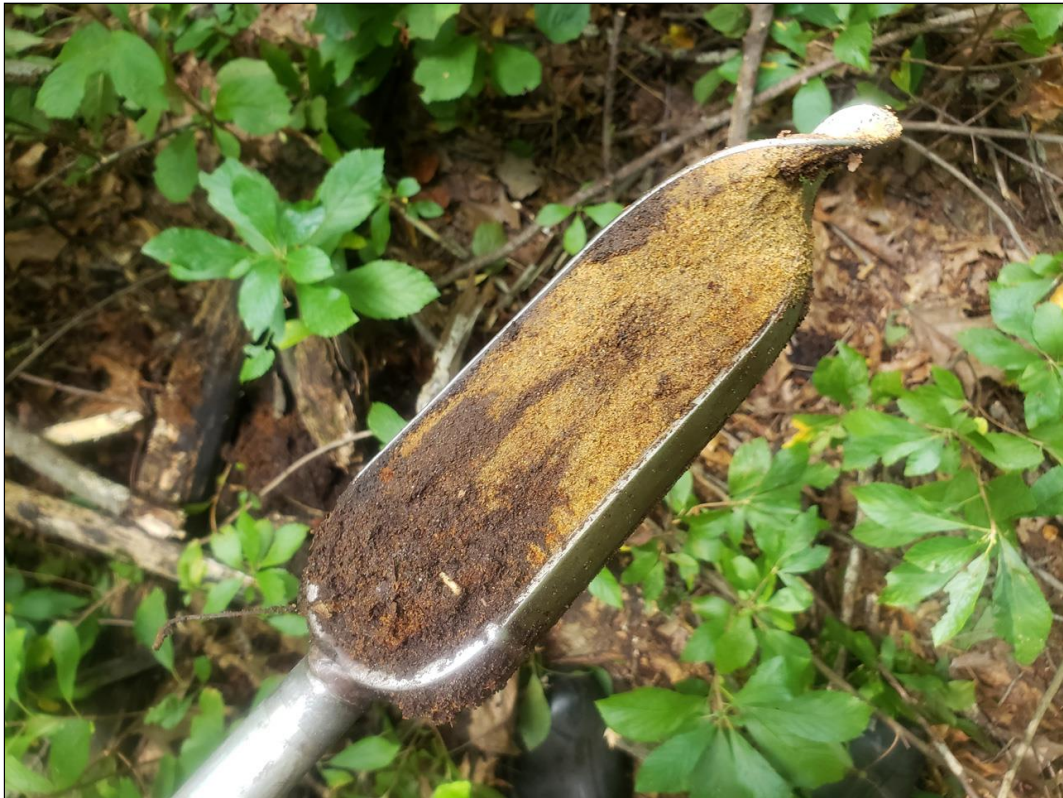
*Photo 8:* Often high chroma mottles was observed within 20" of the mineral horizon, but the matrix chroma was too light for a poorly drained designation (i.e. wetland)

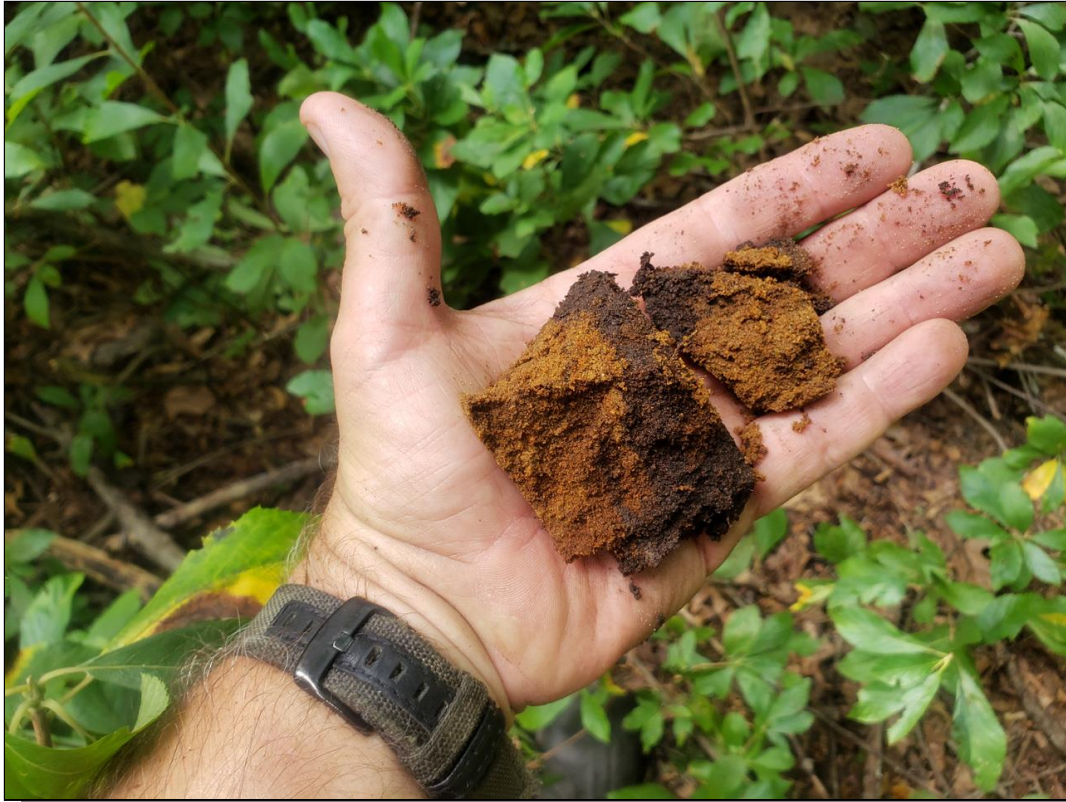
*Photo 9:* The presence of spodic horizons (areas of humus, aluminum and ferric oxides) can challenge interpretation of the drainage class of the site's soils.

7. The predominately undisturbed (except for the plow layer) soils at the site are derived from sandy glaciofluvial deposits. In many locations we encountered rusty colored spodic horizons at depths often between 20 and 24 inches from the top of the mineral horizon. Spodic horizons are areas of accumulation of humus and aluminum and ferric oxides, which can form an "iron pan," although none were observed at the site.

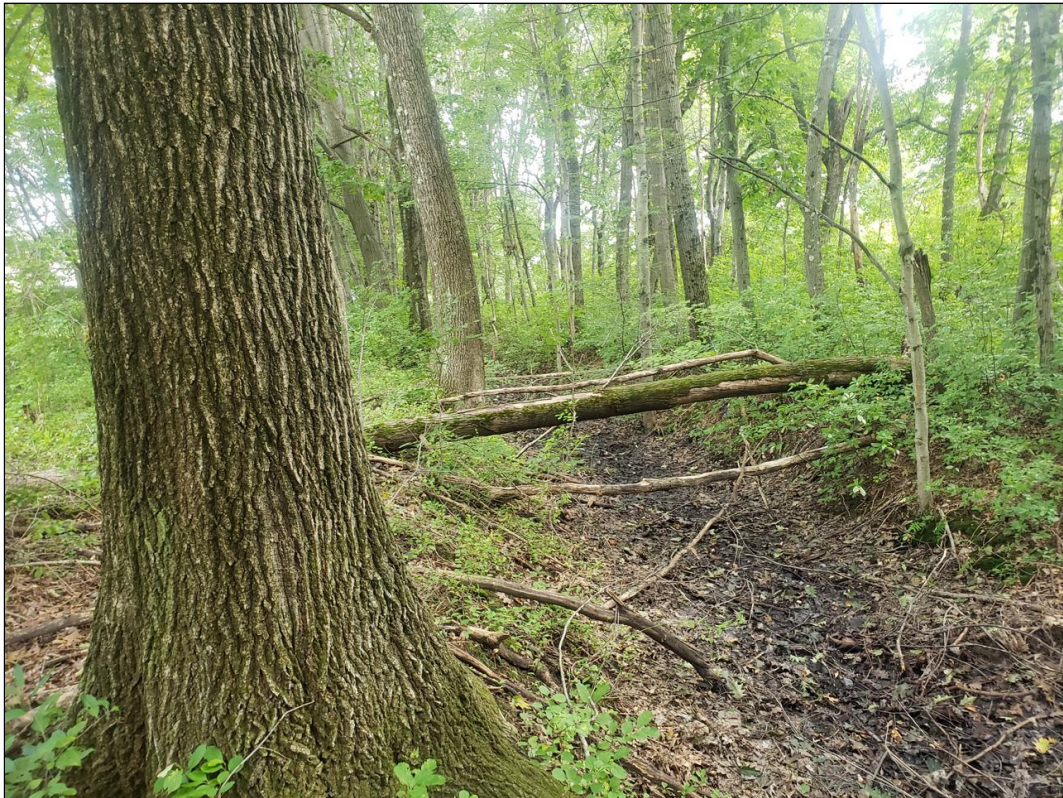
*Photo 10:* One of two dug ditches (southern on here) have wetland/watercourse characteristics; facing easterly

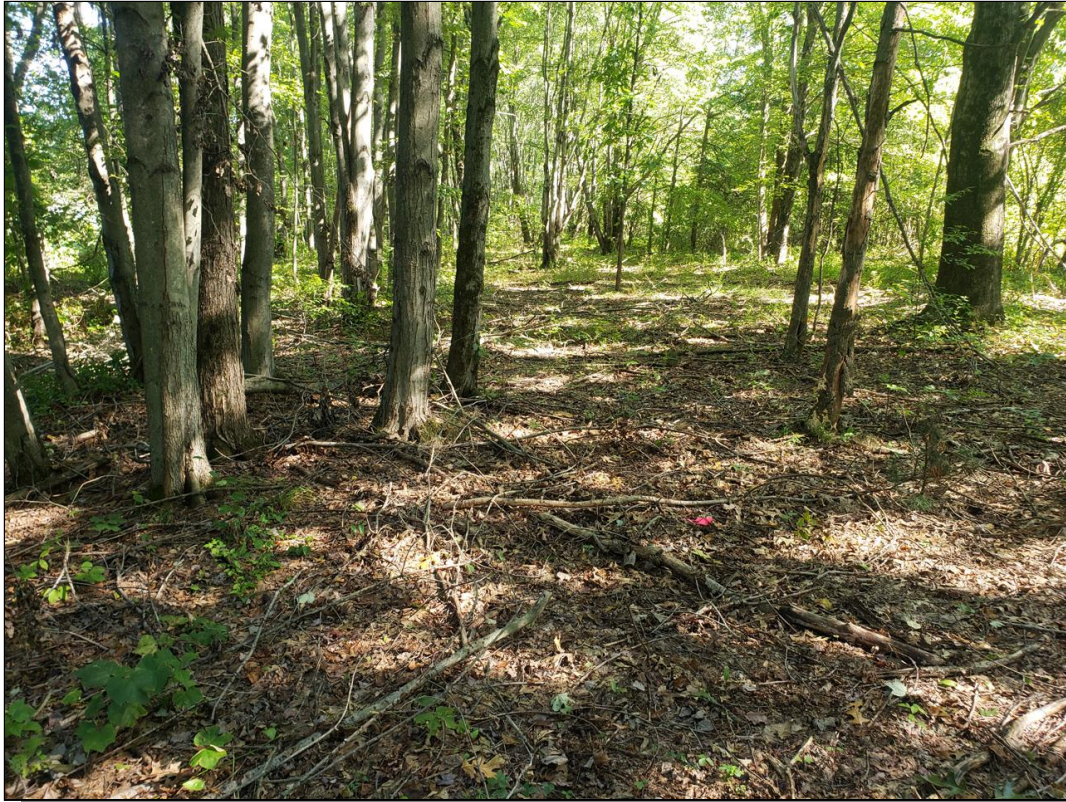
*Photo 11:* Area in northern portion of site where a wetland was delineated. REMA found the delineation very conservative, containing areas of moderately well drained soils.

2. The northern forested wetland by Governor's Highway was found to be substantially correct. In fact, we found that the delineation was conservative and contained inclusions of moderately well drained upland soils.

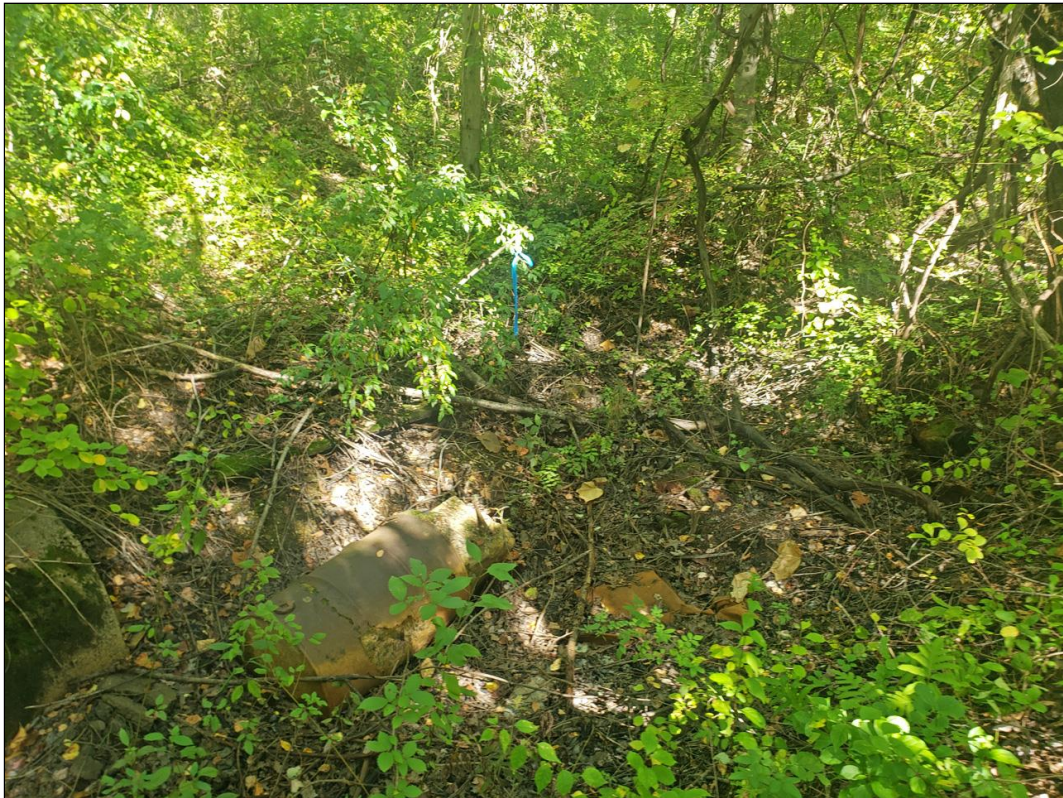
*Photo 12:* Wet dugout depression, too small to delineated, near Governor's Highway; facing northeasterly

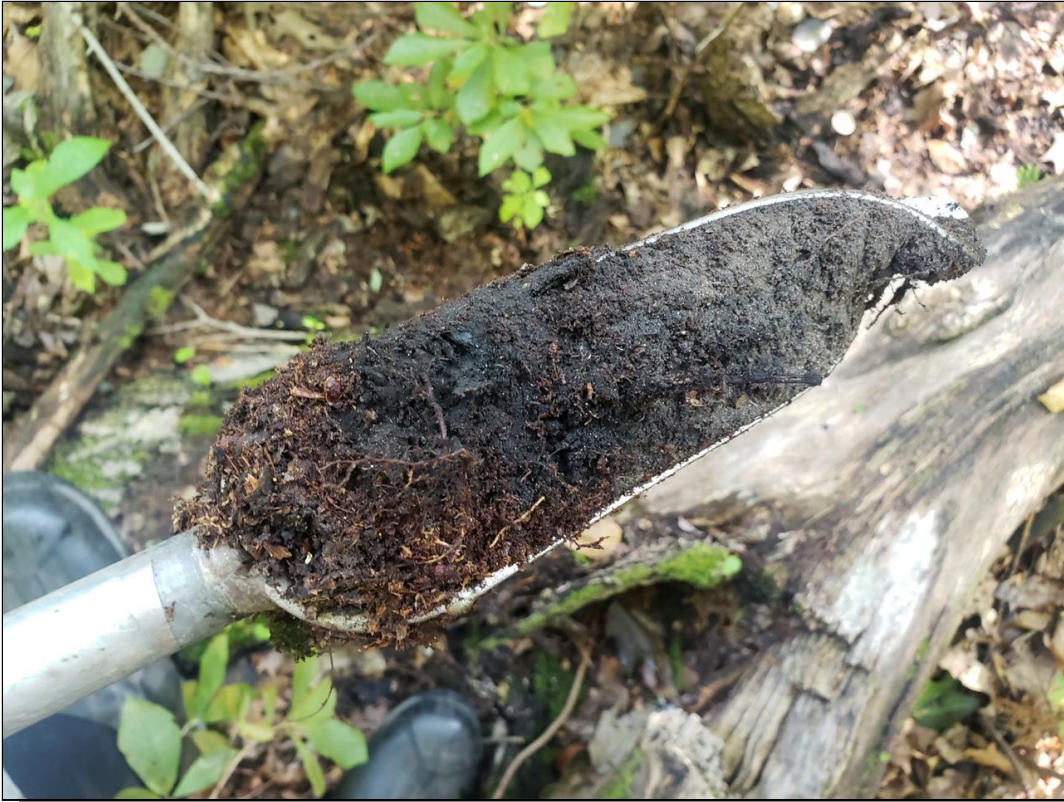
*Photo 13: The presence of “disturbed” E-horizon below a thick Oi (organic, duff) horizon may have led to misinterpretation of soils as poorly drained*

We believe that the “podzolization” (i.e., forming of spodic horizons) that occurs at the site’s soils, including both the presence of mostly disturbed, through plowing, E horizons<sup>1</sup>, and the presence of thick Oi (i.e., organic) horizons, may have led previous delineators to mistaken the thick and very dark A-horizon (i.e., topsoil) overlying a disturbed and “gray” E-horizon, as evidence of a poorly drained soil profile. It is often the case, that while soil scientists are trained to use a 20-inch deep “diagnostic horizon” to assess drainage class, that if the Oi horizon is not factored in, which extends the depth of soil investigation from the soil surface, or if the A-horizon and the E-horizon together are more than 20 inches, that soil probing may not go deep enough for a proper assessment of soil drainage class.

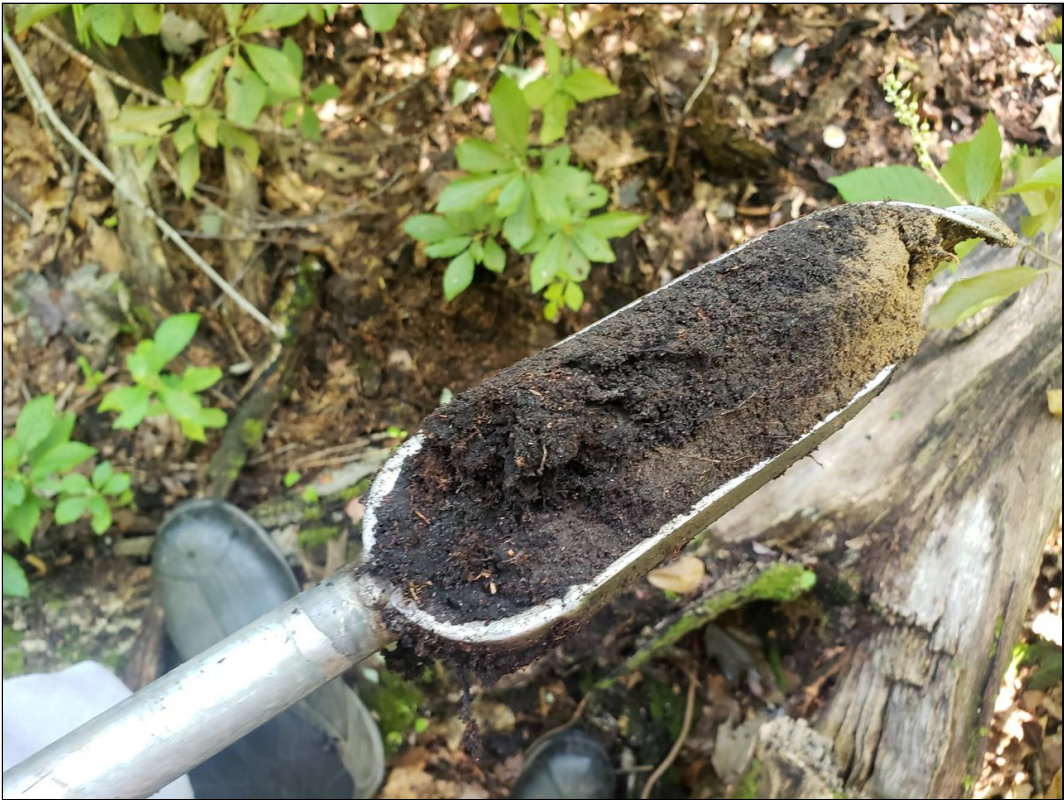
*Photo 14: Below a “confusing” E-horizon at depths greater than 20 inches due to a thick Oi horizon, soil matrix colors indicate moderately well drained upland soils*

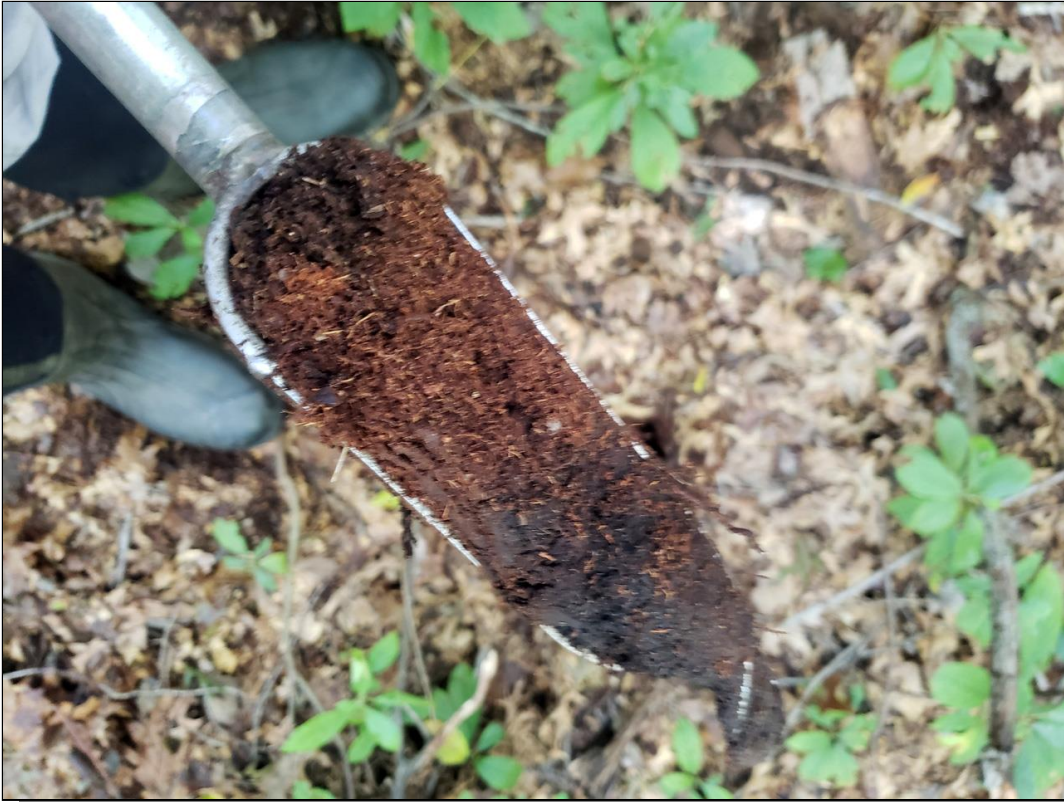
*Photo 15:* The presence of a thick Oi (organic, duff) horizon may have led to misinterpretation of soils as poorly drained, by not exploring soils to proper depths.

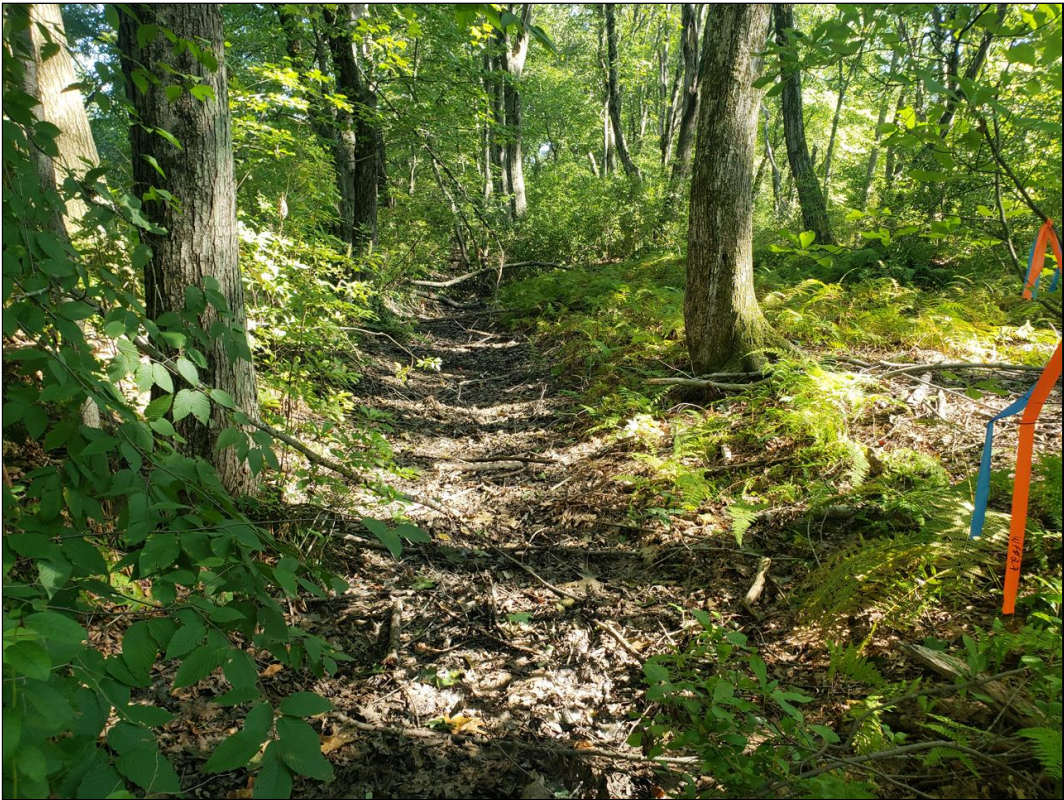
*Photo 16:* Northern delineated watercourse/wetland dugout ditch; facing easterly
