JAMES SIPPERLY
CERTIFIED SOIL SCIENTIST
CONNECTICUT WETLAND SCIENTIST
401 SALEM TURNPIKE
BOZRAH, CT 06334-1516
860-334-7073
james.sipperly.js@gmail.com

May 1, 2023

RE: INLAND WETLAND SOILS AND WATERCOURSES REVIEW OF
APPLICATION #23 11P, INDUSTRIAL FLEX, 75 CONNECTICUT AVENUE
SOUTH WINDSOR, CT

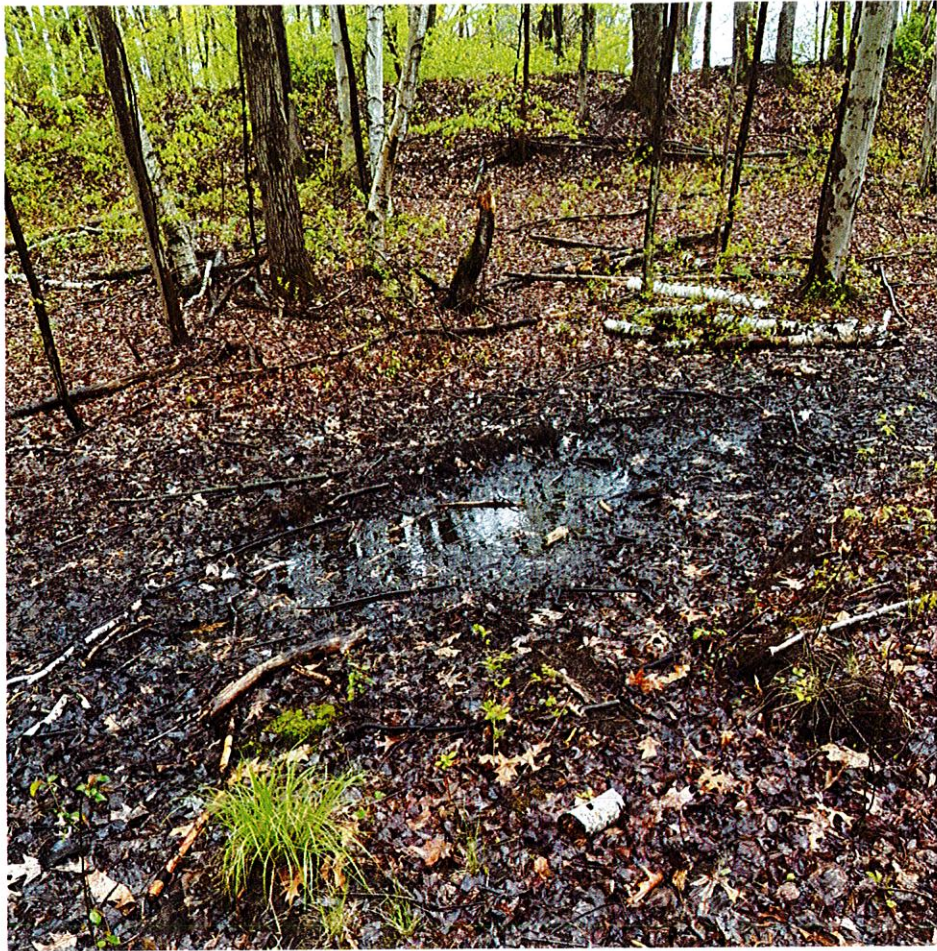
📁 IMG_0145

Having said that, I saw, in other areas of the site, old orange flagging that was placed along an area that was really wet and in a depression. Being a soil scientist and having over 35 years, I see things that other people don't see. In this area (Stacy Ramirez will show you photos and have the exact location) I saw old auger holes that had a mound of subsurface soil next to them. The holes were approximately 16" deep. It appeared that there was a lot of reddish and gray coated silt and sand grains in those mounds. Also, there was old orange flagging that appears to be from earlier delineation surrounding this depression. I am not sure if Mr. McManus tested this area or not seeing that his main focus, as he stated in his report was in the northwest portion of the site.

My recommendation would be to have a neutral, third party soil scientist examine this area to ensure that something was not inadvertently missed. Unfortunately, it does happen sometimes. I will also add that I agree that the site was previously disturbed and that Aquent soils are at times difficult to delineate.
