# PRIEST FARM FEASIBILITY REPORT & CONCEPT PLAN

TOWN OF SOUTH WINDSOR, CT  
1407 SULLIVAN AVE, SOUTH WINDSOR, CT

MAY 16, 2016

Re: Priest Farm Structural Condition Assessment - Final

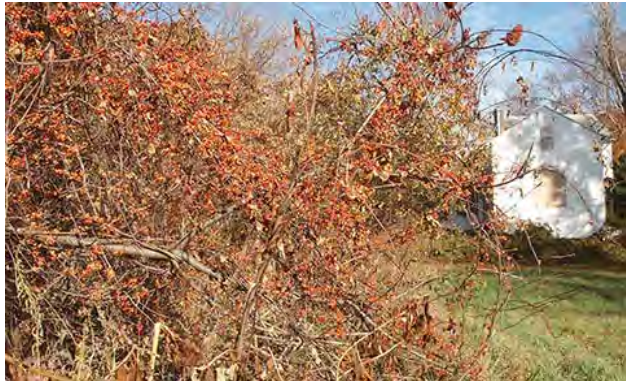
Oriental Bittersweet - invasive

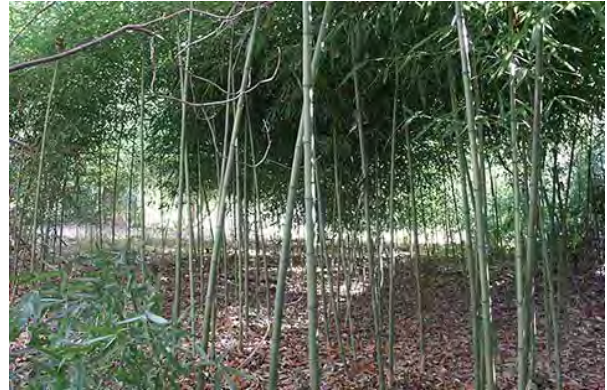
Bamboo - invasive

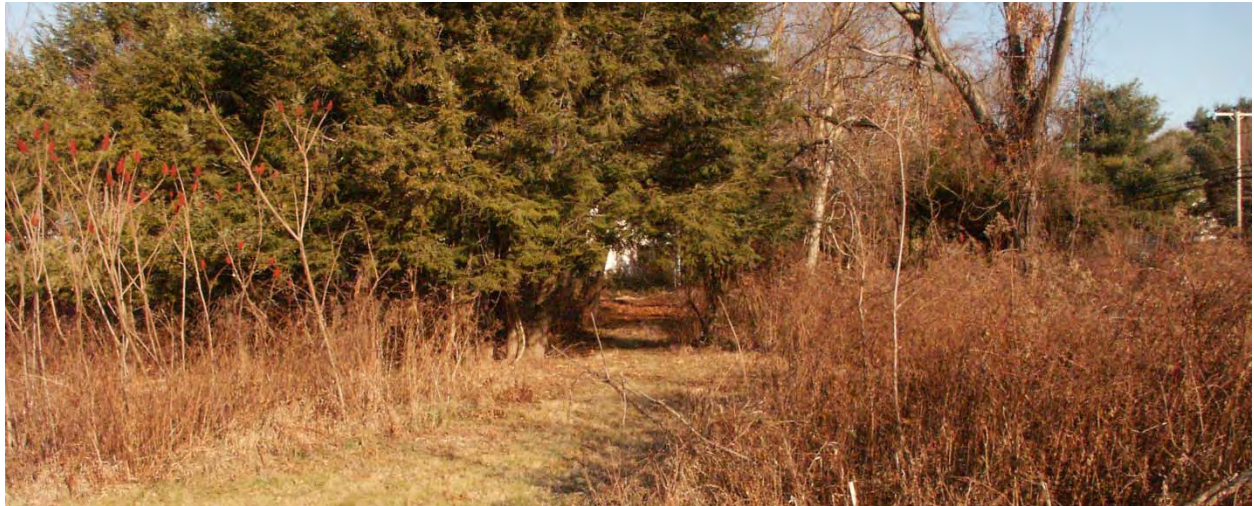
Overgrown vegetation blocks the view north toward the farmhouse.

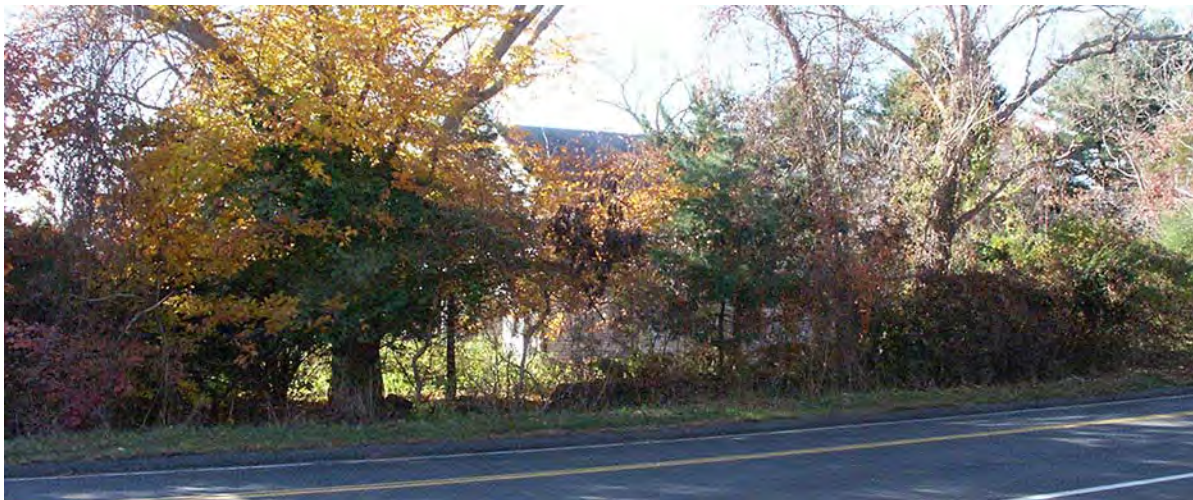
Overgrown vegetation blocks the view of the farmhouse from Sullivan Avenue.

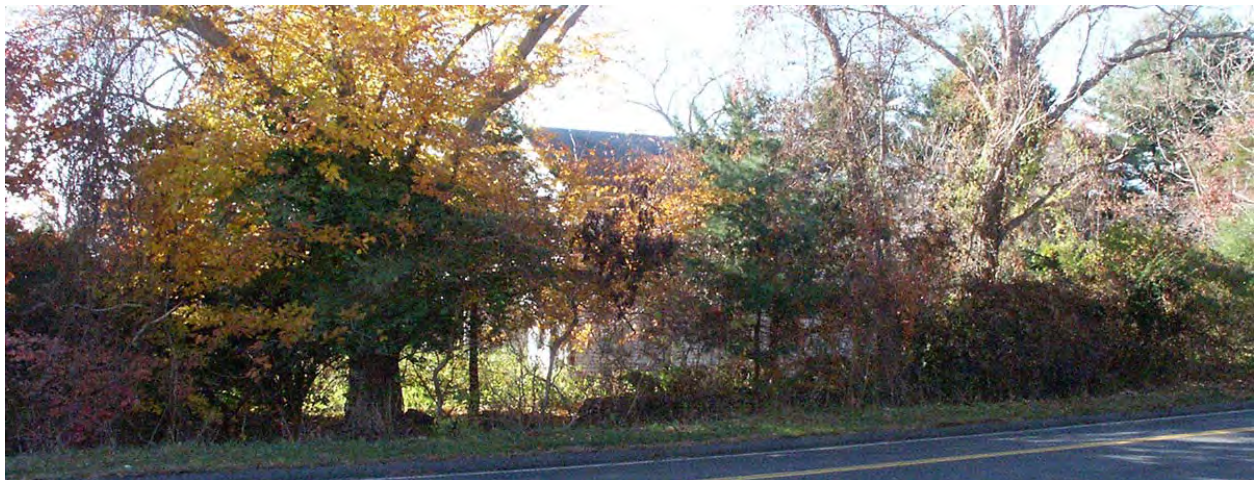
Blocked view of the farmhouse from Sullivan Avenue

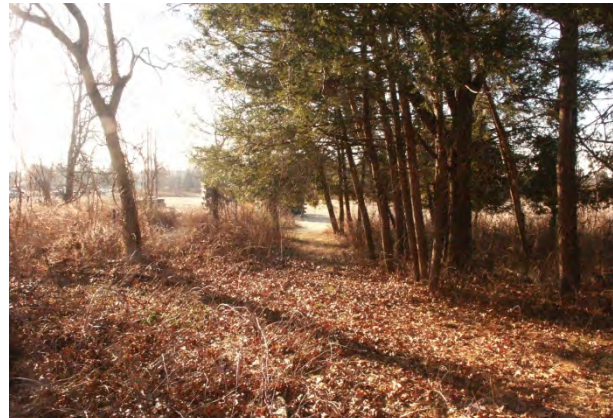
Overgrown path leading south from the farmhouse.

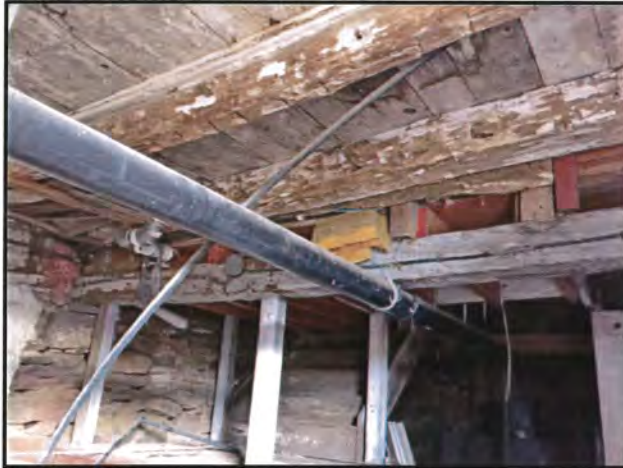
**Photo P01:** West end of Ell with 7 ½" dia. flat-top log joists at 24"-28"oc and a plank floor. 2x joist floor at next bay supported by north-to-south spanning drop beam with timber shore posts. Loose-laid stone walls for foundations in reasonably plumb condition. Stairs to first floor above.

1. Sister timber drop beam with new LVLs or sawn timber and add permanent steel lally columns or pressure-treated posts to achieve 40psf 1<sup>st</sup>-floor load capacity.
2. Remove or reinforce inadequate and unsafe stairs and add proper handrail systems.

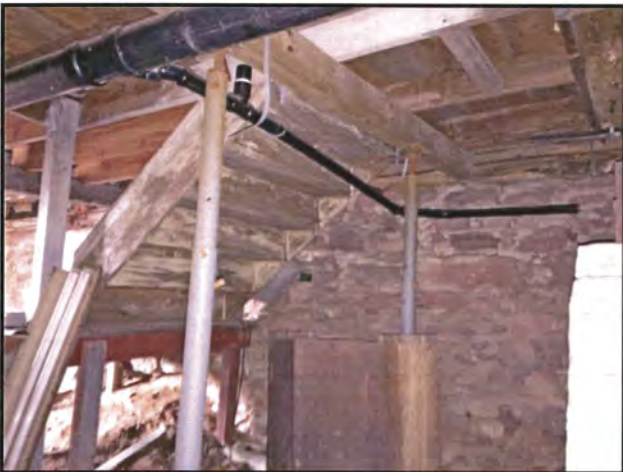
**Photo P04:** Shoring beam in middle of EII floor supporting over-spanned 2x6 modern joists at 18" oc. Temporary lally jacks supporting 4x6 shoring beam. Mortared sandstone foundation walls.

1. Remove shoring beam and sister 2x6 joists with LVLs or rough sawn timber to achieve 40psf 1<sup>st</sup>-floor load capacity.

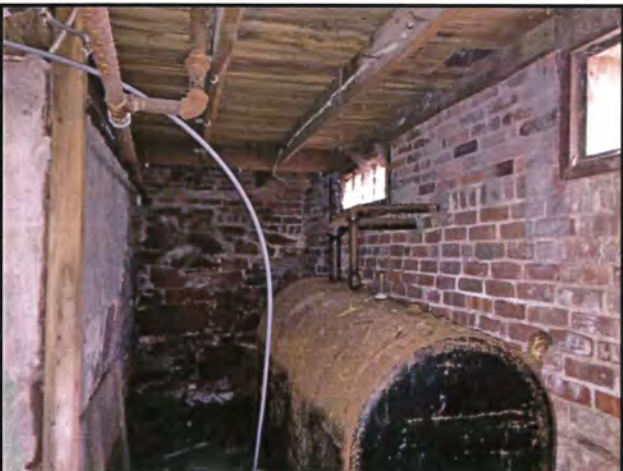
**Photo P05:** Basement and lightly-framed first floor under north addition of EII. Brick masonry basement walls at this location in good condition.

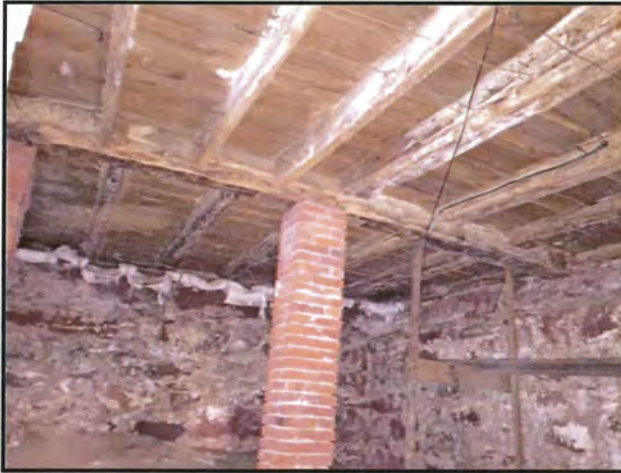
**Photo P08:** Main House first floor framed with a mix of older 7"x5" older joists with newer 2"x7" joists at 26"oc. 8"x8" timber beams. Some remnants of old foundation wall plaster or over-mortared joints on sandstone.

1. Sister joists with rough sawn lumber to achieve a 40psf 1<sup>st</sup> floor load capacity.
2. Clean loose plaster/mortar off of foundation walls and repoint masonry where necessary.

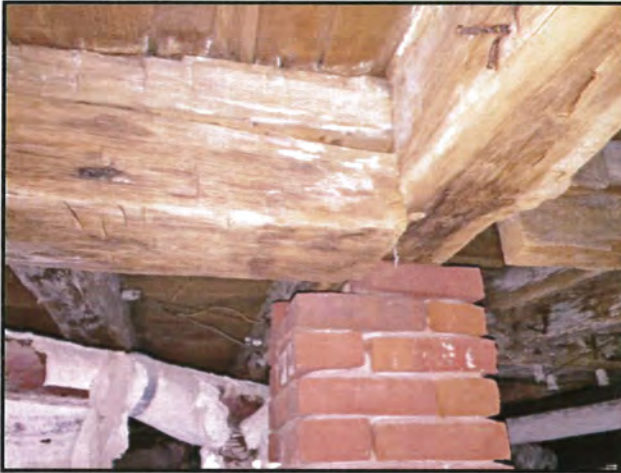
**Photo P11:** Main carrying timber with severe end split at mortise and tenon joint at end connection.

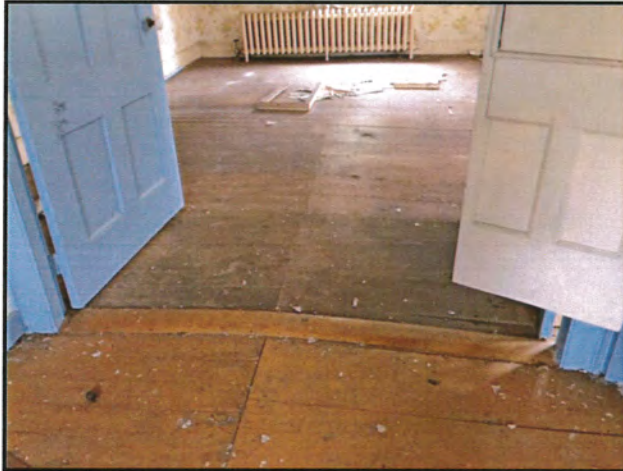
**Photo P13:** East side of Main House first floor looking south at first floor deflections.

1. First floor reinforcement per earlier recommendations will prevent further movement in floor.

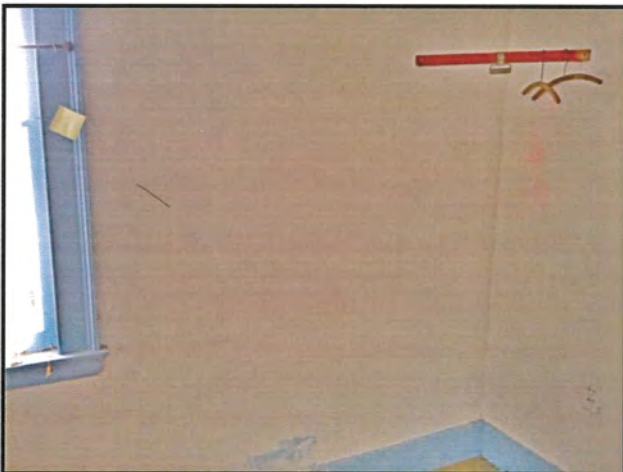
**Photo P14:** Tension cracks in south exterior first floor wall due to movement of first floor framing.

1. First floor reinforcement per earlier recommendations will prevent further movement in floor so wall plaster can be repaired if desired.

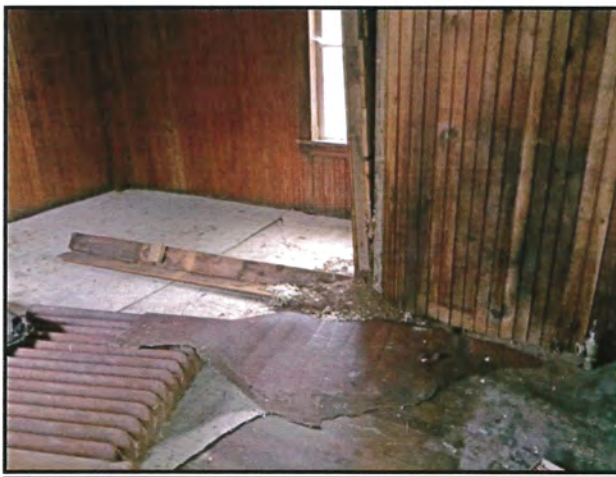
**Photo P17:** Deflections in first floor at west end of Ell.

- 1. First floor reinforcement per earlier recommendations will prevent further movement in floor.*

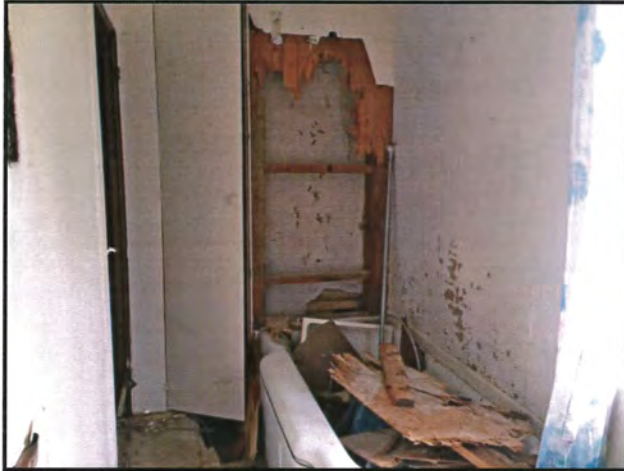
**Photo P18:** Damaged finishes at interior of bathroom walls and second floor decking.

1. Second floor decking should be reinstalled where salvageable or replaced in kind.

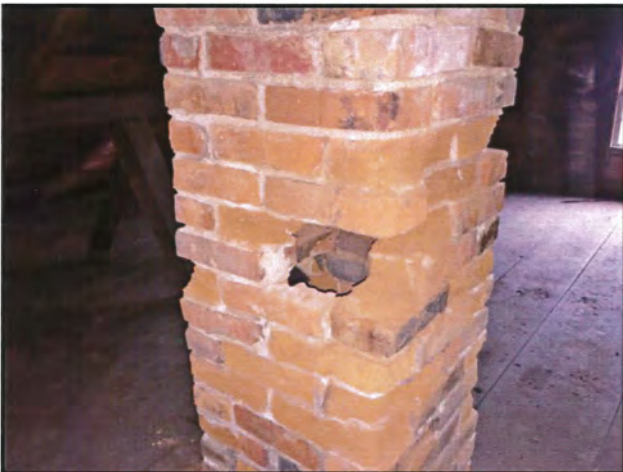
**Photo P23:** Deteriorated chimney brick masonry.

- 1. Replace missing bricks.*
- 2. Clean and repoint all joints with a historic mortar mix.*

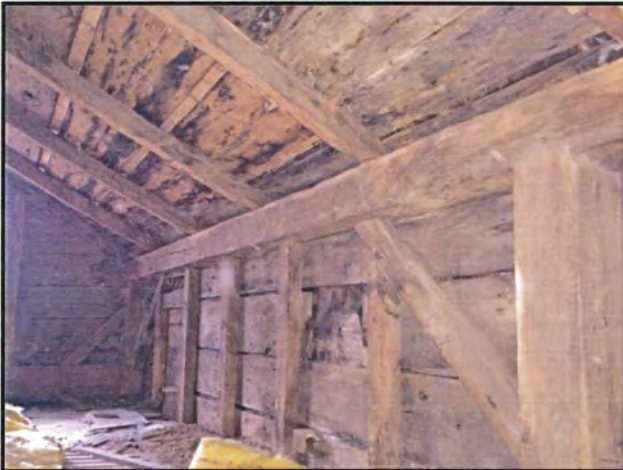
**Photo P27:** Overview of Ell roof and half-story framing.

1. Remove roof sheathing and roofing material to allow roof framing and walls to be re-plumbed as best as possible. Reuse or replace the existing roof sheathing and provide new roofing.
2. Provide 7 ties at the top plate (one at each wall posts and one between each wall post) to adequately tie the roof. Ties can be steel rods or timbers matching the dimensions of the existing wall posts.

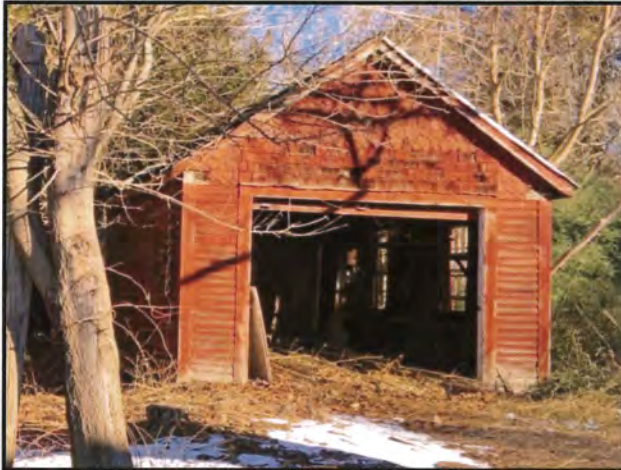
**Photo P1.1:** South gable exterior with opening for garage door. Exterior sheathing consists of 1"x8" horizontal sheathing and clapboards.

1. Remove interior wall finishes to allow inspection of wall construction and make any needed repairs.

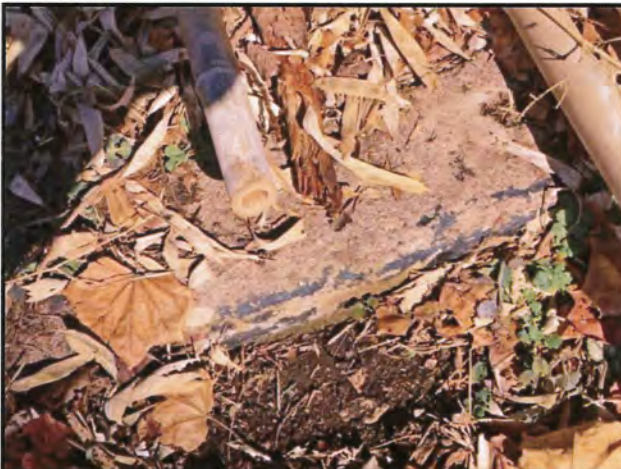
**Photo P1.2:** Edge of 3 1/2" slab-on-grade.

1. Remove items currently being stored in Outbuilding to allow observation of slab-on-grade and anchorage of timber sills.
2. Slab-on-grade will require patching of cracks or spalls.
3. Timber sills will require post-installed anchorage for holdowns of walls.

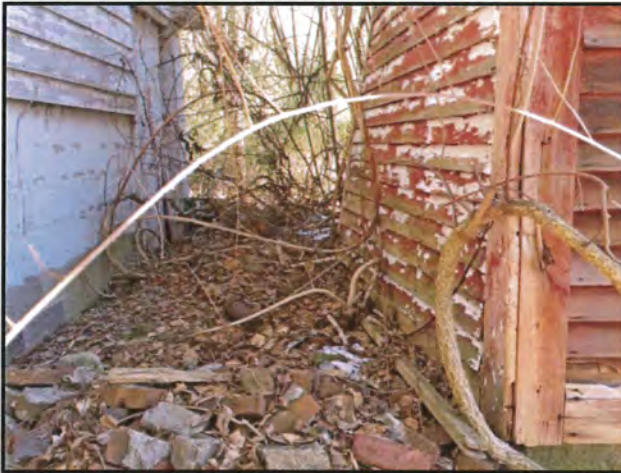
**Photo P1.6:** North exterior pushed off its base. Top plate viewed from interior appears to have moderate water damage.

1. Remove exterior clapboards and sheathing.
2. Inspect condition of wall framing, sill, and concrete foundations to determine if structure can be salvaged for rebuilding.
3. Reconstruct wall using salvaged members, where possible, and new lumber.

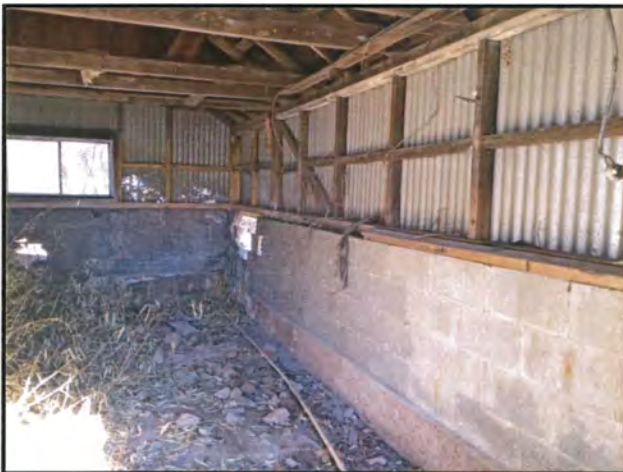
**Photo P2.2:** Northeast corner of outbuilding showing damaged CMU foundation wall.

1. Anchor sill plates to CMU providing  $\frac{1}{2}$ " threaded rods x 1'-4" embed at 24" c (and ends of each wall), and grouting cells solid at anchor points. (Applies to all walls)
2. Repair damaged CMU per recommendations in P2.7.

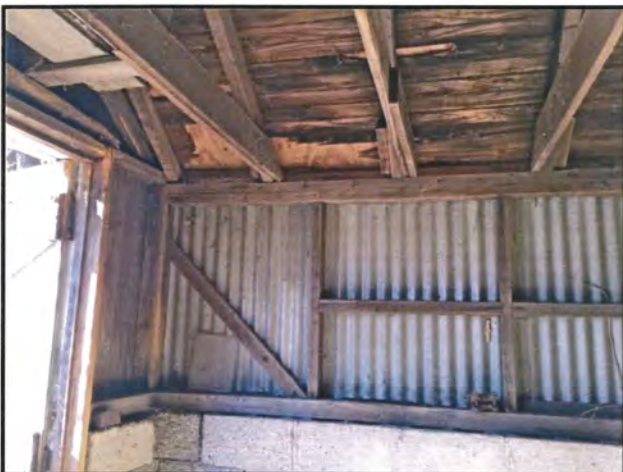
**Photo P2.5:** Southwest corner of outbuilding showing outriggers for eave framing.

1. Reinforce rafter/tie connections and rafter/top plate connections per previous recommendations in P2.3 and P2.4.

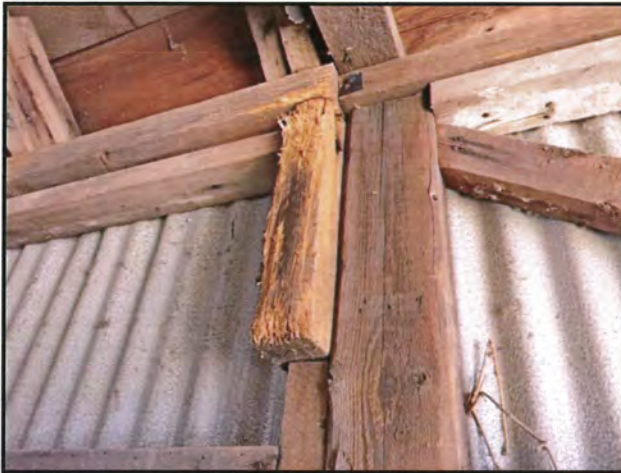
**Photo P2.9:** Transition in wall framing between original building and north addition showing some squirrel damage at repair section of post.

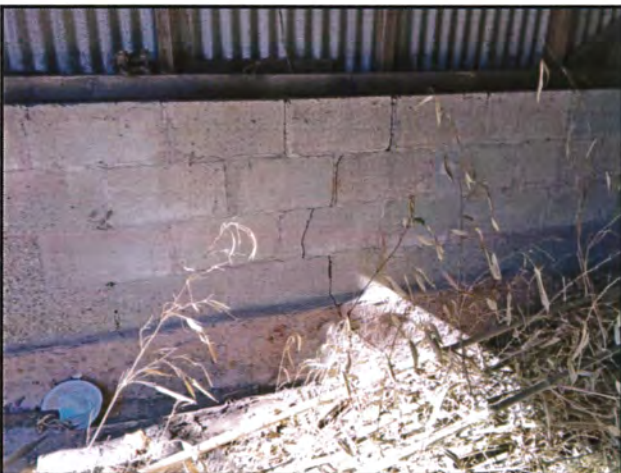
**Photo P2.11:** Shrinkage crack at interior of west CMU foundation wall.

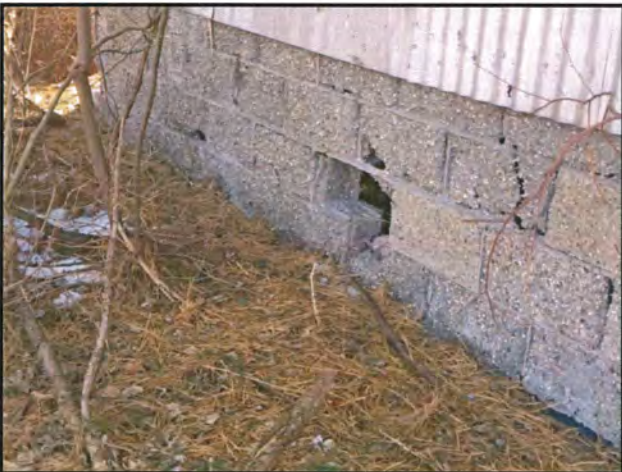
**Photo P2.14:** North exterior showing damaged CMU foundation wall.

1. Repair block and wall sheathing per previous comments in P2.7 and.
2. Coat exterior of CMU foundation wall with concrete sealant such as SikaTop 144 for resistance to degradation from organics.

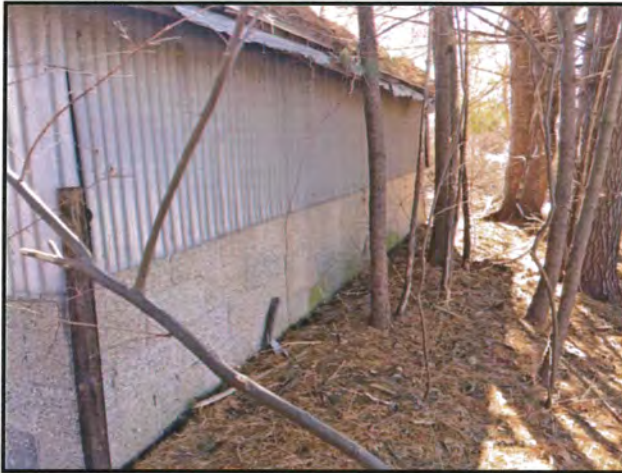
**Photo P2.15:** West exterior of outbuilding.

1. Seal exterior of CMU foundation wall with breathable concrete sealant such as SikaTop 144 for resistance to degradation from organics.

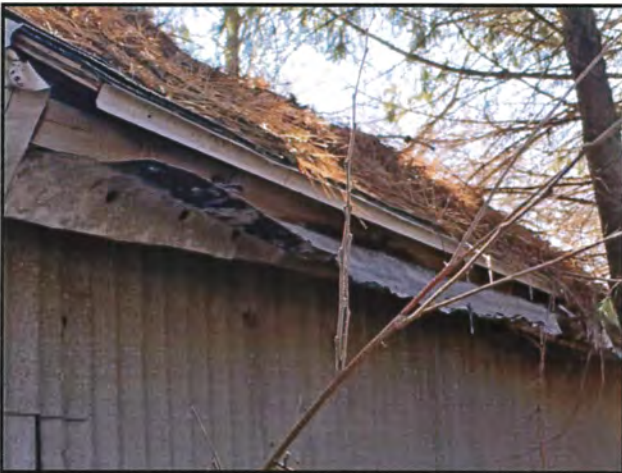
**Photo P2.16:** West eave overhang.

1. Remove deteriorated trim/flushing to allow inspection of outrigger edges.
2. Reinforce outriggers with sisters if deficient.
3. Replace trim in kind.

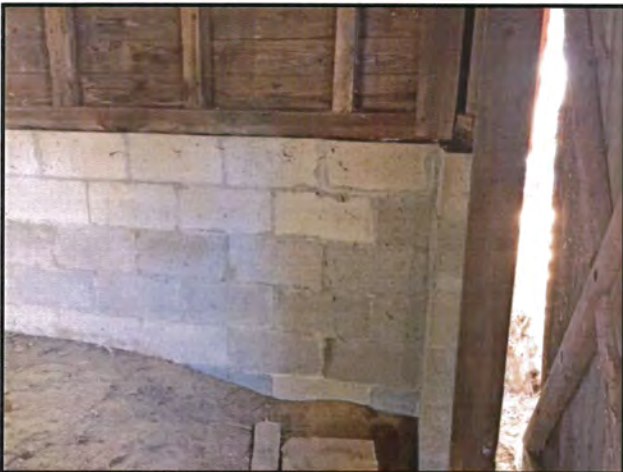
**Photo P3.2:** Northwest corner of outbuilding showing tall 8" hollow CMU foundation wall and wall stud framing.

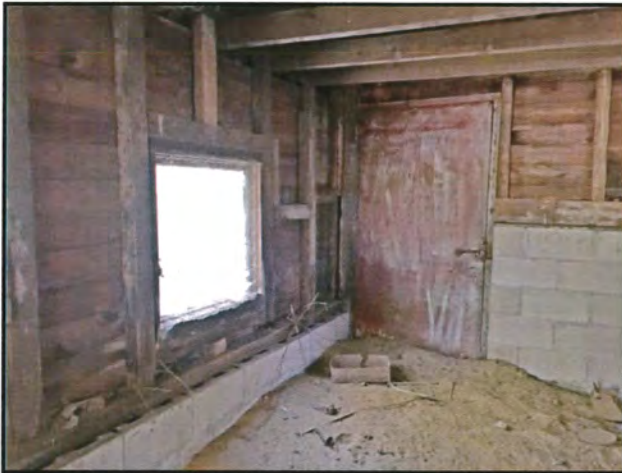
**Photo P3.4:** Southeast corner of outbuilding showing short 8" hollow CMU foundation wall and wall stud framing.

1. Provide sill anchorage per previous recommendation.

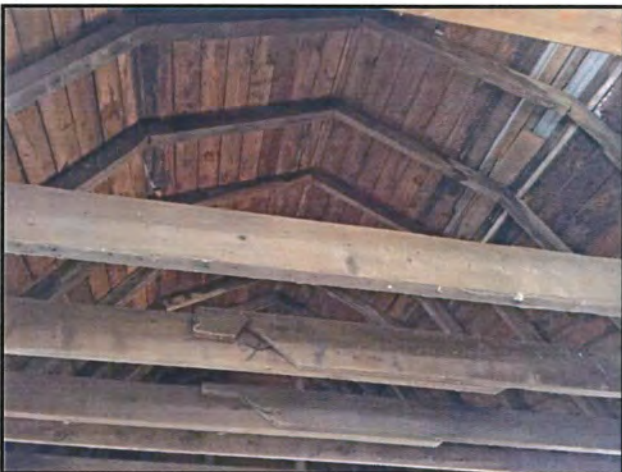
**Photo P3.5:** Gambrel roof framed with 4"x4" lower rafters, 3"x3" upper rafters, and 2"x5" rafter ties at 24"oc. Some rafter ties are spliced.

1. Provide 2"x4" RSL rafter ties at upper rafters.
2. Reinforce lapped rafter ties with Fastenmaster Headlok screws at 6"oc top and bottom.

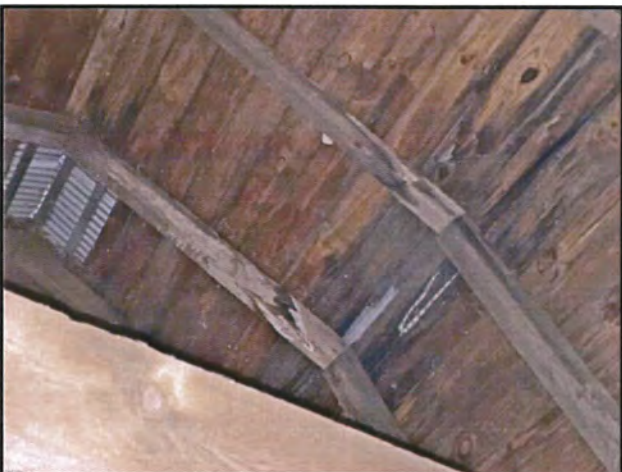
**Photo P3.6:** Some water staining/damage at lower/upper rafter ridge.

1. Replace deteriorated decking in kind.
2. Inspect tops of rafters at location of water staining when decking is replaced to determine if there is a need for sistering.
3. Water-stained rafters can remain in place.

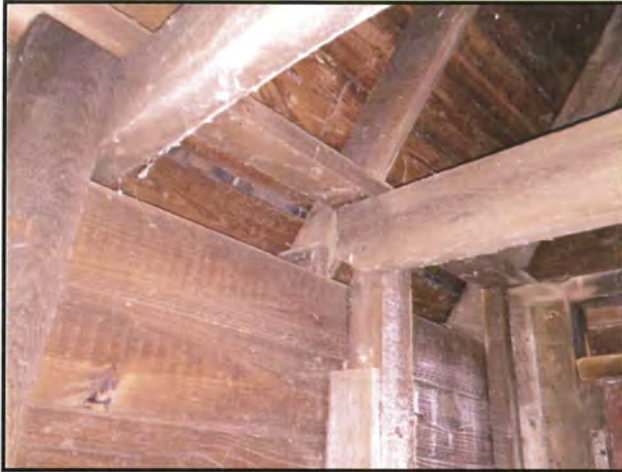
**Photo P3.7:** Rafter overhangs and top plates and interface of wall studs with rafter ties.

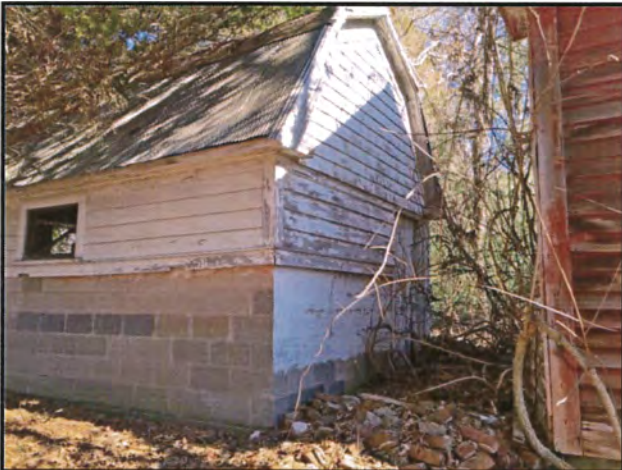
**Photo P3.8:** South gambrel exterior.

1. No recommendations.

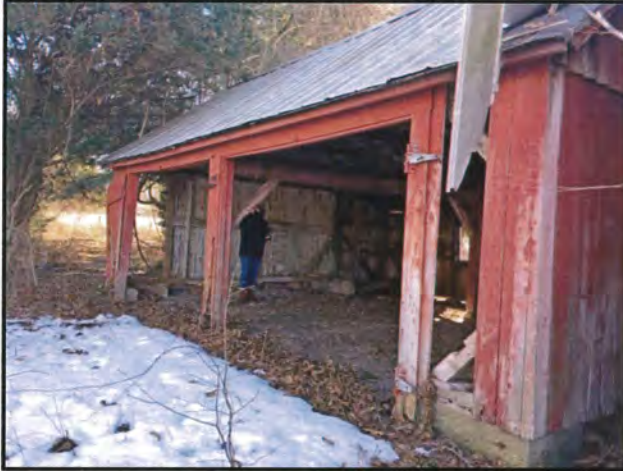
**Photo P4.1:** North exterior of outbuilding showing door openings, vertical exterior sheathing, and metal standing seam roofing.

1. Reinforce girder over door openings with (2) 1  $\frac{3}{4}$ " x 7  $\frac{1}{2}$ " LVL sisters.
2. Remove standing seam roofing to allow repair of roof sheathing.
3. Repair or replace roofing material.

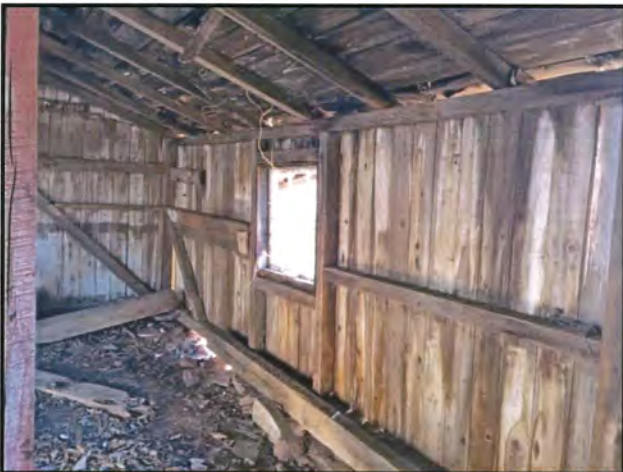
**Photo P4.2:** South corner of outbuilding showing deterioration at shed overhang, lack of support of sill, and damaged roof decking.

1. Replace damaged decking in kind. Provide sisters at rafters to reconstruct deteriorated eave overhang and fasten to top plate with Simpson A35 framing clips.

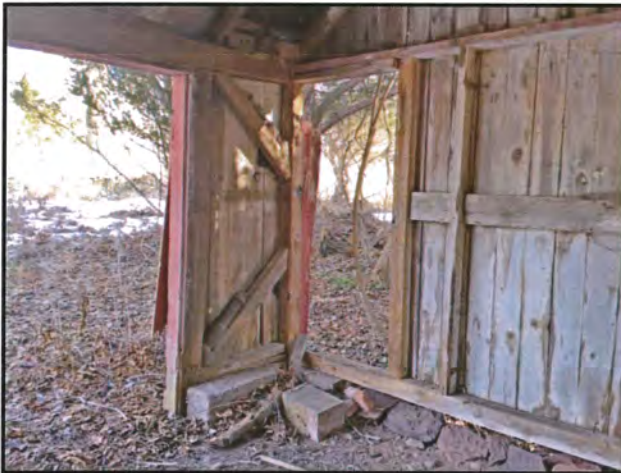
**Photo P4.7:** Northeast corner of outbuilding with concrete corner foundation (no holddown observed). Stud wall is pushed north off of foundation.

1. Provide new foundations and anchorage per previous recommendations in P4.3.

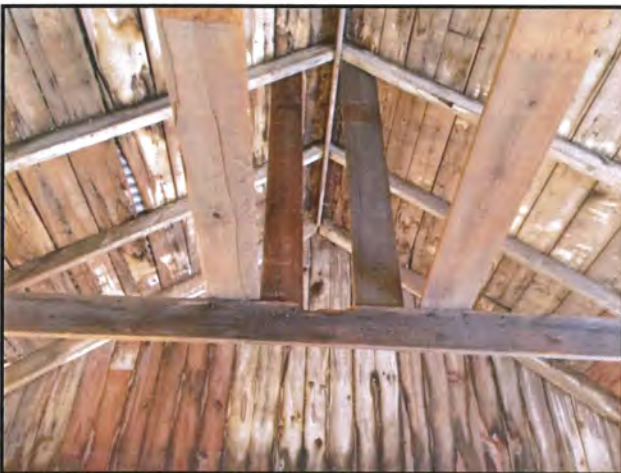
**Photo P4.8:** Typical 2" x 4" rafters at 26"oc with make-shift 1x truss at west side of structure.

1. Reinforce roof rafters with 2"x8" RSL sisters.
2. Provide 2"x6" RSL rafter ties at all rafters to span between reinforced girders.

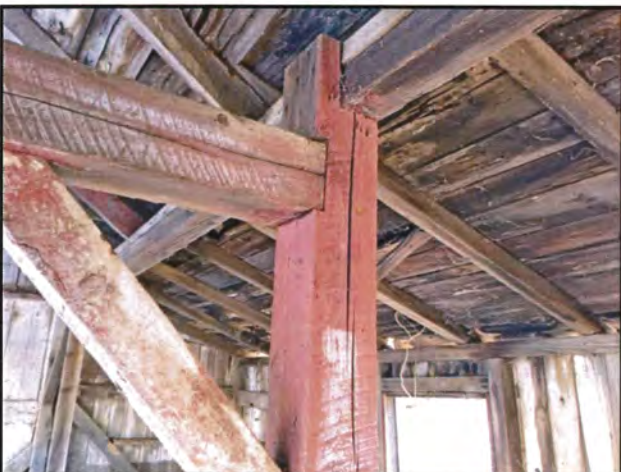
**Photo P4.9:** Center post at south side of gable roof supporting roof girder and tie girder at center of outbuilding.

1. Reinforce roof girder supporting gable and shed rafters per previous recommendations in P4.4.
2. Tie gable roof rafters per previous recommendations in P4.8.
3. Repair base of post (not pictured) which is sitting on grade and is rotted. Insert new bottom post splice with half-lap and provide new CMU pier with concrete footing.

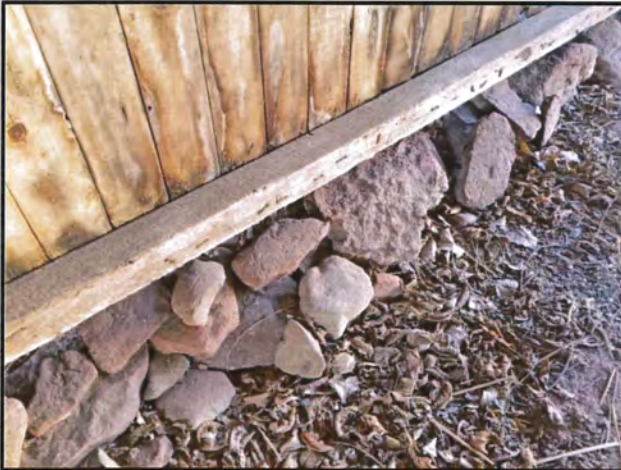
**Photo P4.11:** Rubble masonry along west perimeter no longer providing support for sill.

1. Rebuild foundations per previous recommendations in P4.3.

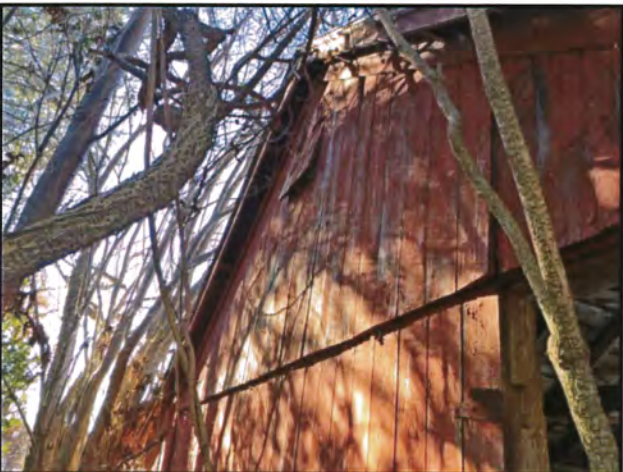
**Photo P4.15:** East exterior and rake overhang.

1. *Connection of outriggers to gable rafters to be inspected after removal of standing seam roofing to determine need for reinforcing/repair.*

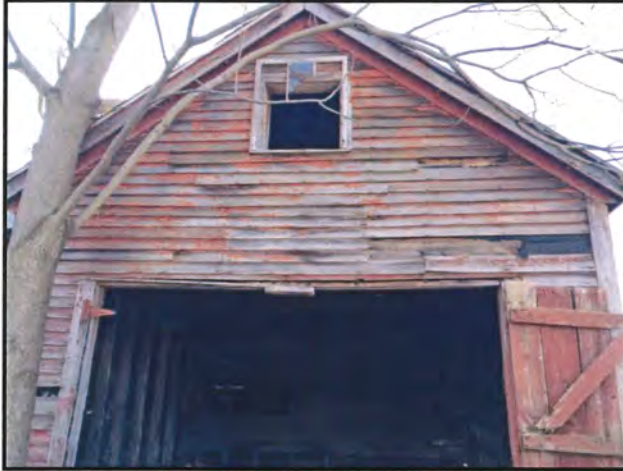
**Photo P5.1:** North gable exterior with large opening for front door. Stud wall framing and interior sheathing is visible beyond.

1. Refer to recommendations to follow.

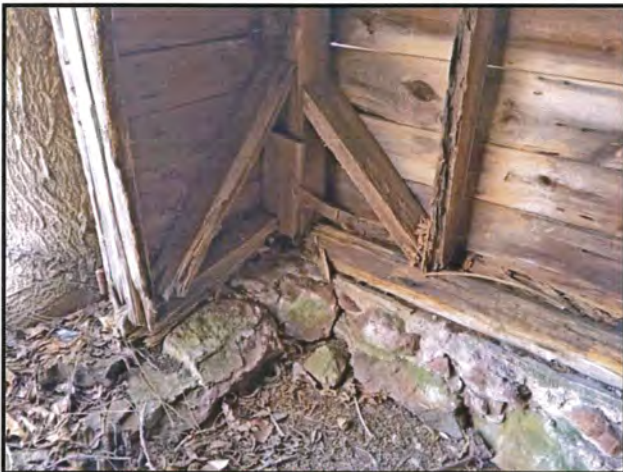
**Photo P5.2:** Northeast corner of outbuilding with deteriorated wall studs, braces, and sill plate.

1. Refer to recommendations to follow.

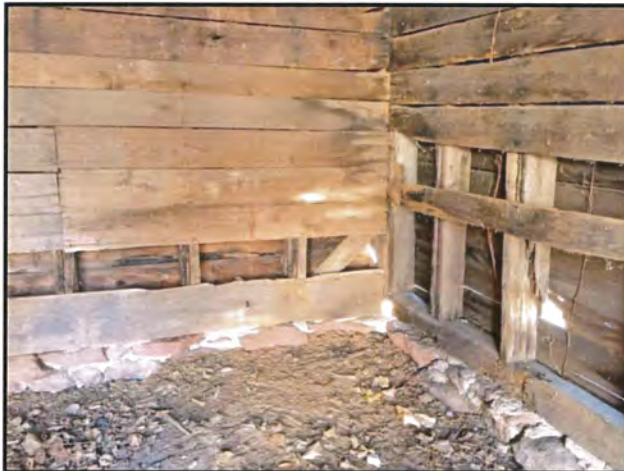
**Photo P5.5:** Southwest corner of outbuilding showing sistered studs at south wall and deteriorated stud bases, sill, and sheathing at west wall.

1. Reinforce wall studs with 2"x6" RSL x 4'-0" sisters and provide Simpson A35 framing clips to new sill.
2. Replace sill in kind (approximately 6" x 6") and anchor to foundation with  $\frac{3}{4}$ " dia. threaded rods at 1'-4" oc and at ends of all walls.
3. Replace missing or deteriorated interior/exterior sheathing in kind.

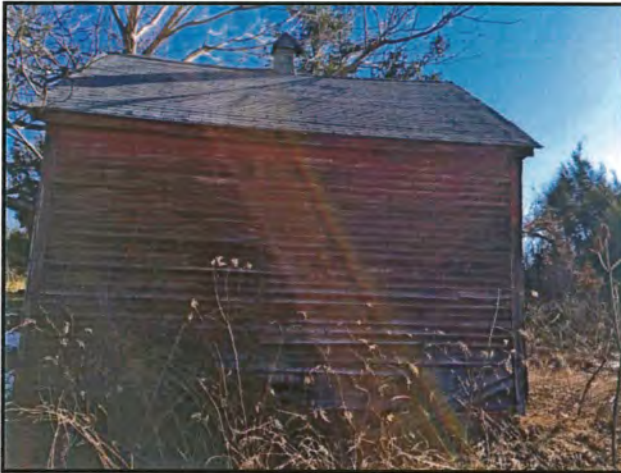
**Photo P5.8:** West exterior of outbuilding showing deflection in roof ridge.

1. Reinforce roof framing per previous recommendations in P5.6 for prevent further deflections.

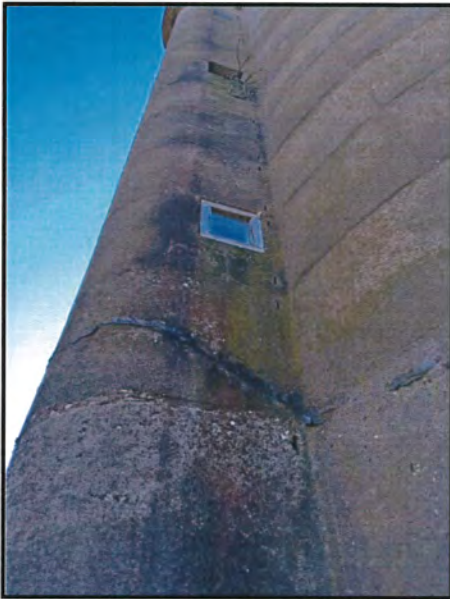
**Photo PS.2:** Exterior of bump-out.

1. Seal concrete per previous recommendations.

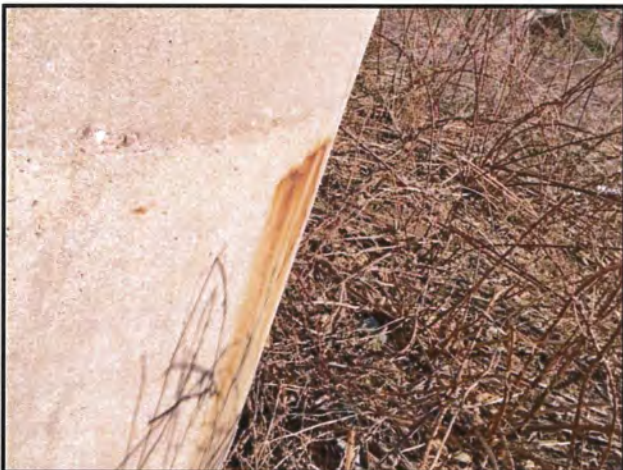
**Photo PS.5:** Minor rusting at southwest side of silo.

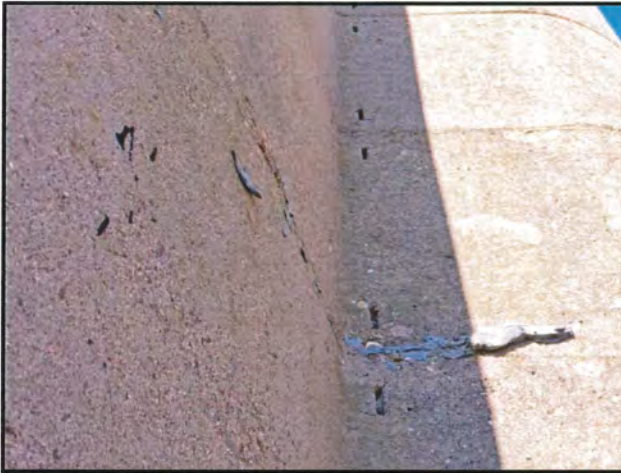
**Photo PS.7:** South side of bump-out exterior.

1. Seal concrete per previous recommendations.

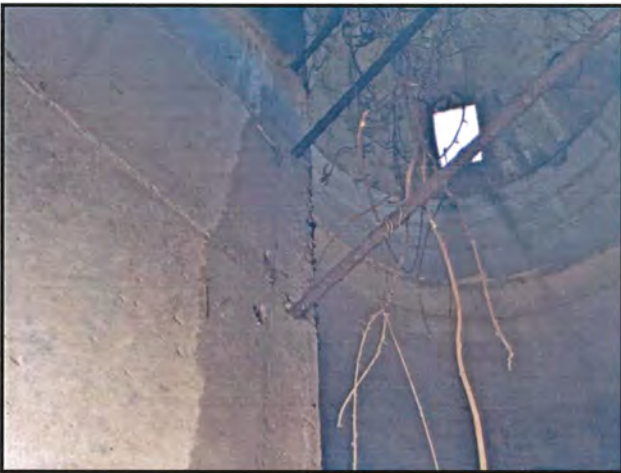
**Photo PS.8:** Rebar ladder for access to silo.

1. Rebar to remain, be cleaned, and be sealed.
2. Ladder should not be used for access to silo any longer.

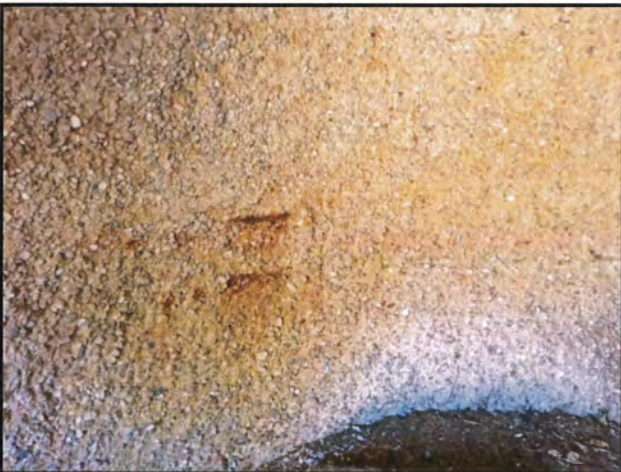
**Photo PS.9:** South interior showing typical condition at bottom 15 feet of structure. Interior face of concrete is deteriorated due to weathering and some rebar is exposed and rusted.

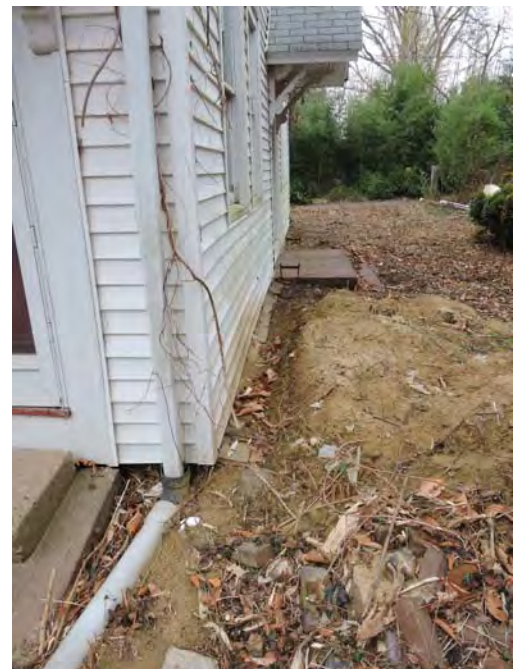
Grade is too close to sill at the East elevation (even without the pile of sand)  
**Photo No. 4**

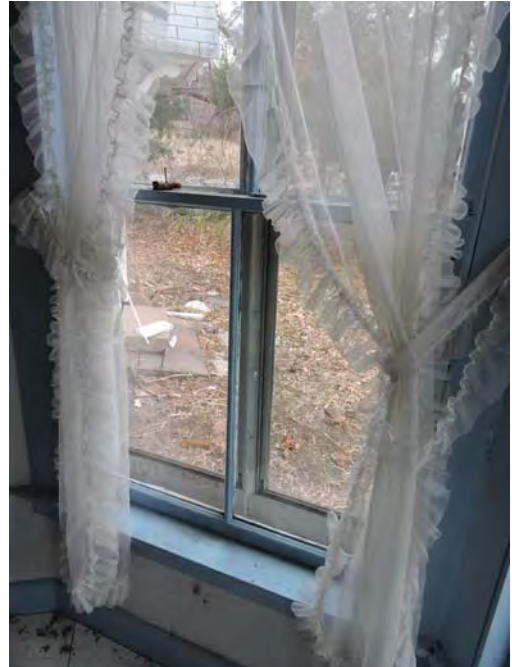
Bay window at South elevation.  
Side by side storm units in one window opening.  
**Photo No. 9**

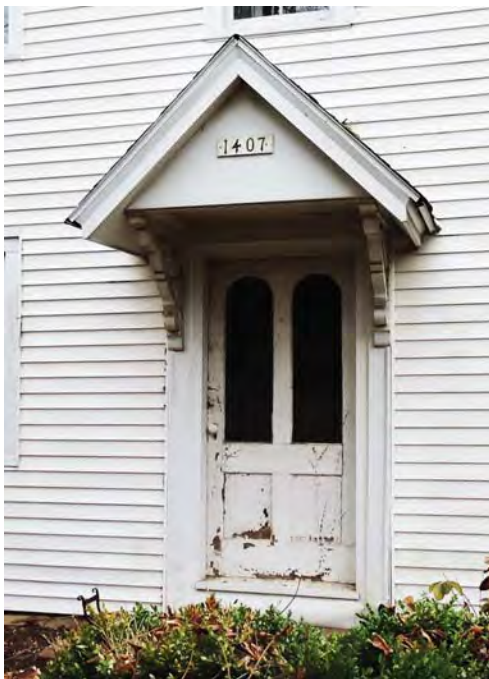
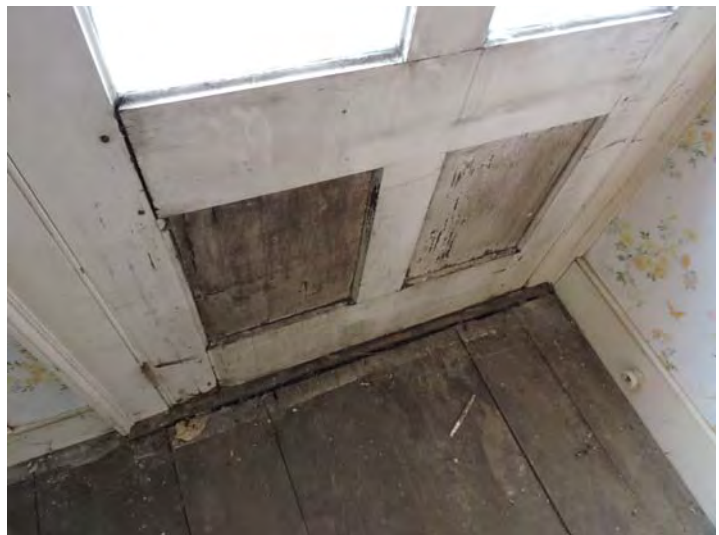
Door 'A' is in poor condition (see photos 10A & 10B). The midrail /stile joints are separating, the exterior paint is peeling and the door is warped. The door also appears to have been covered with vines at one time, which can be quite destructive, although they have been removed. The condition of the door sill should be reviewed when the timber sills are investigated (see IV. Sills, and Structural report).

Front Door 'A' at East elevation - exterior  
**Photo No. 10A**

Front Door 'A' at East elevation - interior  
**Photo No. 10B**

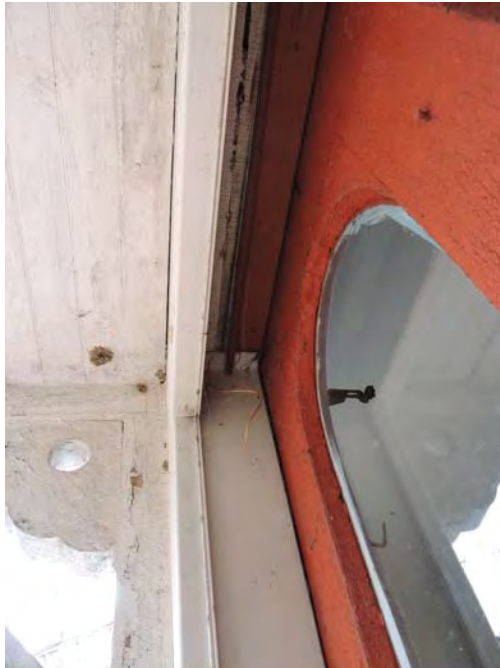
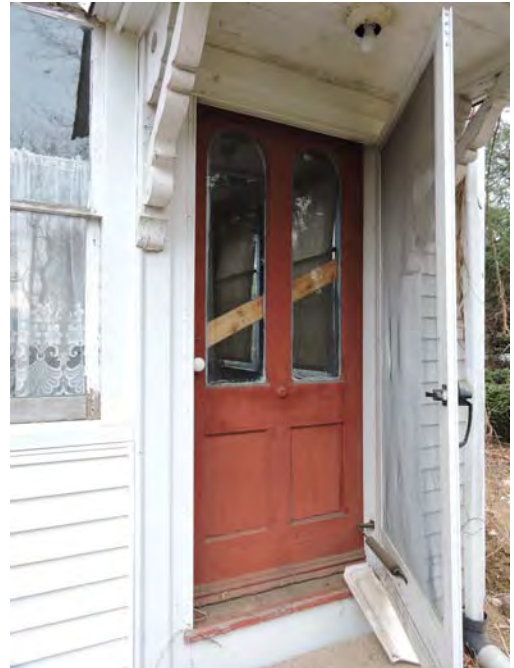
Door 'B' is protected on the exterior with a modern aluminum storm door, which has been installed at the exterior with a head height that is lower than the door head height (see photos 11A & 11B). From the exterior, the top stile is not completely visible through the transparent glazed panel of the

Door 'B' at South Entry - exterior  
**Photo No. 11A**

Door 'B' at South Entry  
storm door head lower than door head  
**Photo No. 11B**

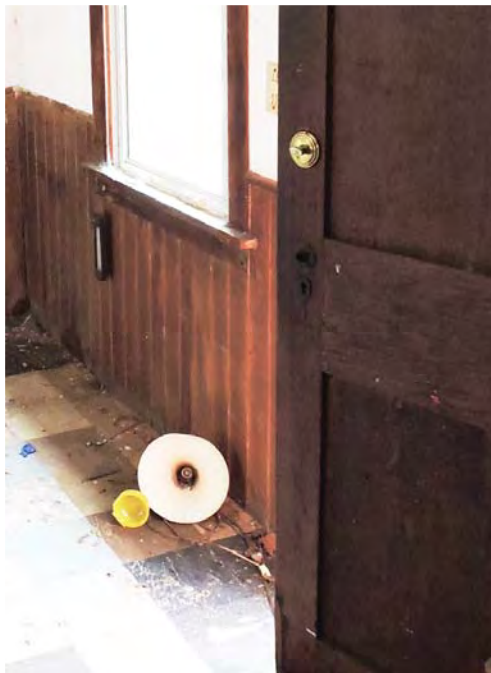
Door 'C', at the North Ell, is a six-panel solid wood stile and rail with solid panels (see photo 12). It has an aluminum storm door and some shelter from a soffit overhang at the roof. Some of the original hardware is missing.

Door 'C' at North Ell - interior finish.  
**Photo No. 12**

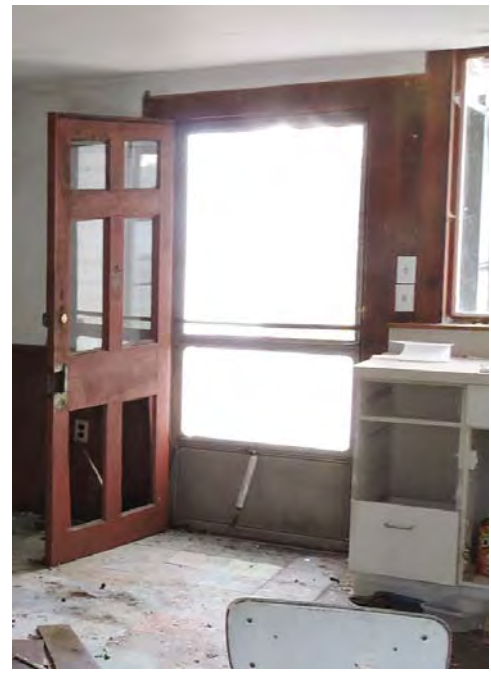
Door 'D', next to the solarium greenhouse is a six panel solid wood stile and rail with 6 glazed panels (see photo 13). It has an aluminum storm door and is under a sheltered overhang. The lockset has been removed and the door stile damaged.

Door 'D' at South Elevation, near greenhouse  
**Photo No. 13**

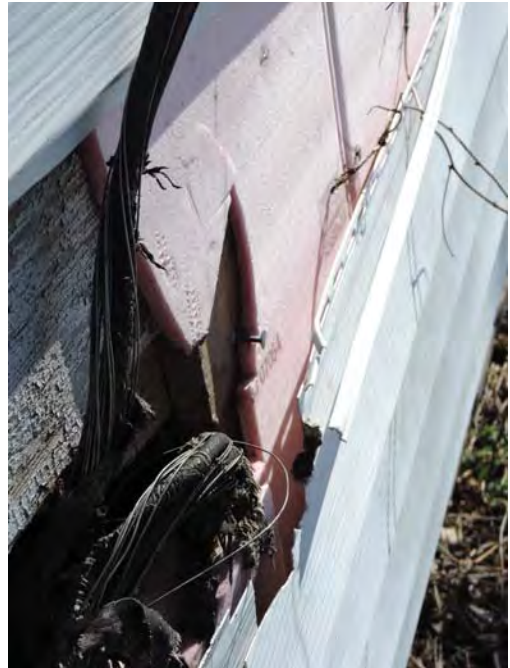
Photo No. 14

The extruded polystyrene insulation just behind the vinyl siding (see photo 14) provided an R-value of approximately 1.8 when it was first installed, but this type of insulation tends to absorb moisture over time so it does not retain its insulation value over the term. Because of this low R-value, this insulation is not sufficient to keep the wall warm enough in this climate to prevent condensation behind the vapor impermeable vinyl siding, and under these circumstances, the vinyl/insulation cladding will actually be doing more harm than good when the building is occupied.

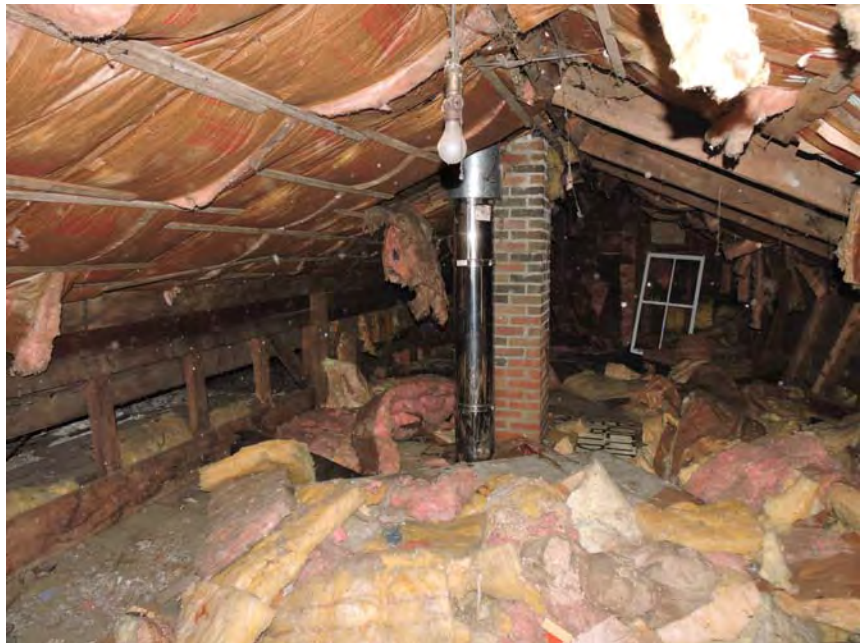
At West Ell attic, there is fiberglass batt insulation in both floor and rafters, but it is almost all dislocated and/or hanging in ribbons (see photo 15). It should all be removed prior to stabilization work in the attic.

West Ell attic - batt insulation in disarray  
Photo No. 15

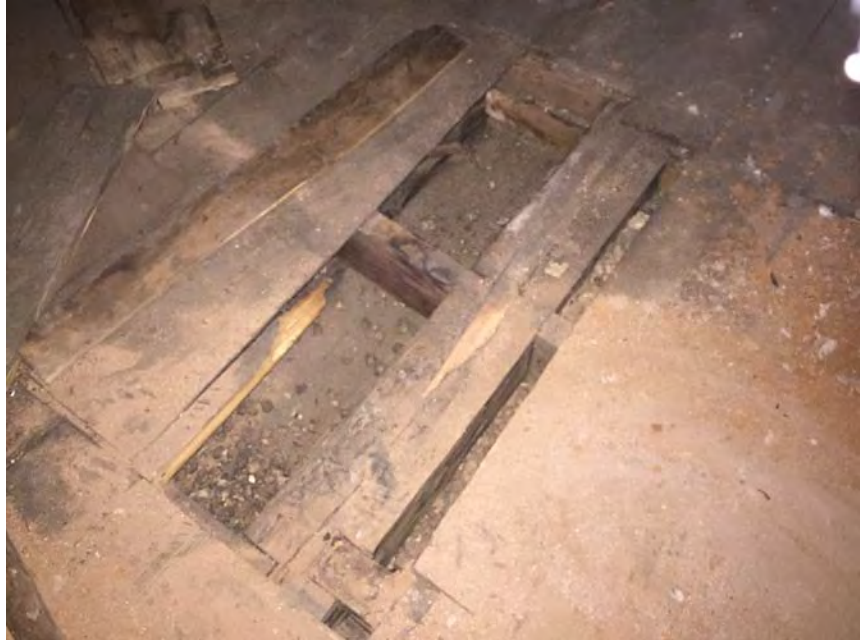
There is no insulation in the floor or rafters of the Main block (see photo 16).

Main Attic - no insulation below floorboards of main attic.  
**Photo No. 16**
