# PRIEST FARM FEASIBILITY REPORT & CONCEPT PLAN

TOWN OF SOUTH WINDSOR, CT  
1407 SULLIVAN AVE, SOUTH WINDSOR, CT

MAY 16, 2016

Re: Priest Farm Structural Condition Assessment - Final

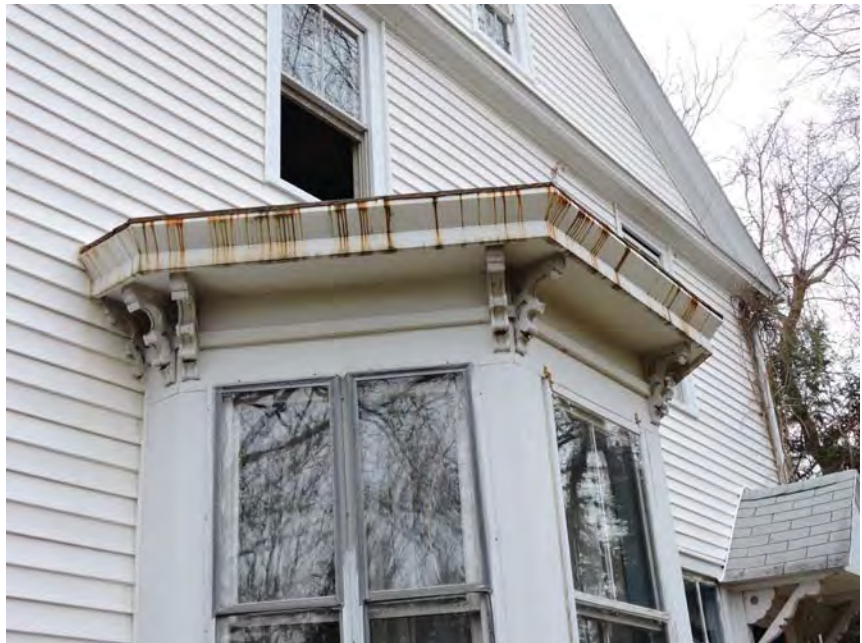
**Photo No. 17**

asphalt shingle system is 15-18 years; this roof is 24 years old. The low slope roof at the bay window is corroded ferrous metal, which has left iron oxide drip stains (see photo 17)

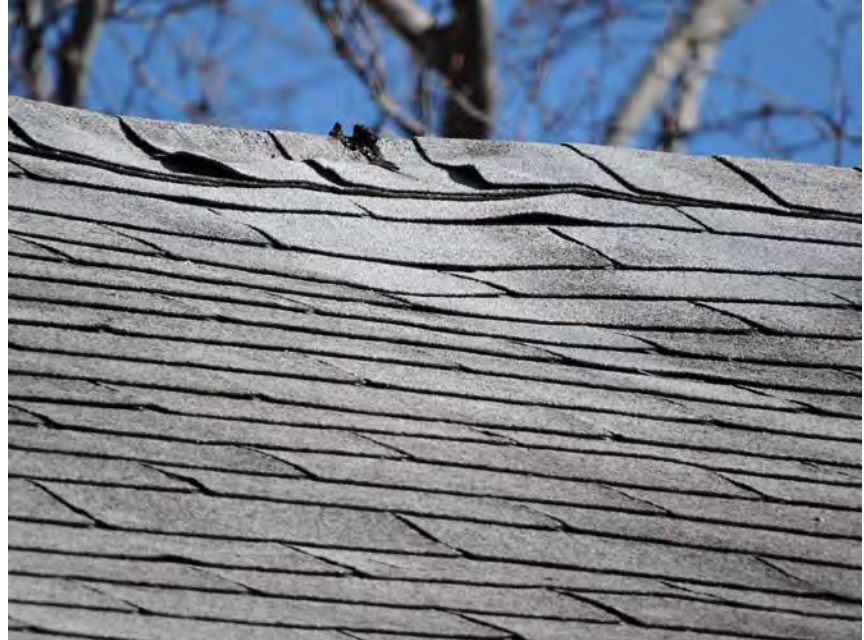
There is a chimney centered at the ridge of the main house block, although it is no longer visible from the exterior because it was capped and the exterior portion was removed. The remedial framing at the closed off hole may appear to be not completely flush with the original roof, so there is a 'divot' in the ridge line at this location (see photo 18 and Structural report). In addition, appears from the ground that there may have been a lightning rod adhered in that location with roof cement, which may have been stolen by vandals for the value of the copper, along with its grounding cables.

'Divot' at ridge where original chimney was roofed over  
**Photo No. 18**

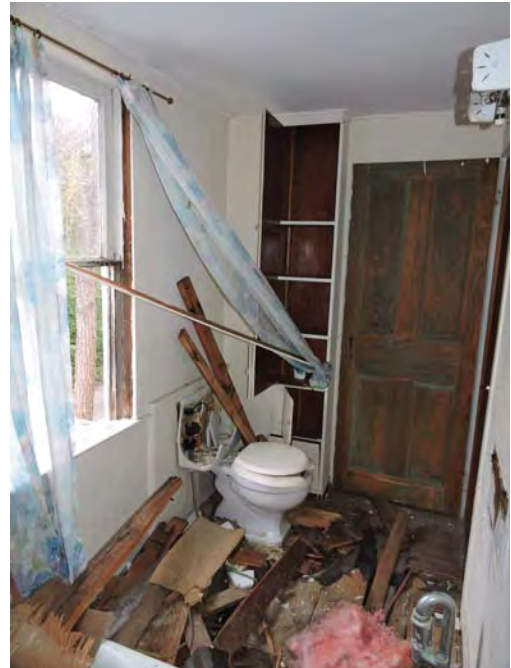
Plumbing in upstairs bathroom was raided by vandals.  
**Photo No. 20**

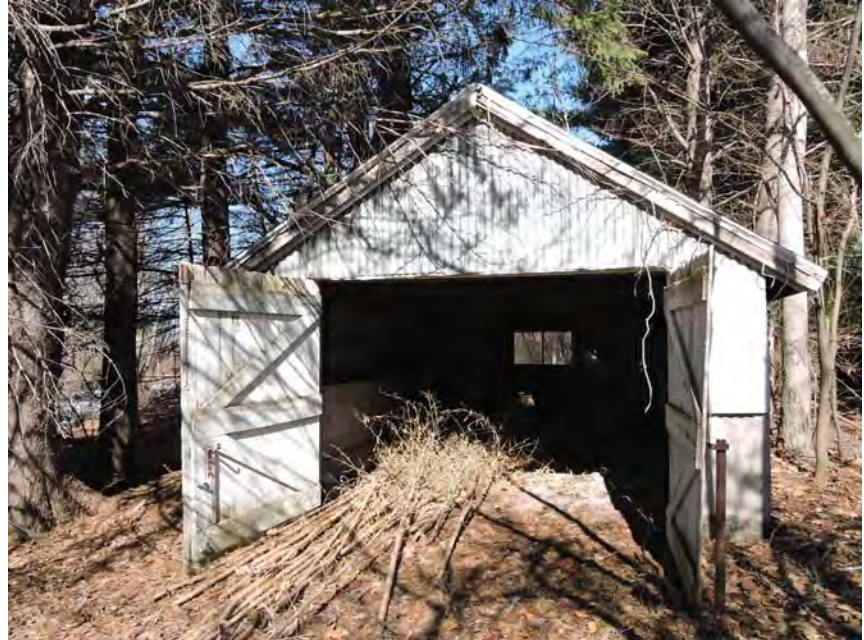
Building No. 2 - South elevation  
**Photo No. 24**

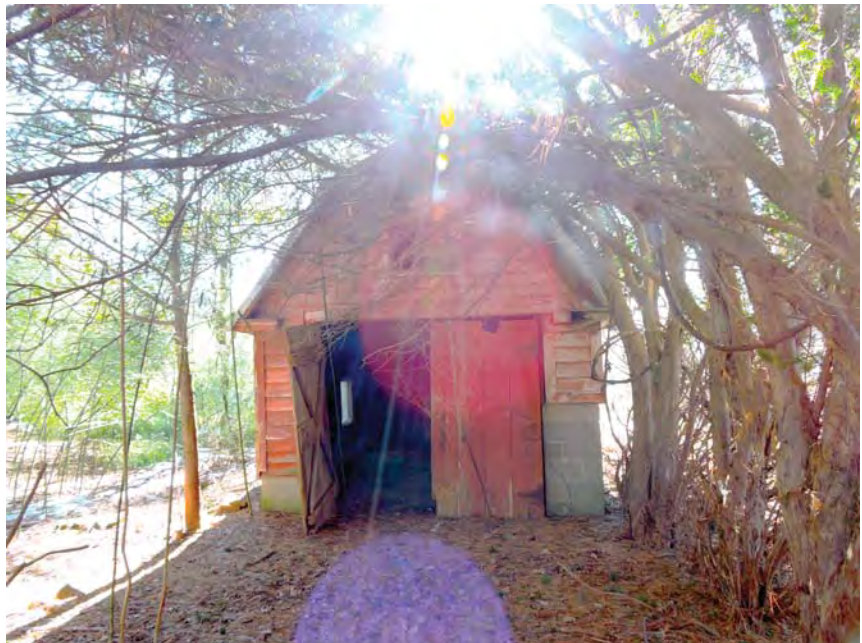
Building No. 3 - North elevation.  
**Photo No. 28**

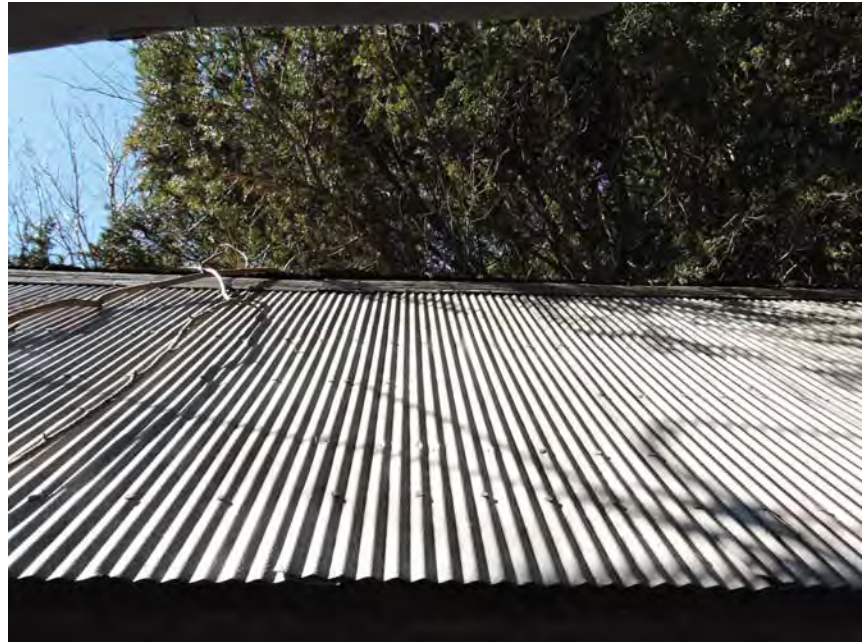
The existing roof is a finely corrugated metal panel installed over top of wood shingle (see photo 29). Straight wood shingles clad the exterior from the eave to the roof ridge on the gambrel elevations. The wood clapboard siding on the rest of the wood-framed portions of the building is in reasonably good condition.

Building No. 3 - Existing corrugated metal roof  
**Photo No. 29**

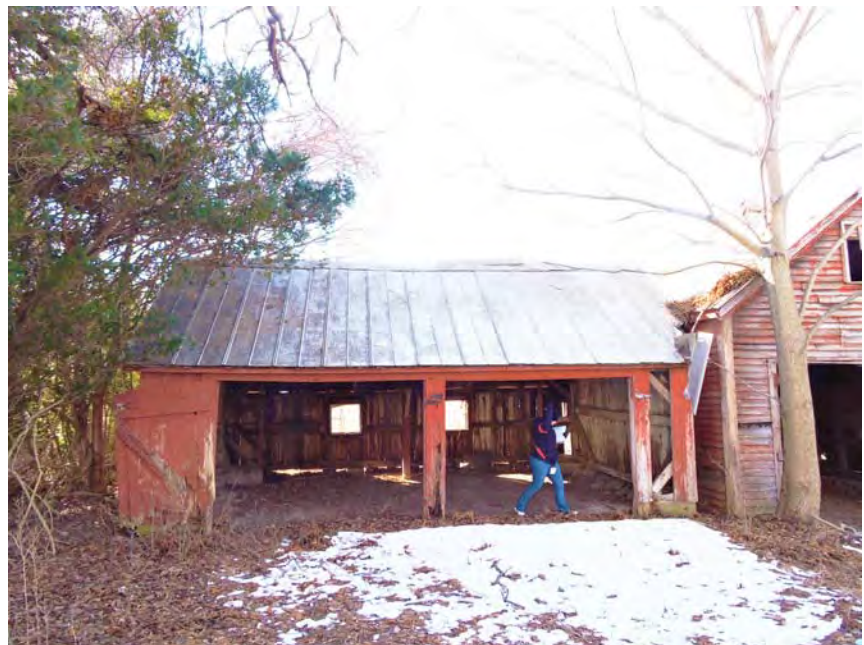
Building No. 4 - North elevation.  
**Photo No. 30**

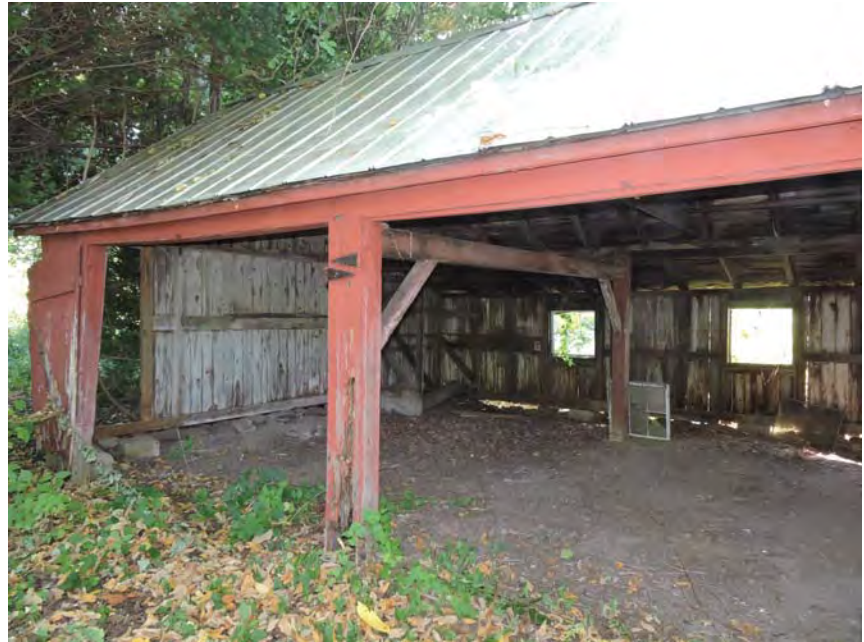
This building is generally in fair to poor condition (see photo 31). See *Structural Engineer's report for recommendations*.

Building No. 4 - interior  
**Photo No. 31**

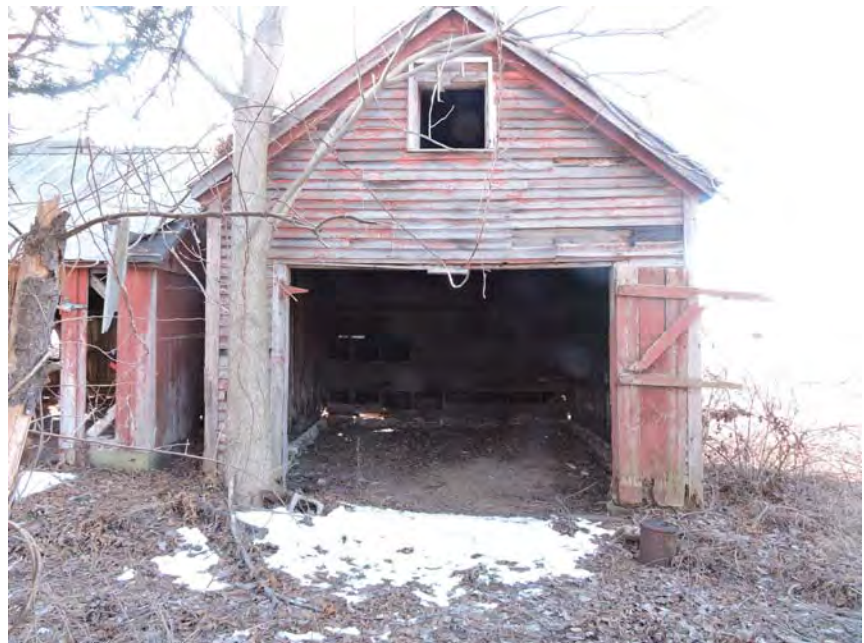
Building No. 5 - North elevation  
**Photo No. 32**

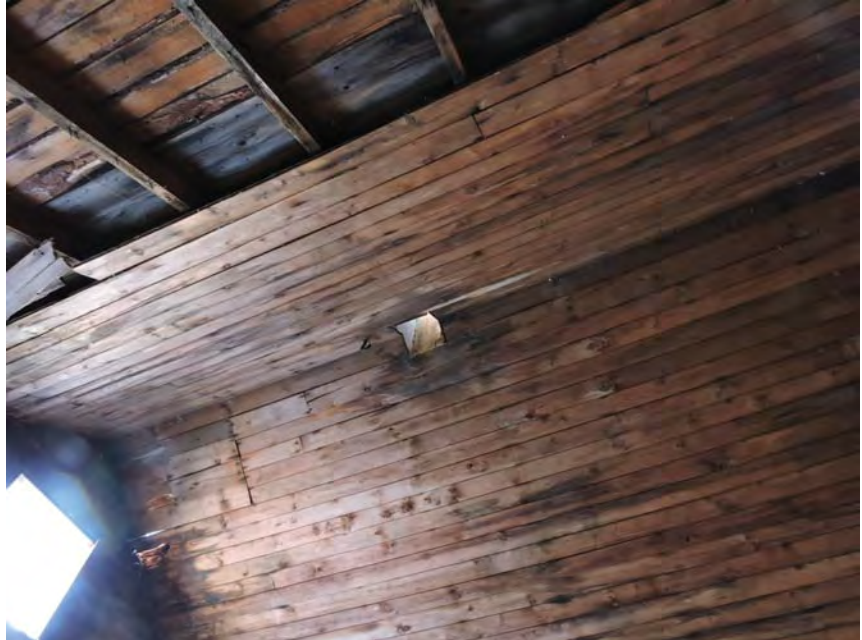
There is a small ventilation cupola at the roof ridge (see photo 33). The roof is asphalt shingle similar to what is on the Farmhouse. On the exterior, horizontal clapboard siding is fastened over asphalt felt paper on top of board sheathing. The clapboards are in rough condition and would need to be replaced if the building is salvaged.

Building No. 5 - ventilation cupola  
**Photo No. 33**

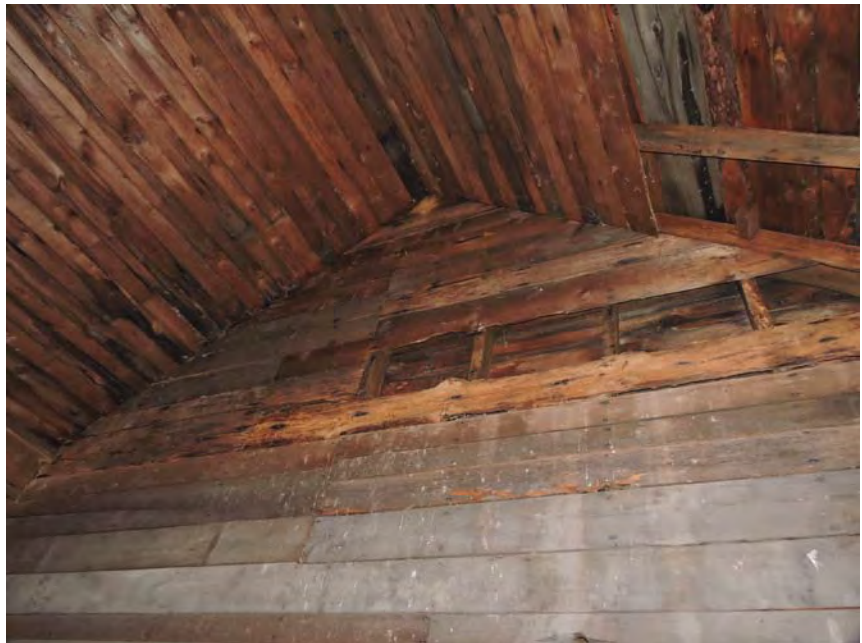
On the interior, there are horizontal boards fastened to the wall studs on the inside surface, and narrower boards fastened to the underside of the roof rafters (see photo 34). The efforts to close the stud spaces suggest that the building may have been built for livestock such as horses.

Building No. 5 - interior  
**Photo No. 34**

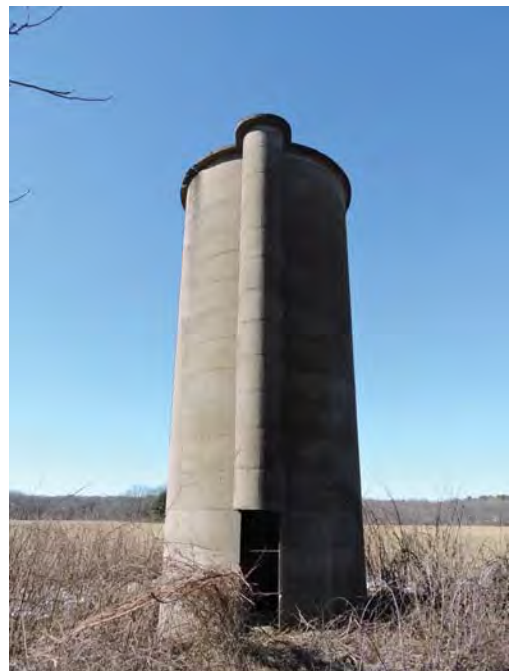
Silo - view from East.  
**Photo No. 36**

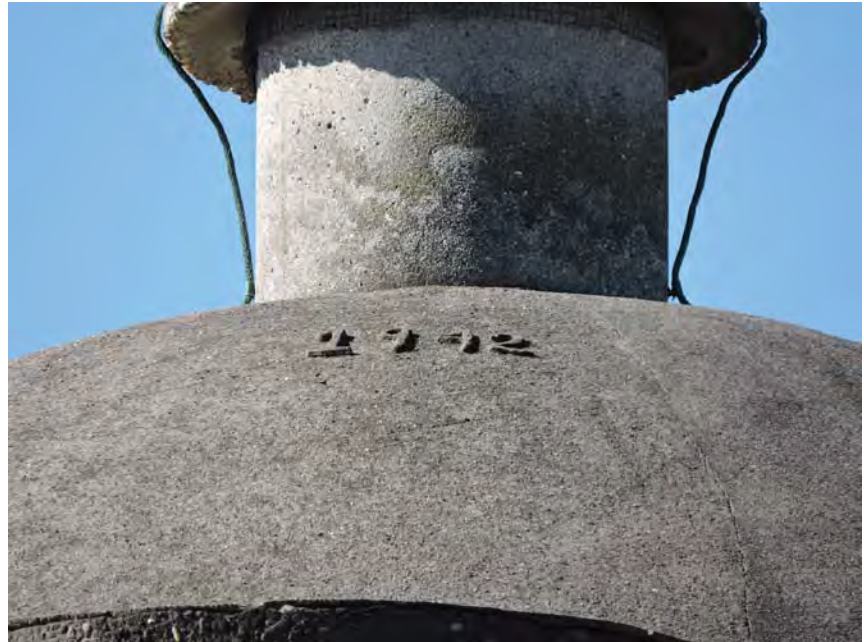
The silo is formed of poured concrete (also called 'monolithic') and was built in 1942 (see photo 37). This construction technique was developed in the Midwest around the turn of the century and first

Silo - date of construction molded onto concrete roof dome.  
**Photo No. 37**
