# DEFECTIVE CONCRETE FOUNDATIONS

WHERE ARE WE AND WHERE  
ARE WE GOING?

William Neal  
Residential Engineering Services, LLC  
860-871-1830 ResEng88@gmail.com

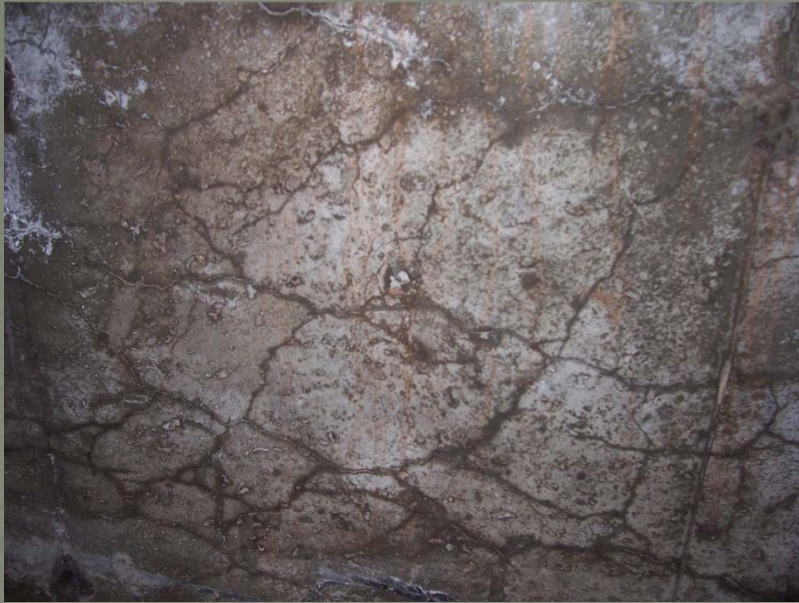
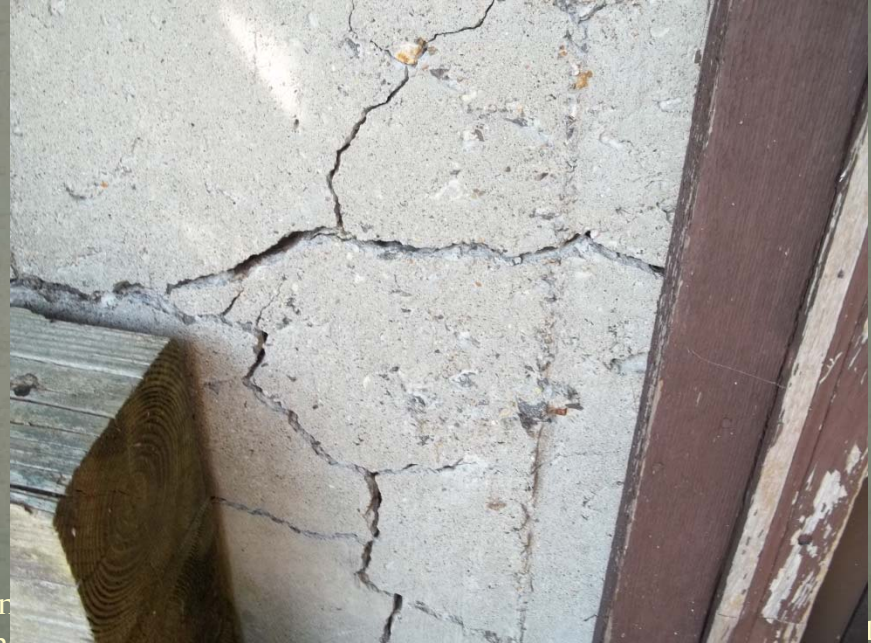
# More than one problem?

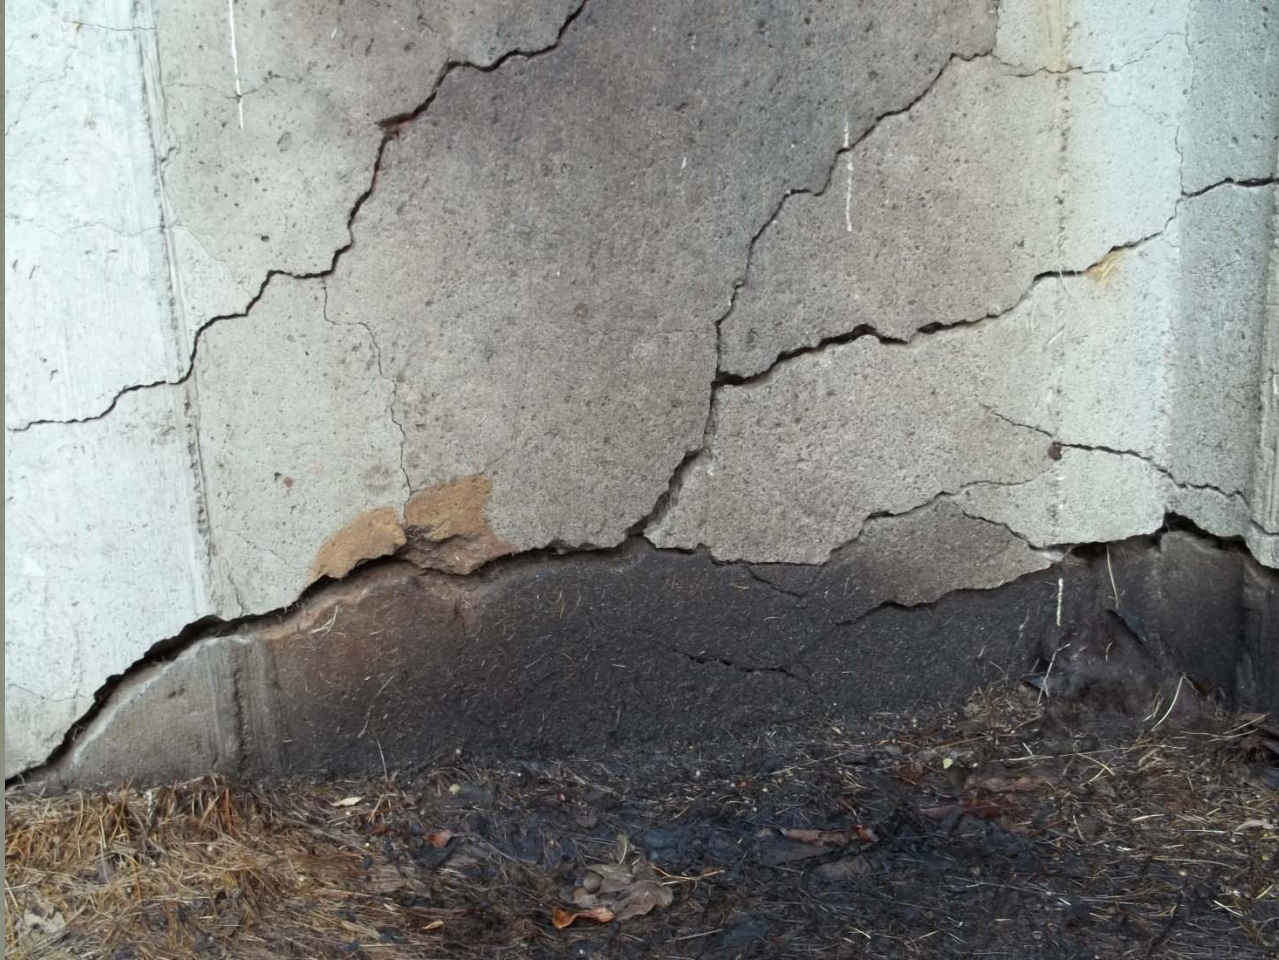
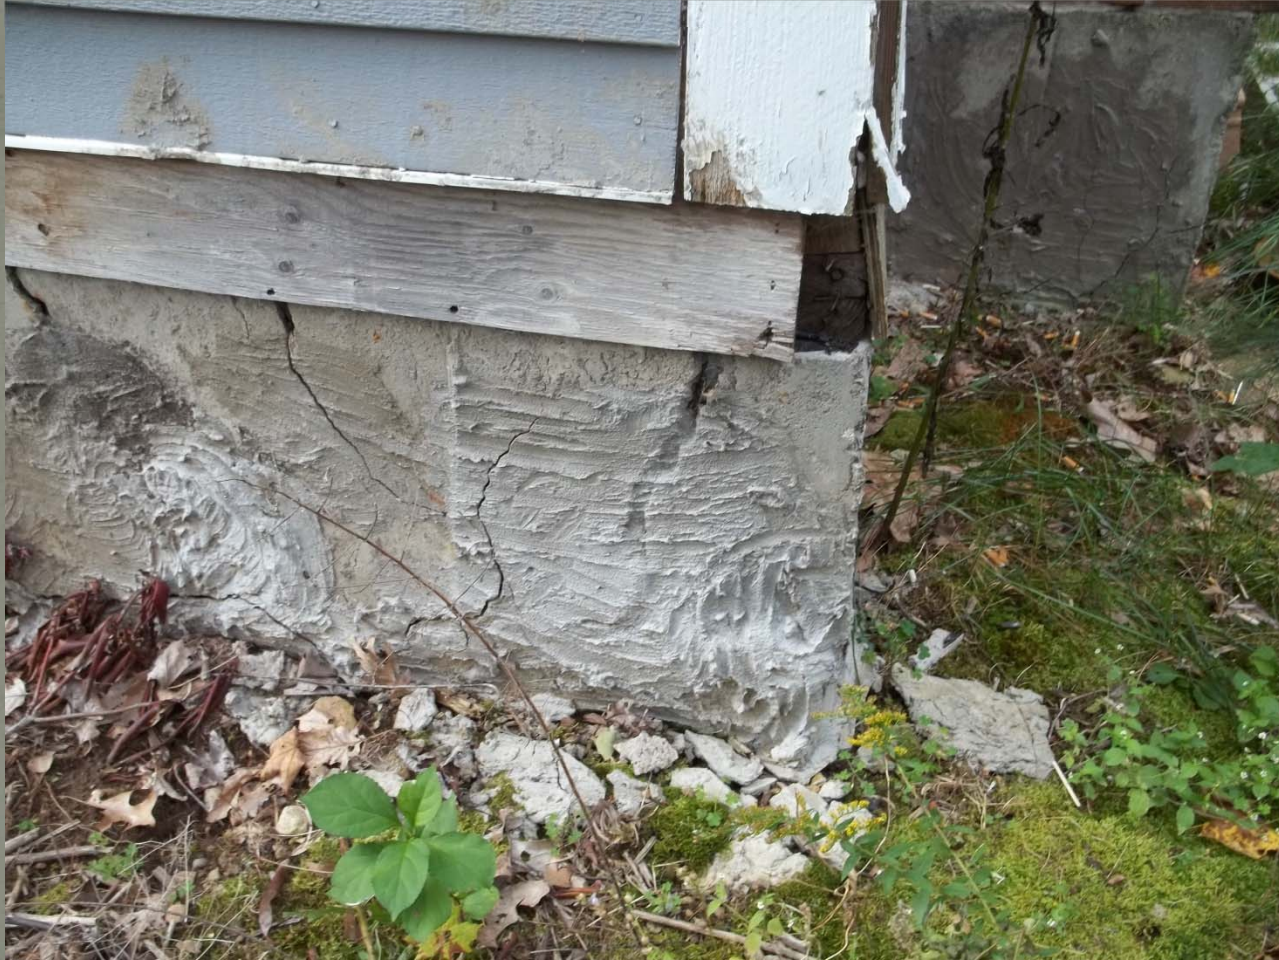
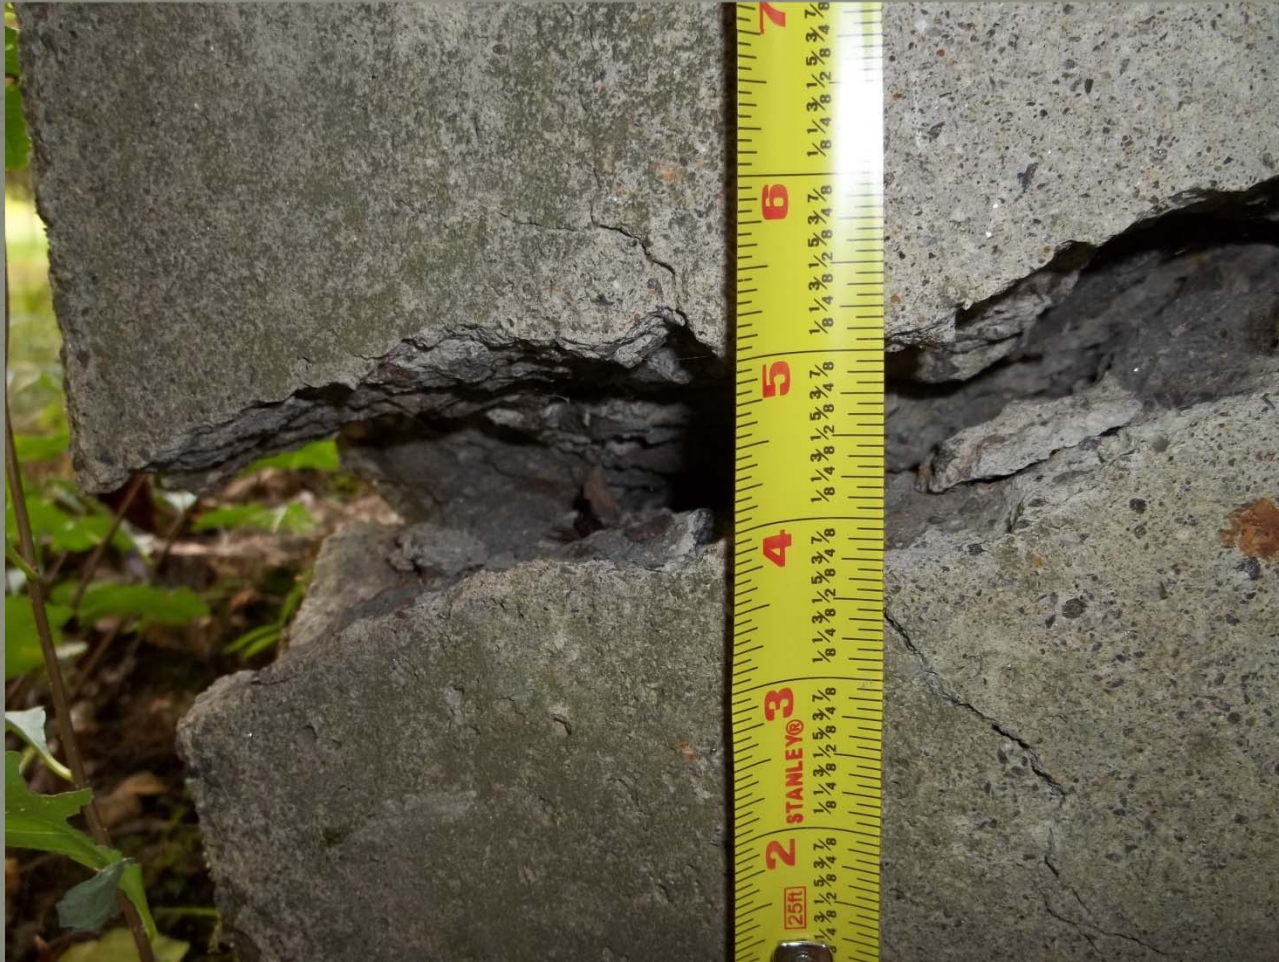
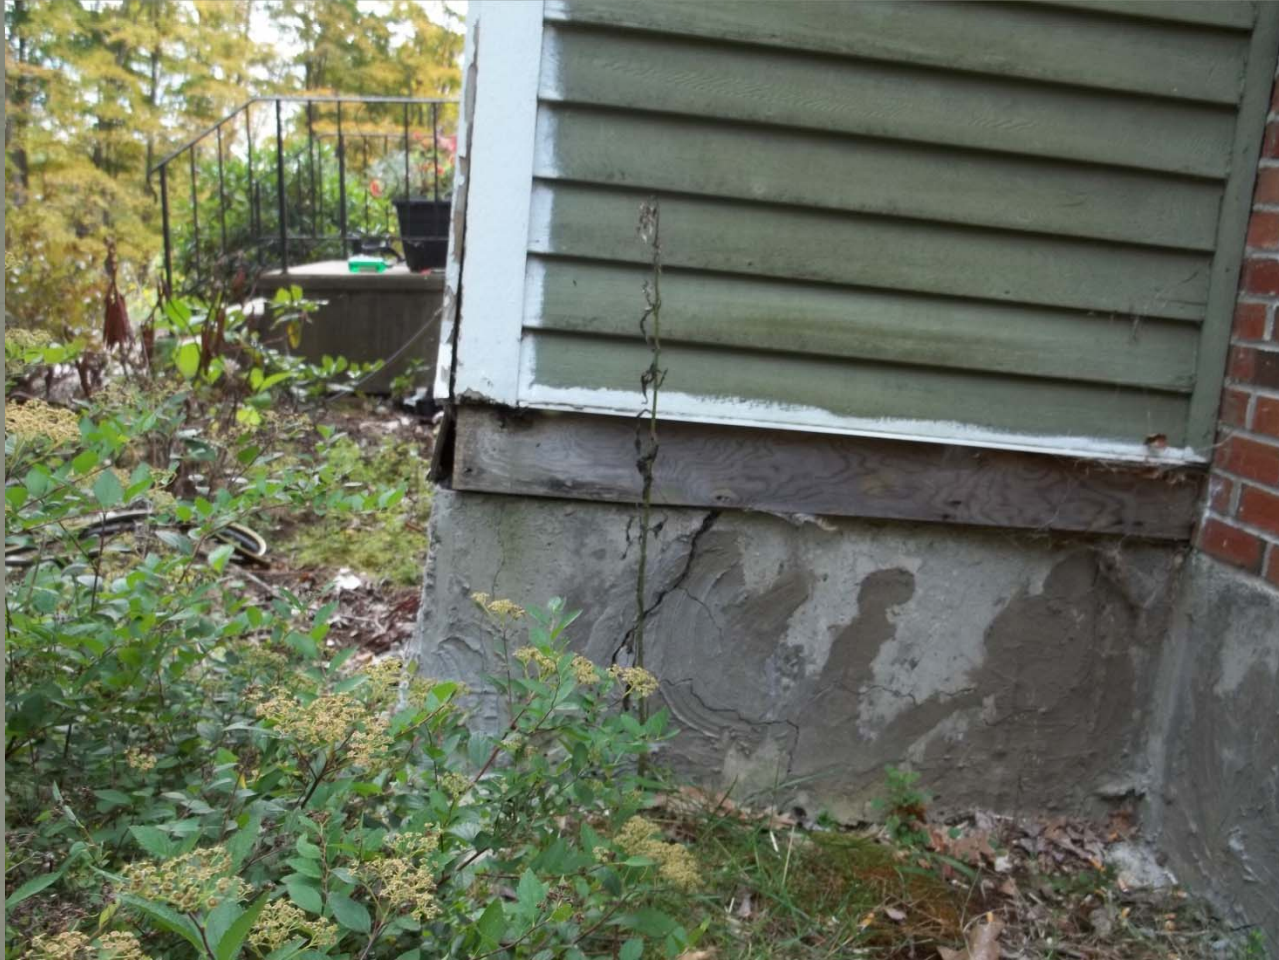
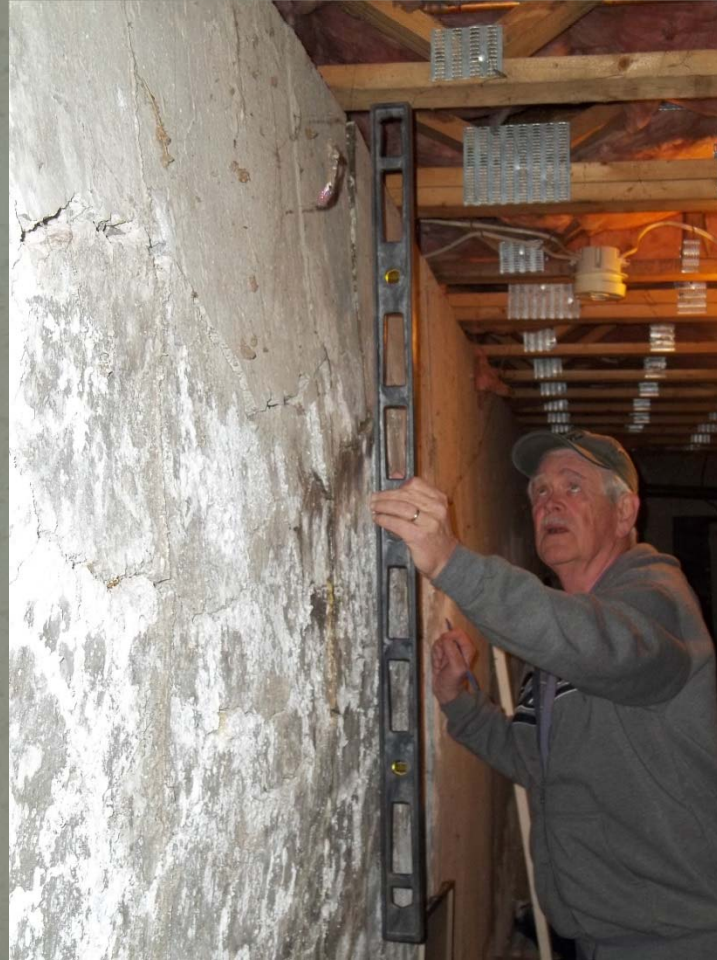
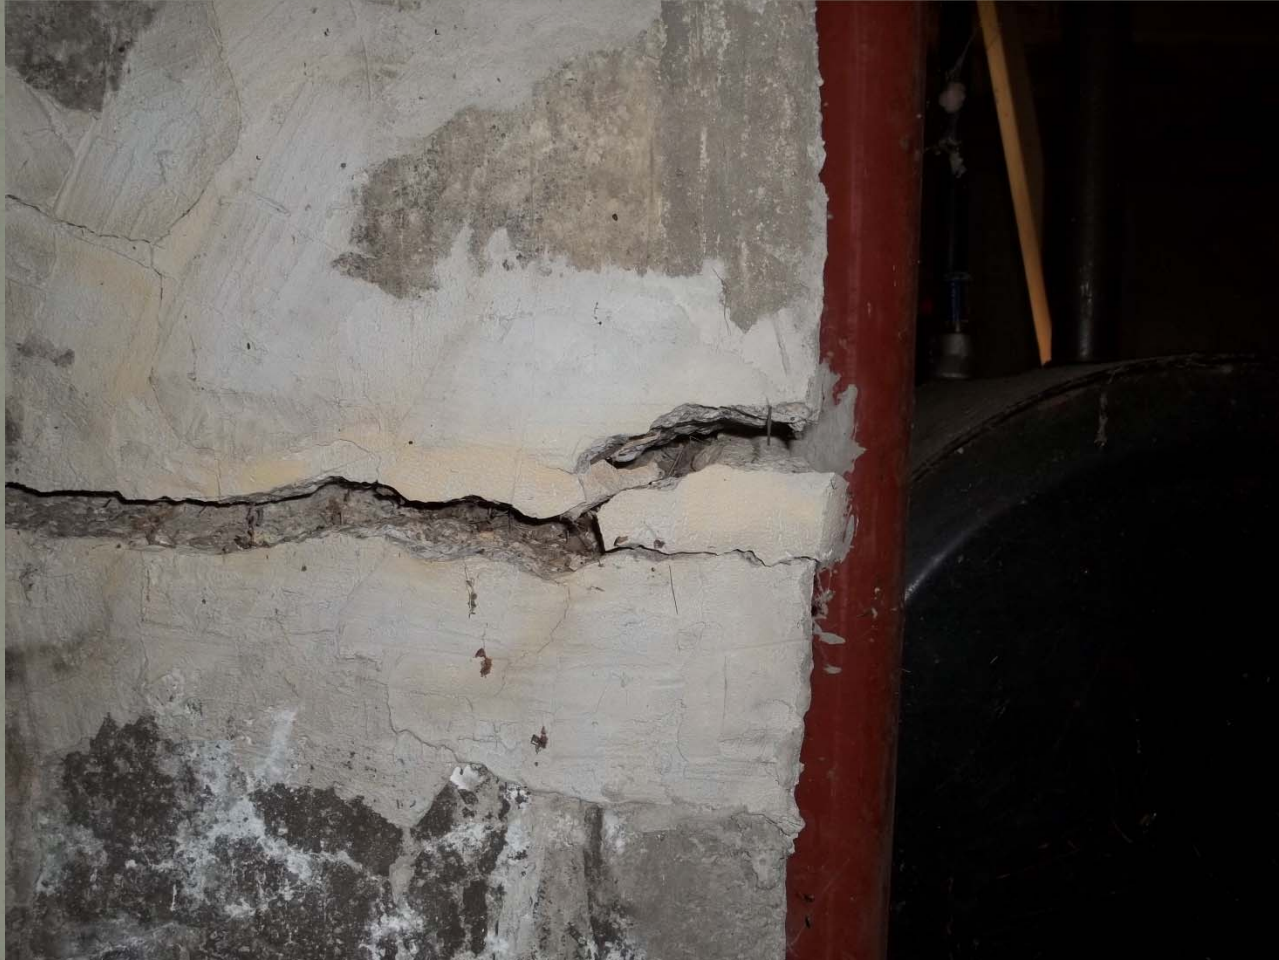
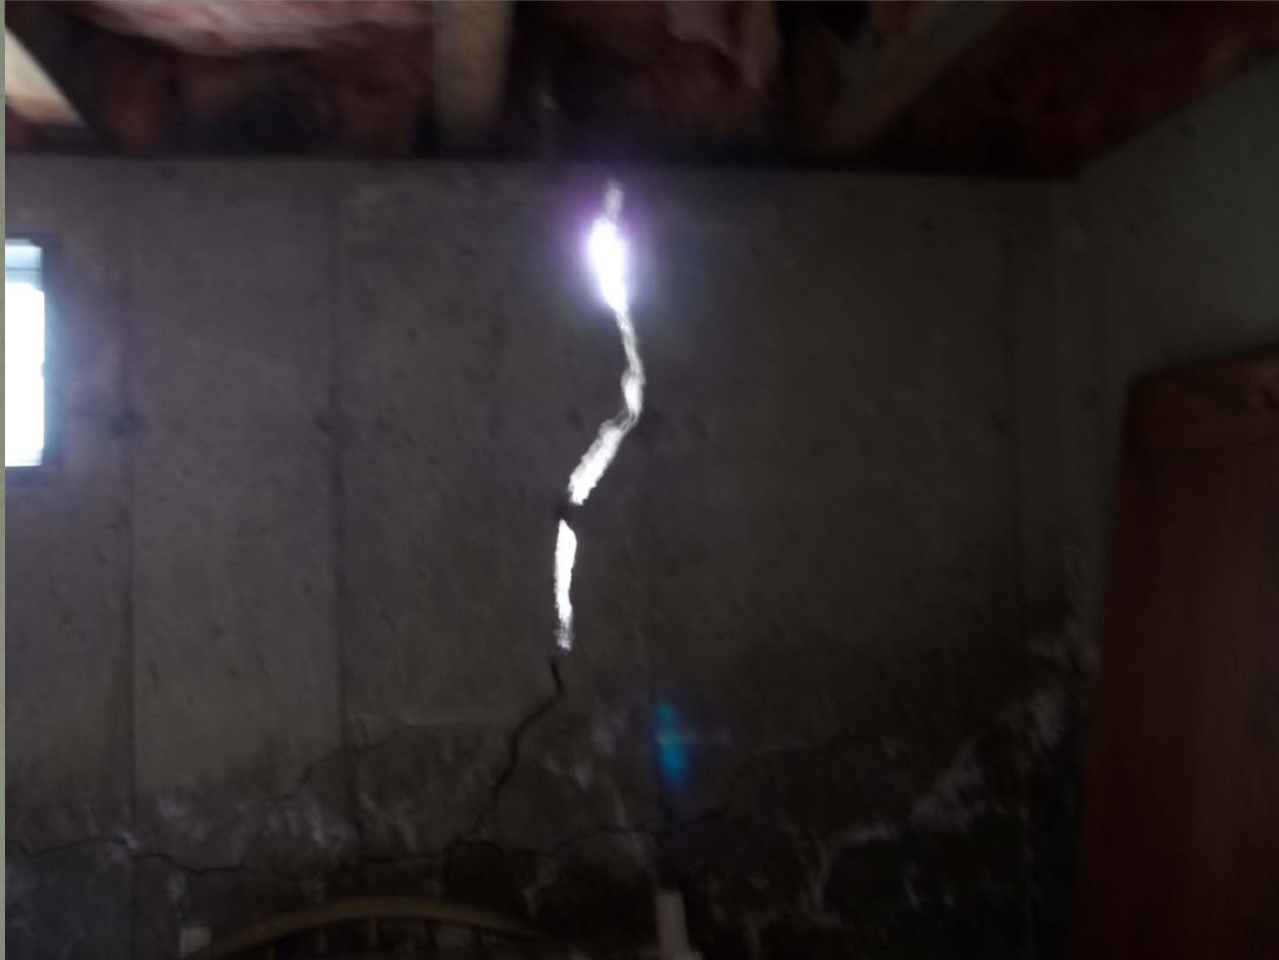
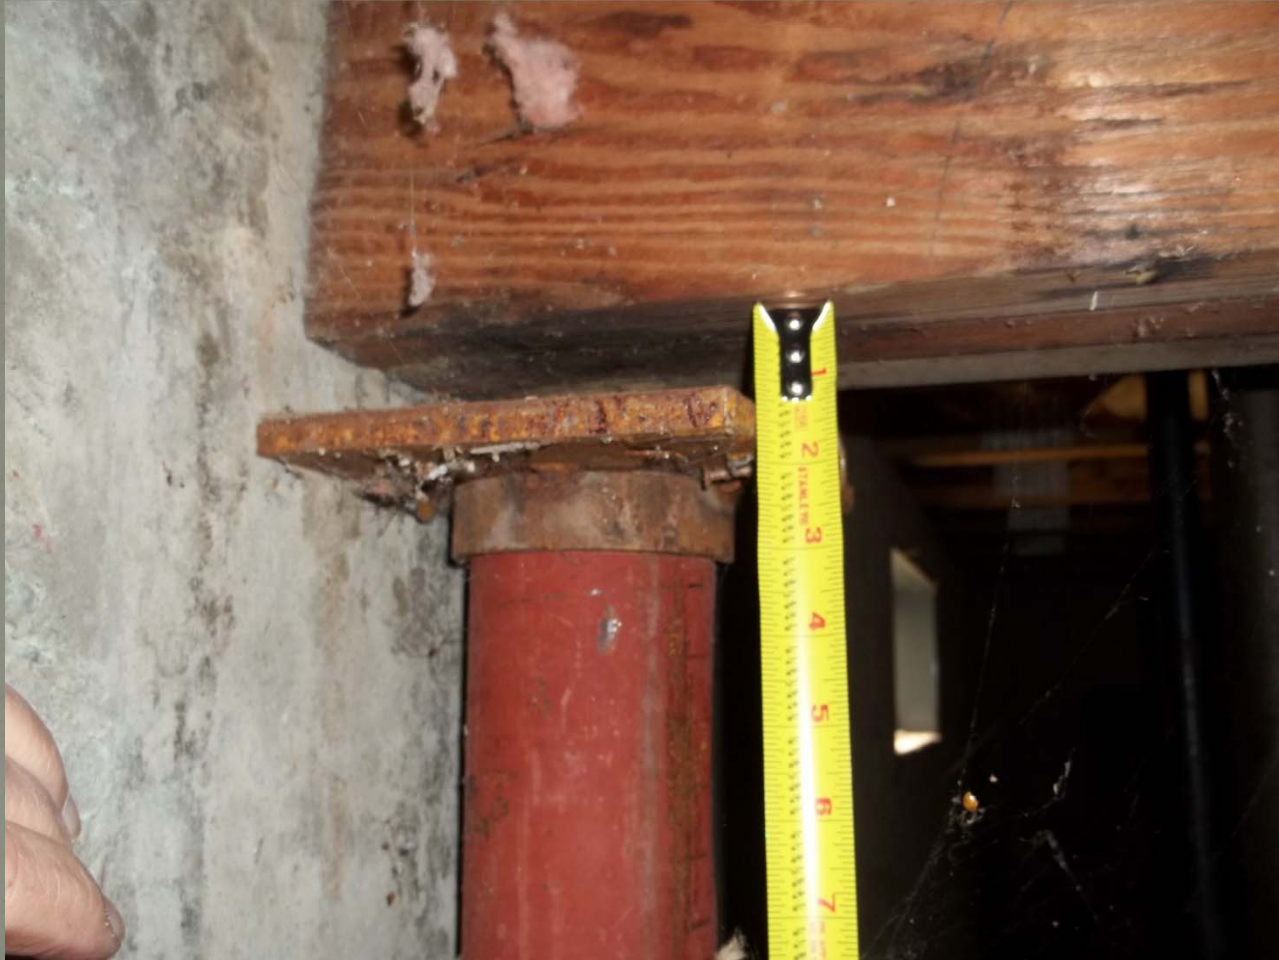
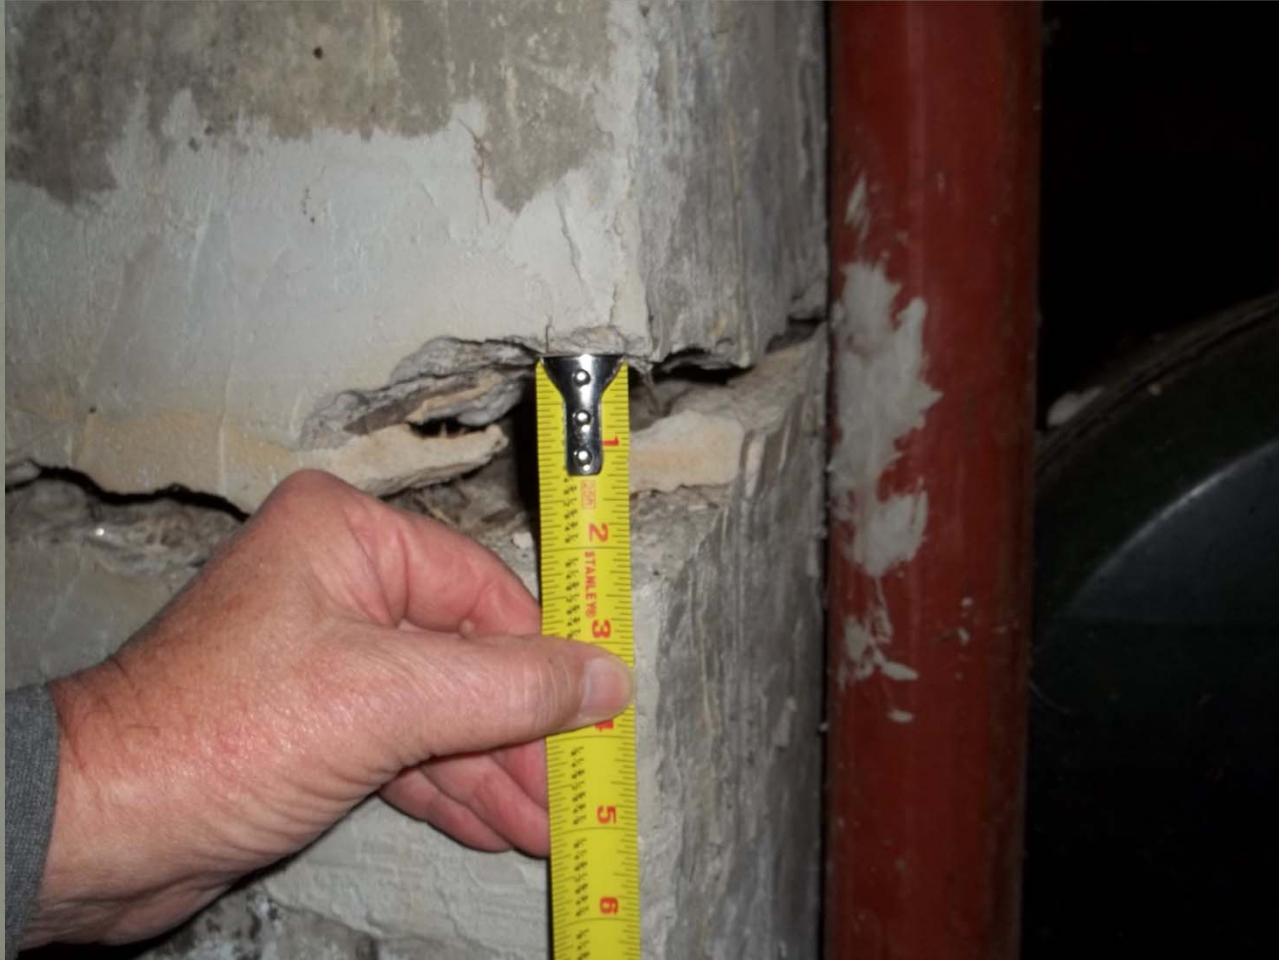
# Structural distress/failure is possible

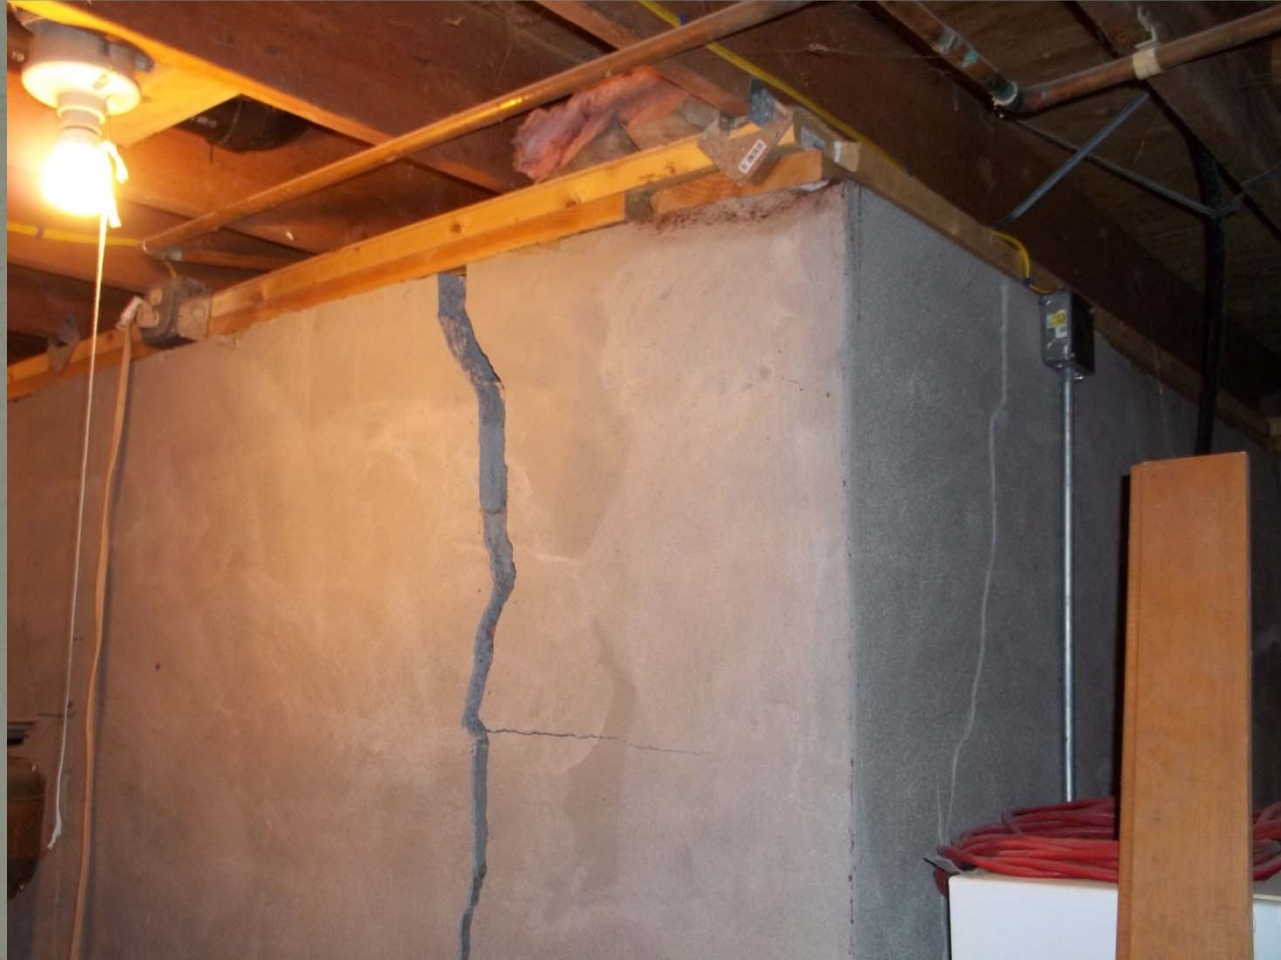
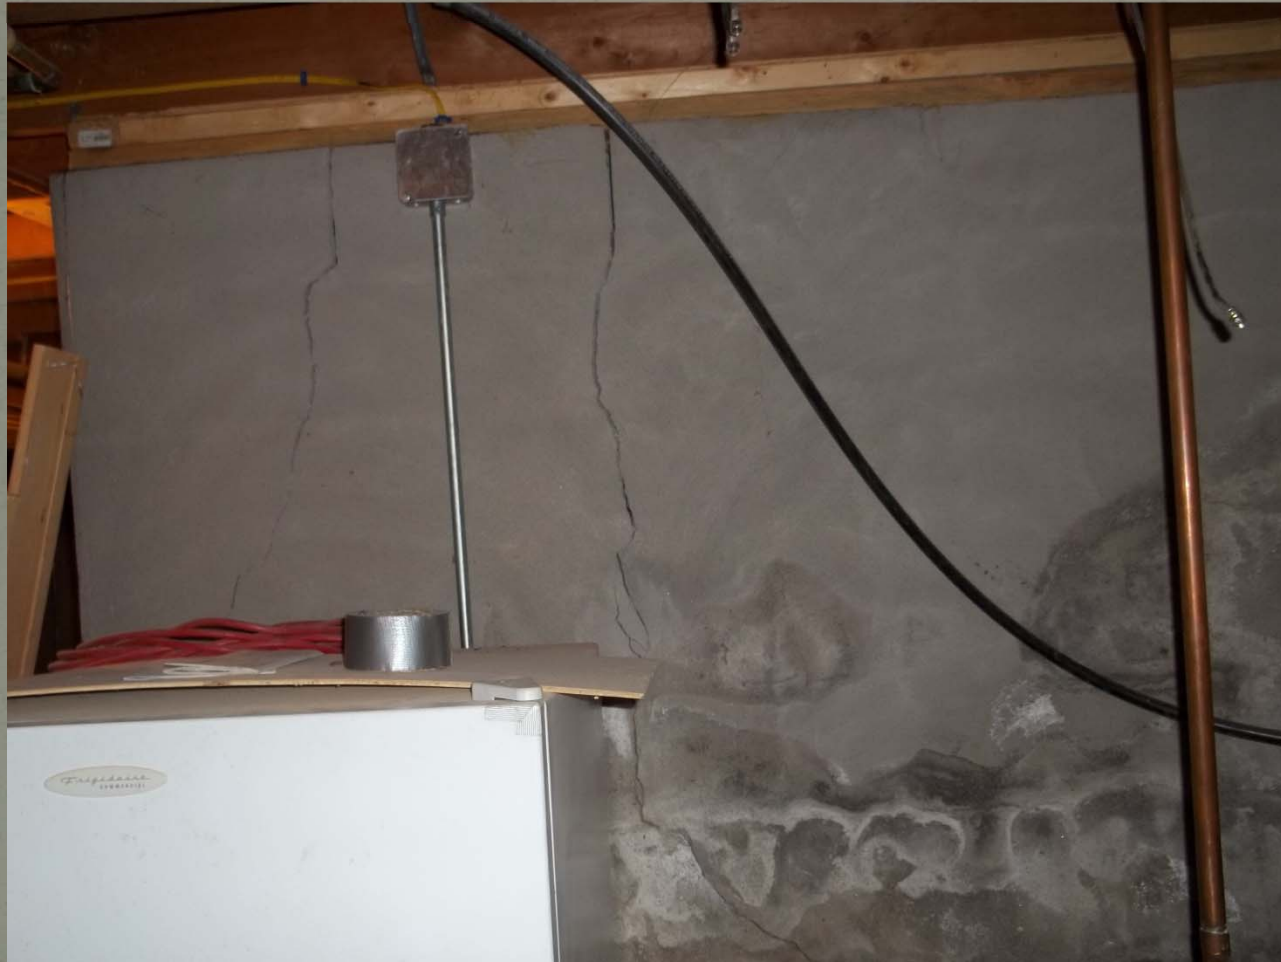
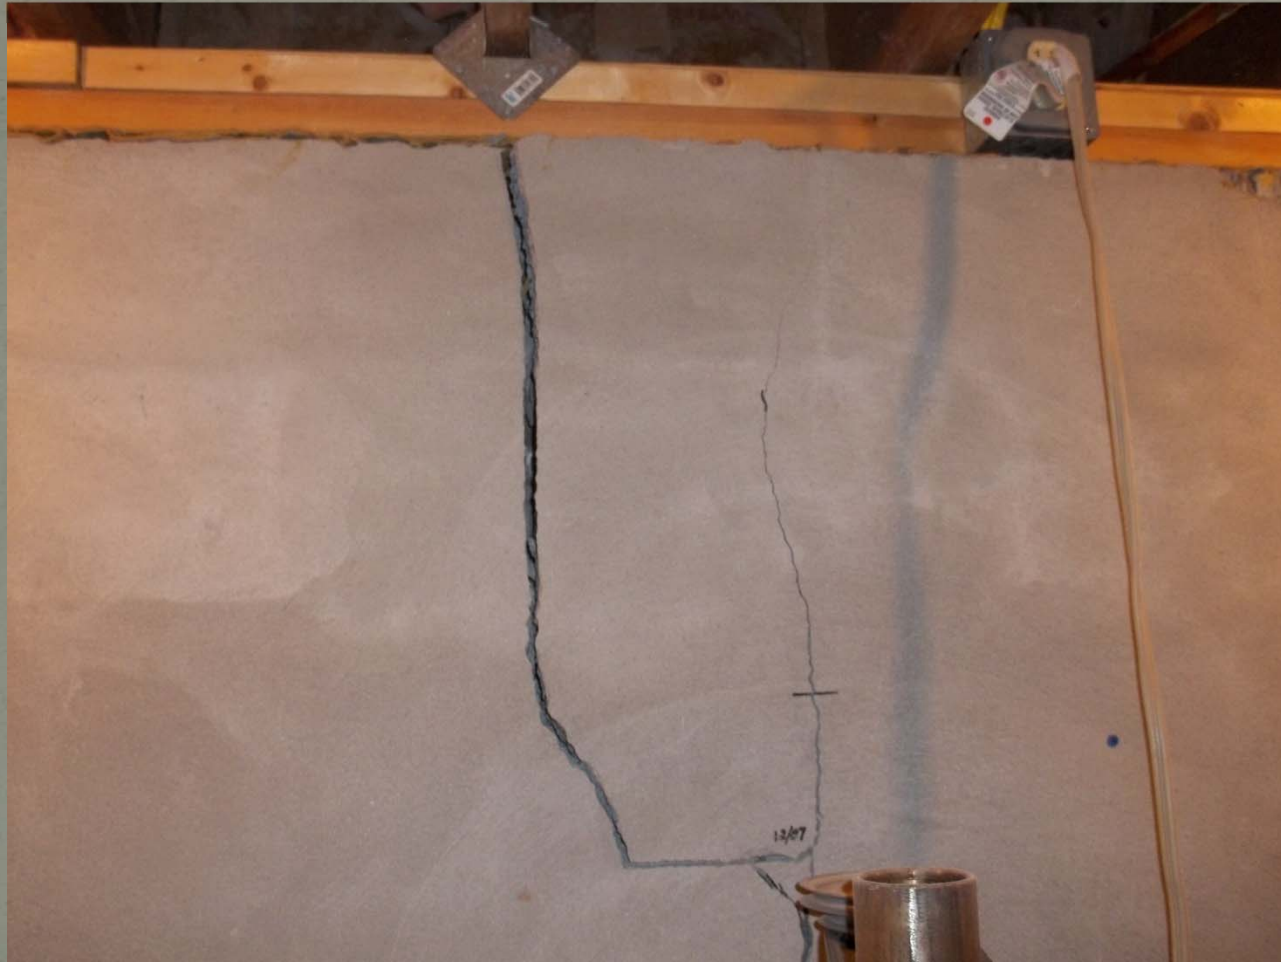
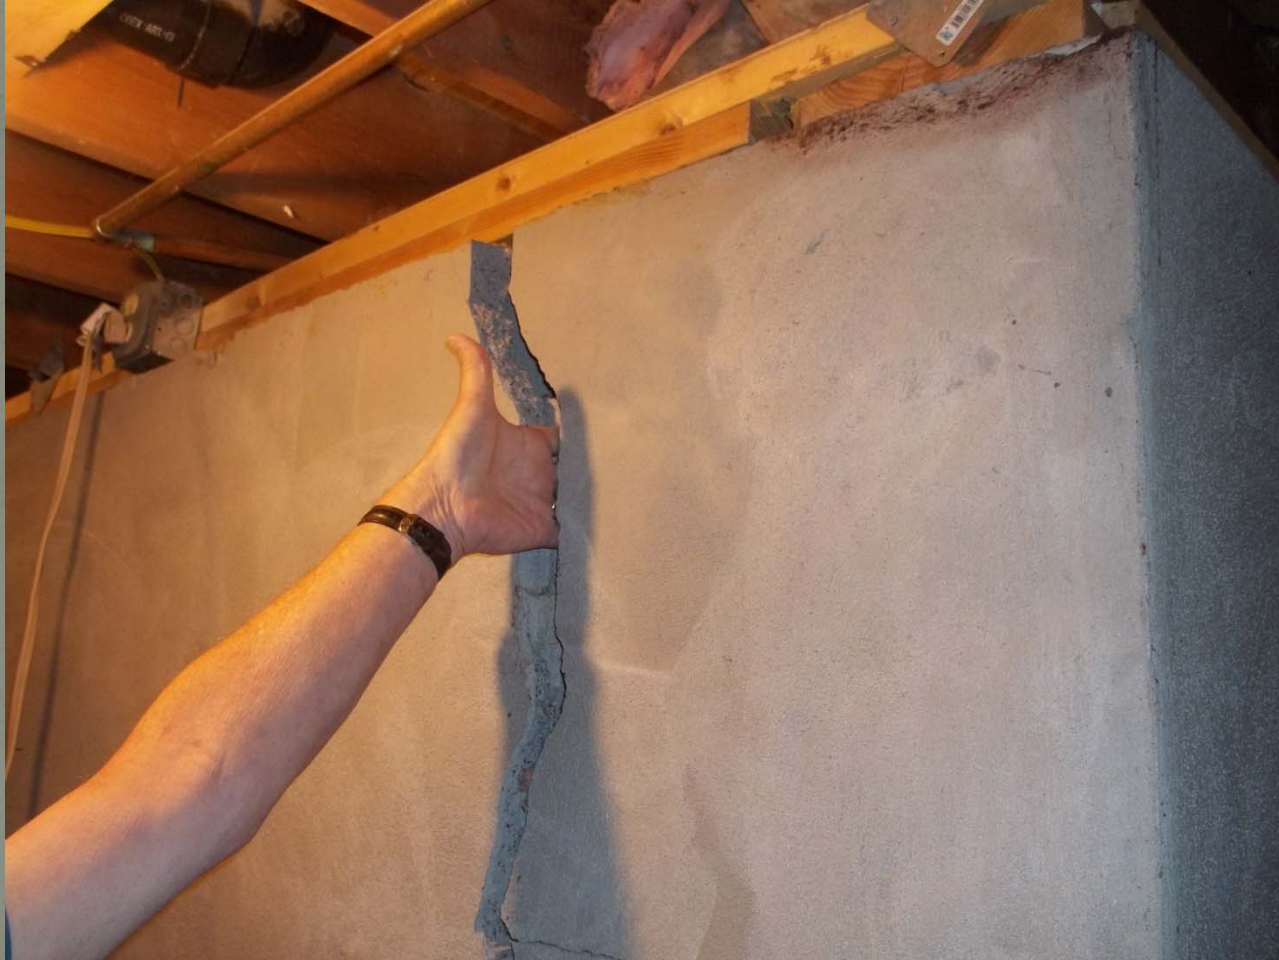
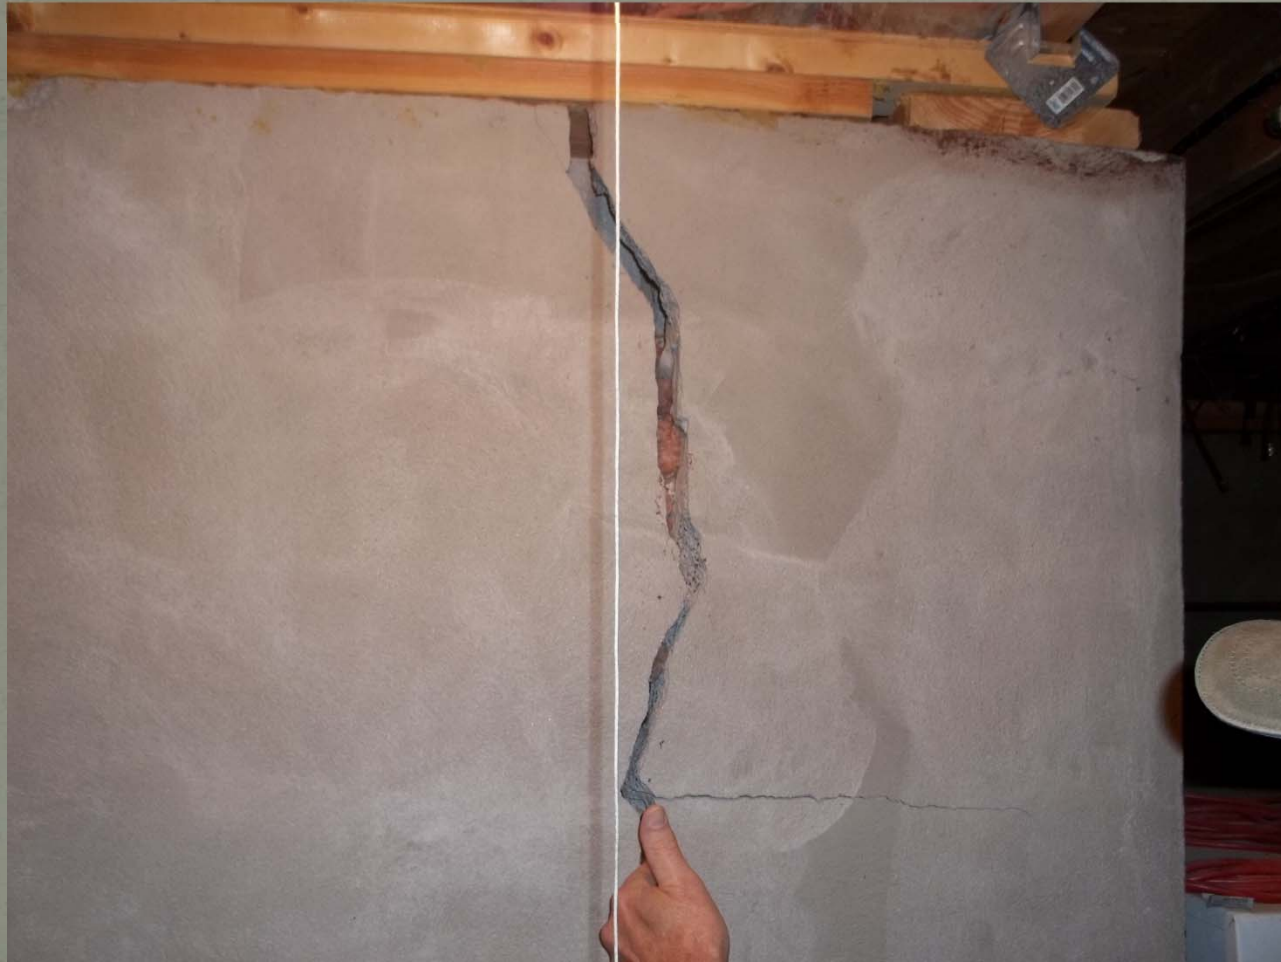
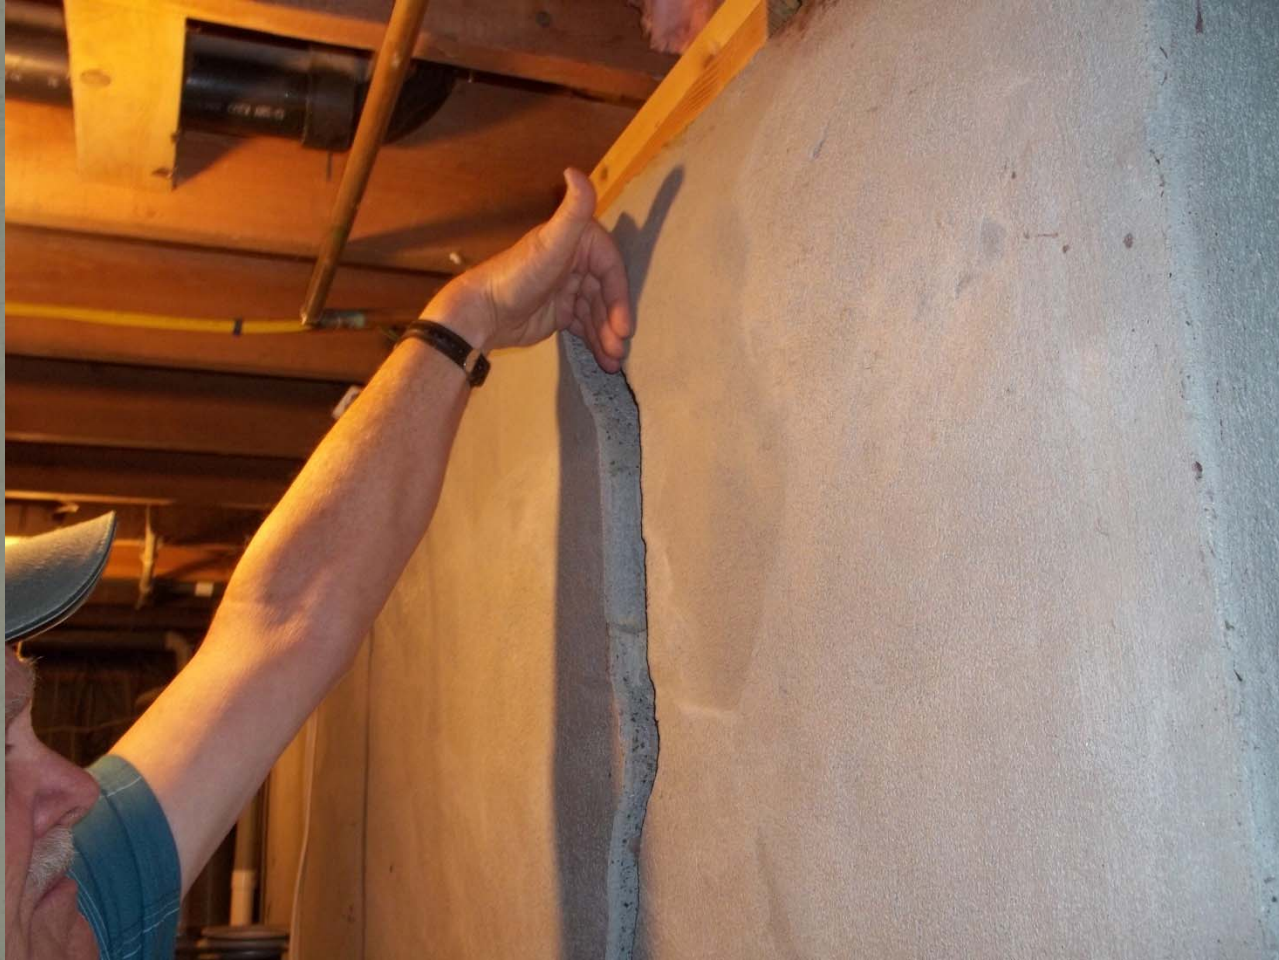
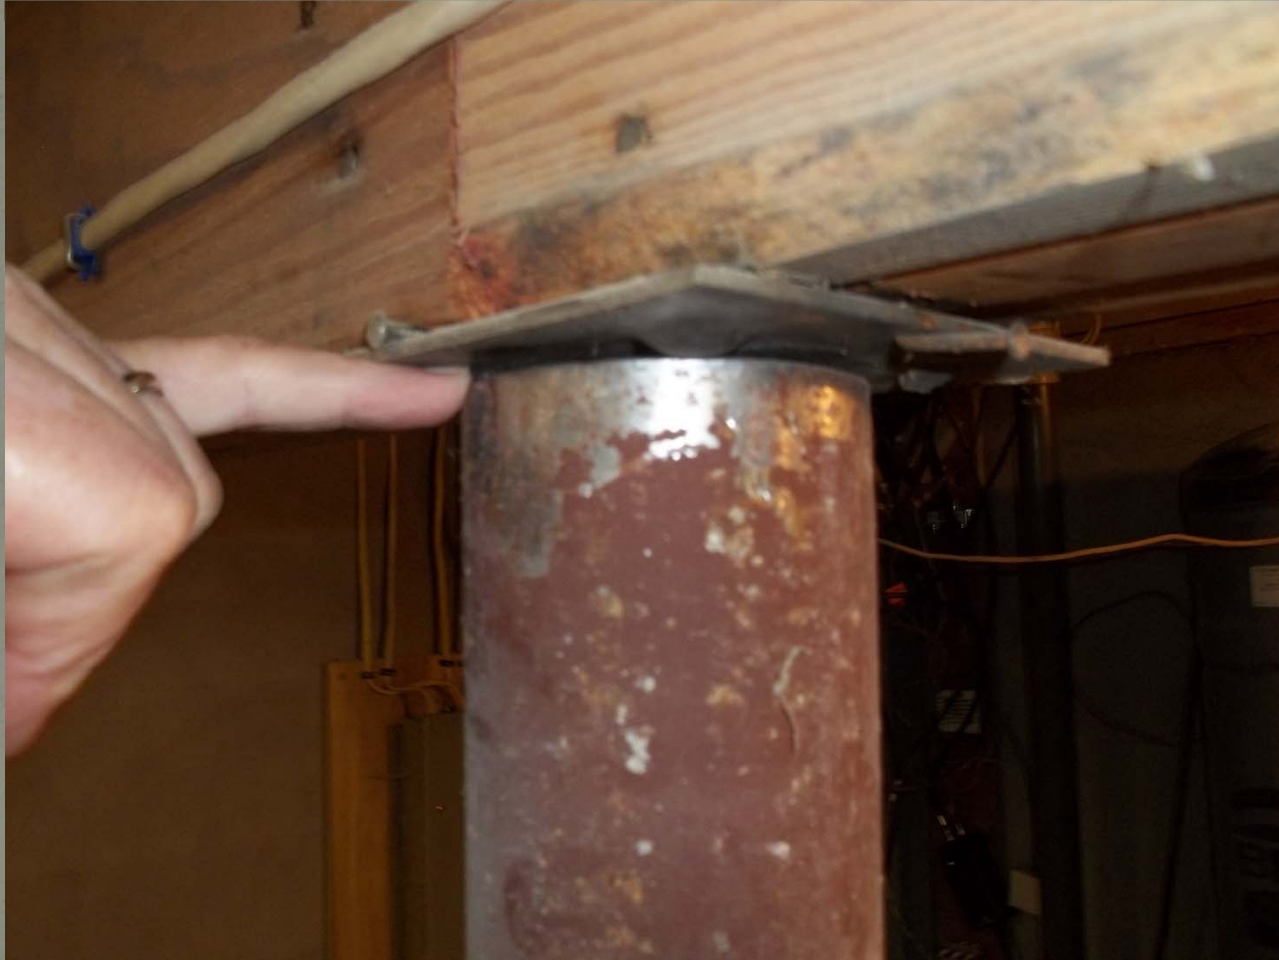
# How a new “inside” foundation “works”

- Build new block or concrete foundation inside existing – doesn't work
- Repair cracks with epoxy – doesn't work
- Structural steel buttresses – doesn't work
- Defective foundation will continue to expand and move until “repair” fails
