# DEFECTIVE CONCRETE FOUNDATIONS

WHERE ARE WE AND WHERE  
ARE WE GOING?

William Neal  
Residential Engineering Services, LLC  
860-871-1830 ResEng88@gmail.com

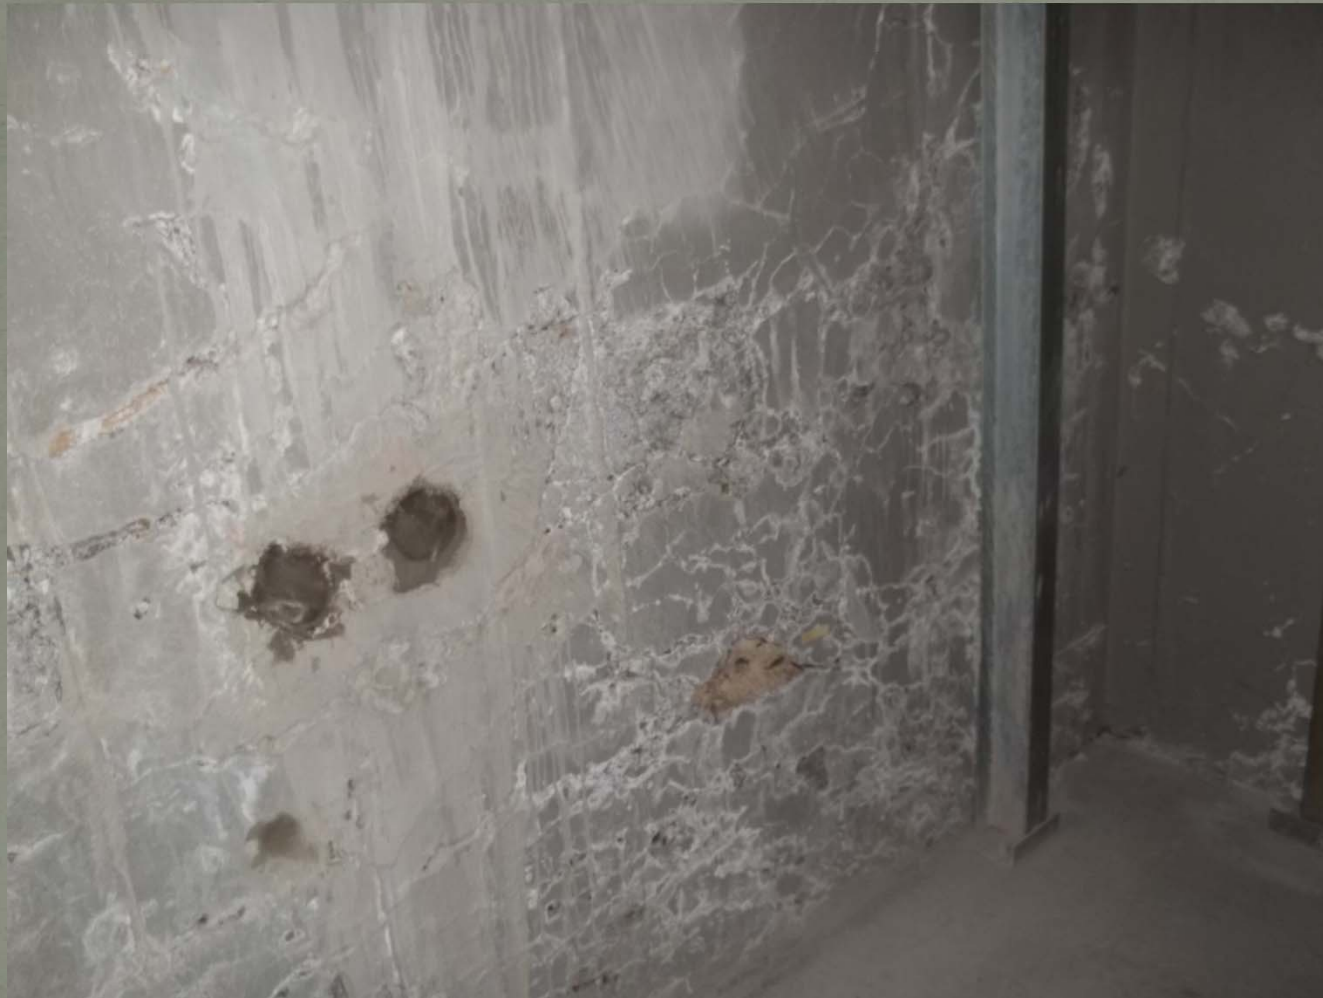
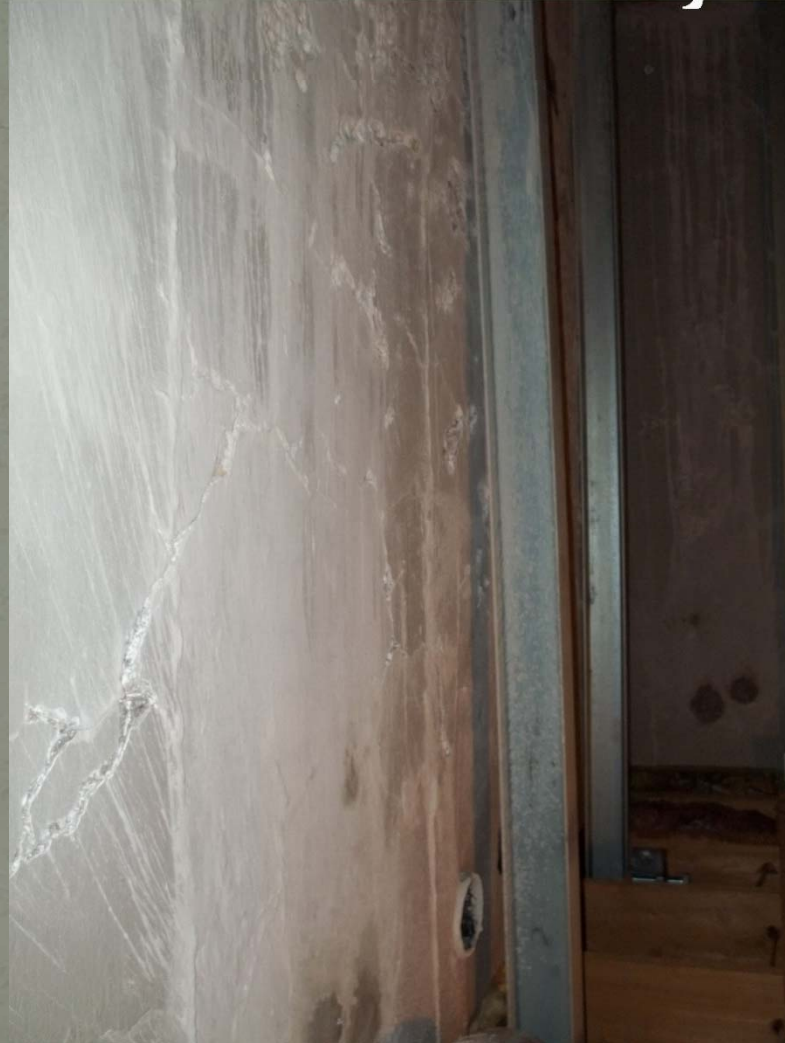
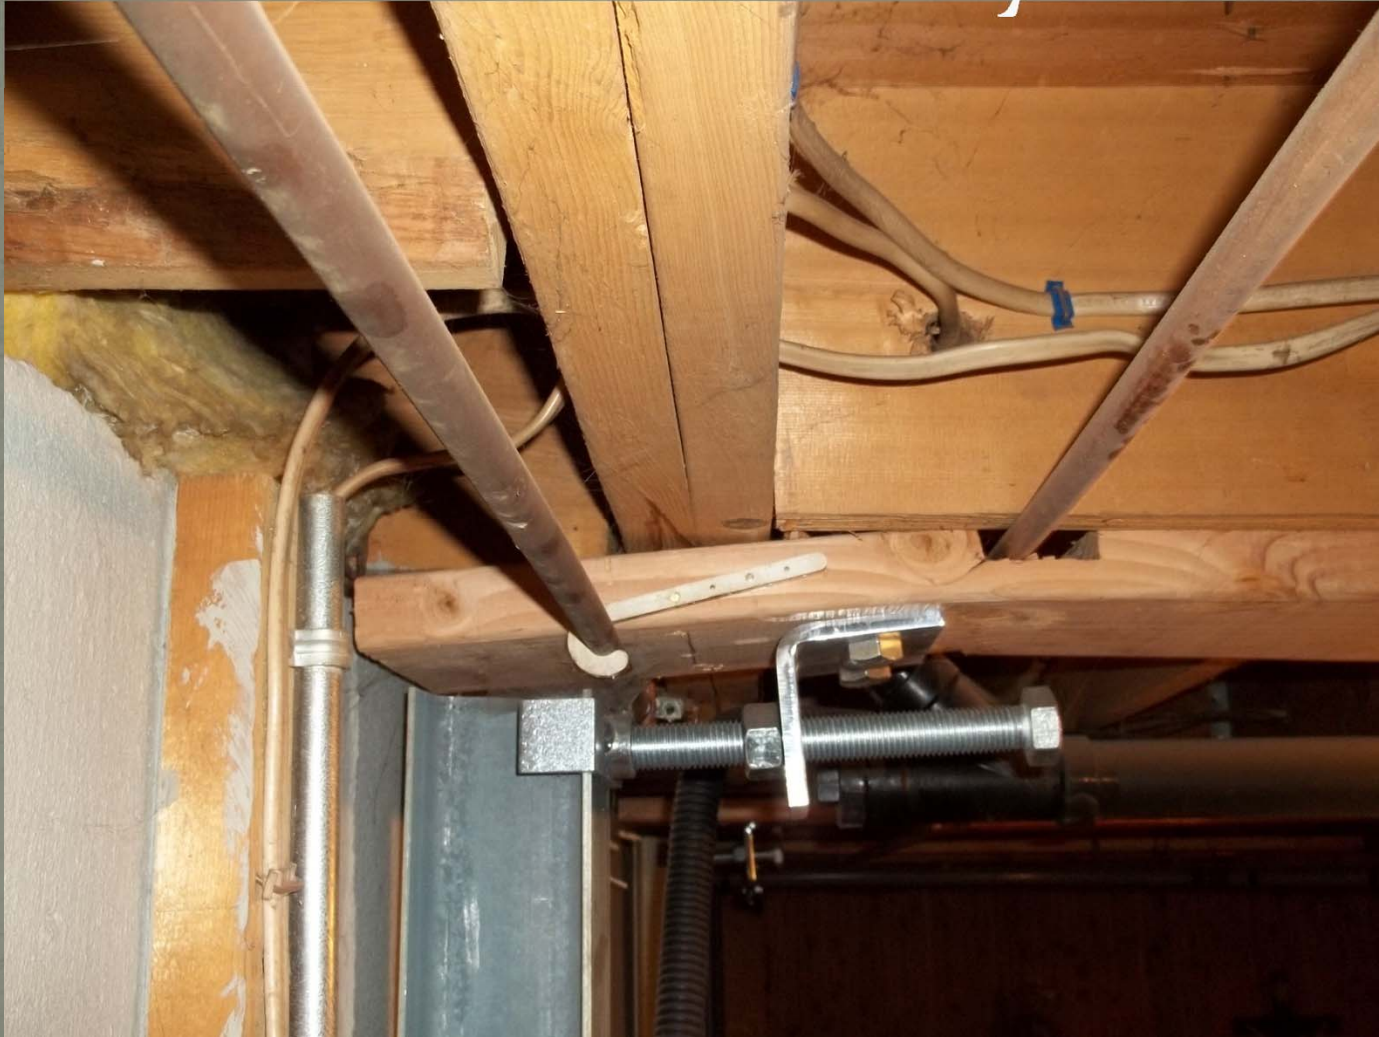
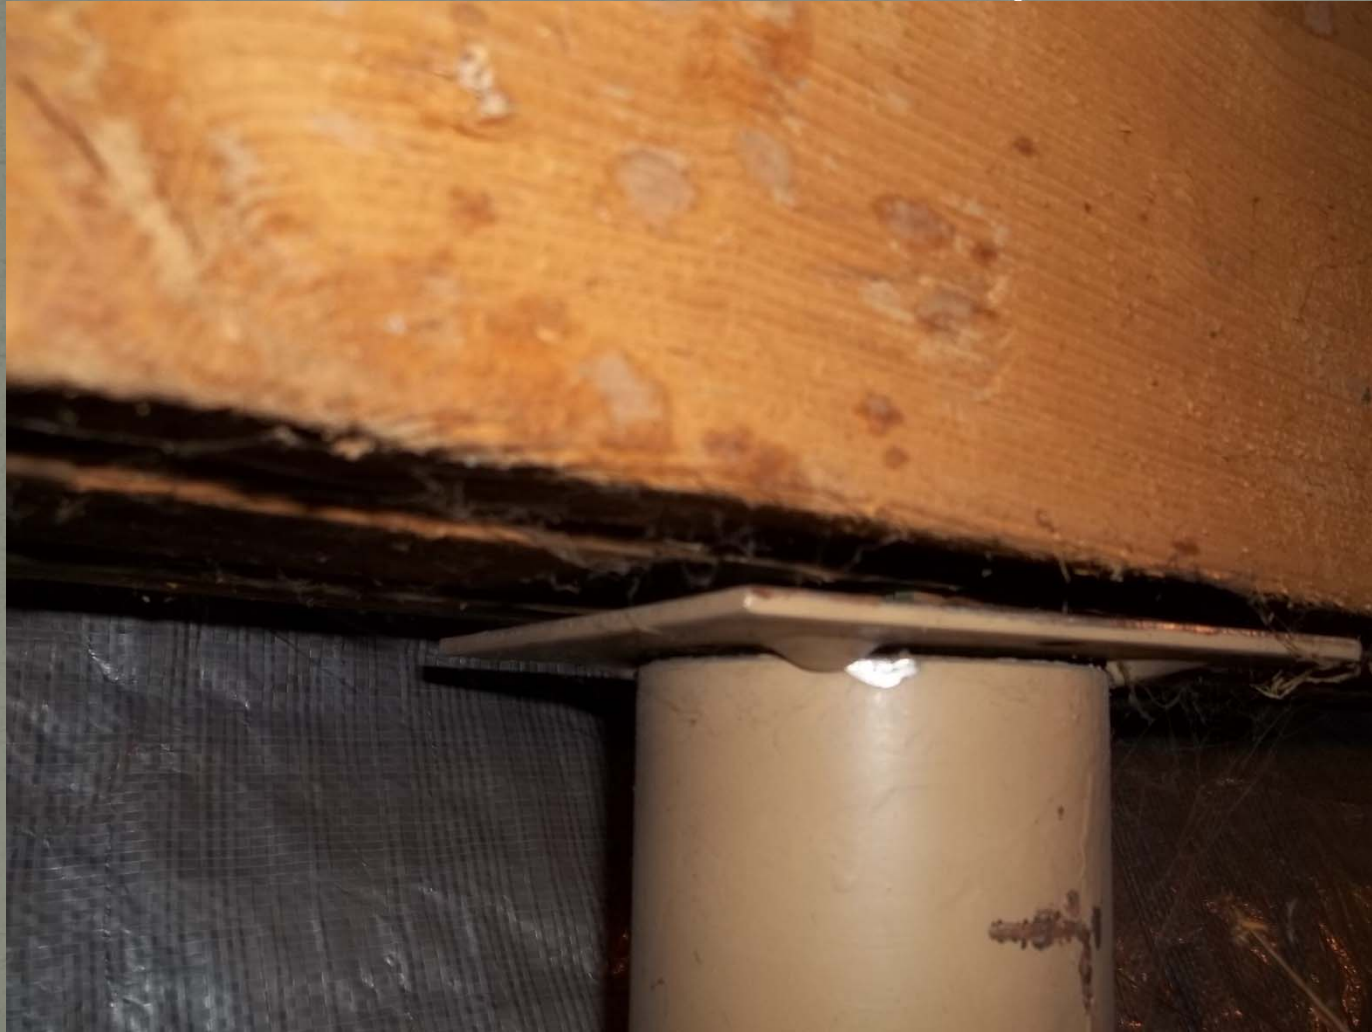
# Steel buttresses aren't any better

- Build new block or concrete foundation inside existing – doesn't work
- Repair cracks with epoxy – doesn't work
- Structural steel buttresses – doesn't work
- Defective foundation will continue to expand and move until “repair” fails

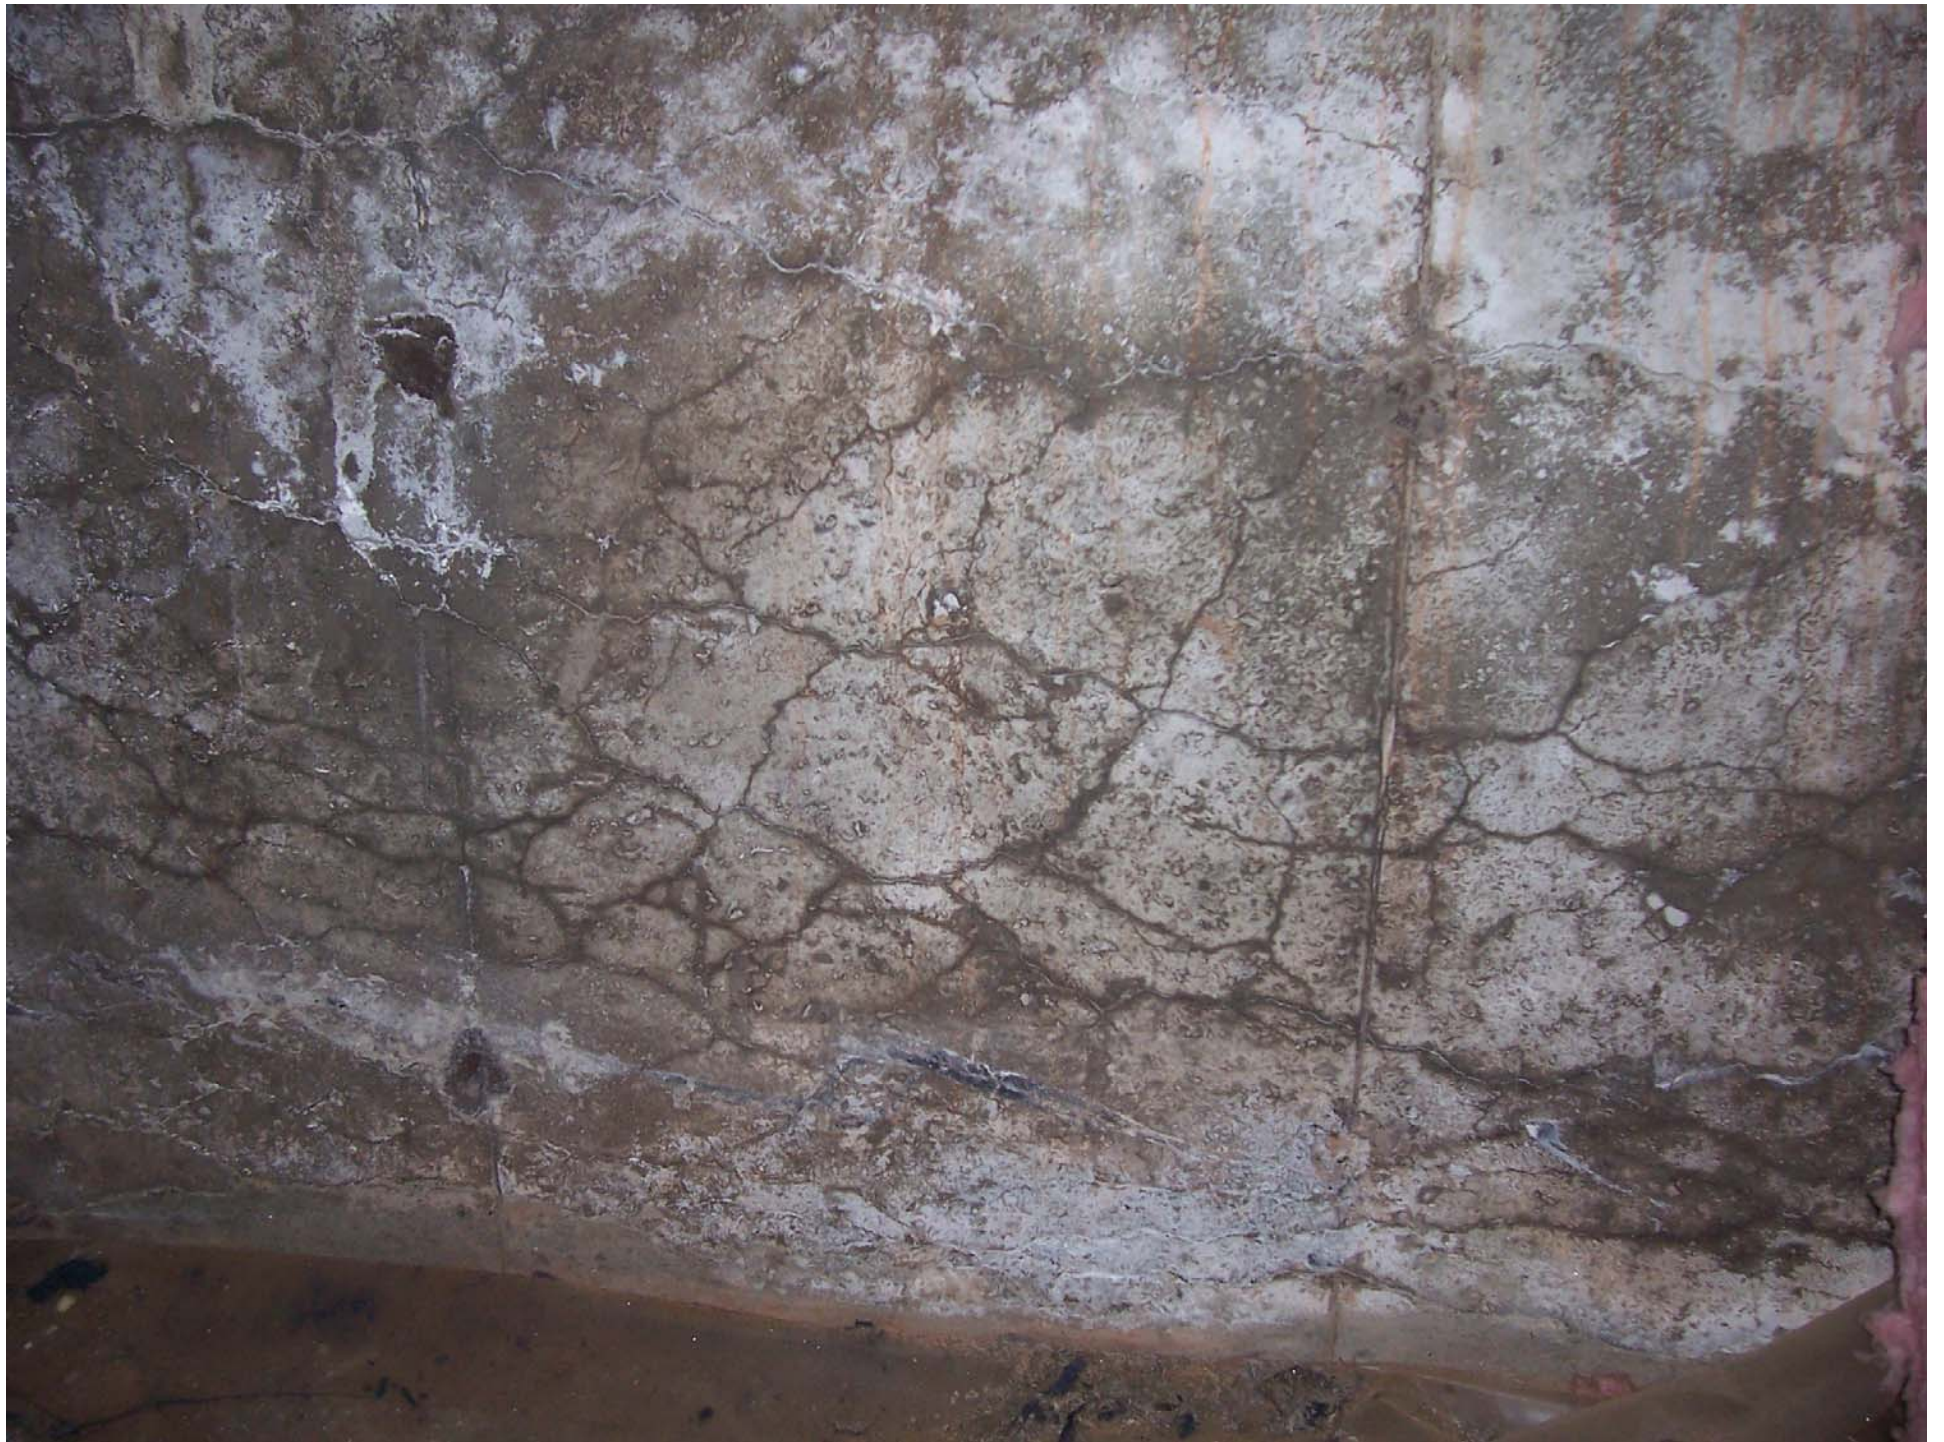
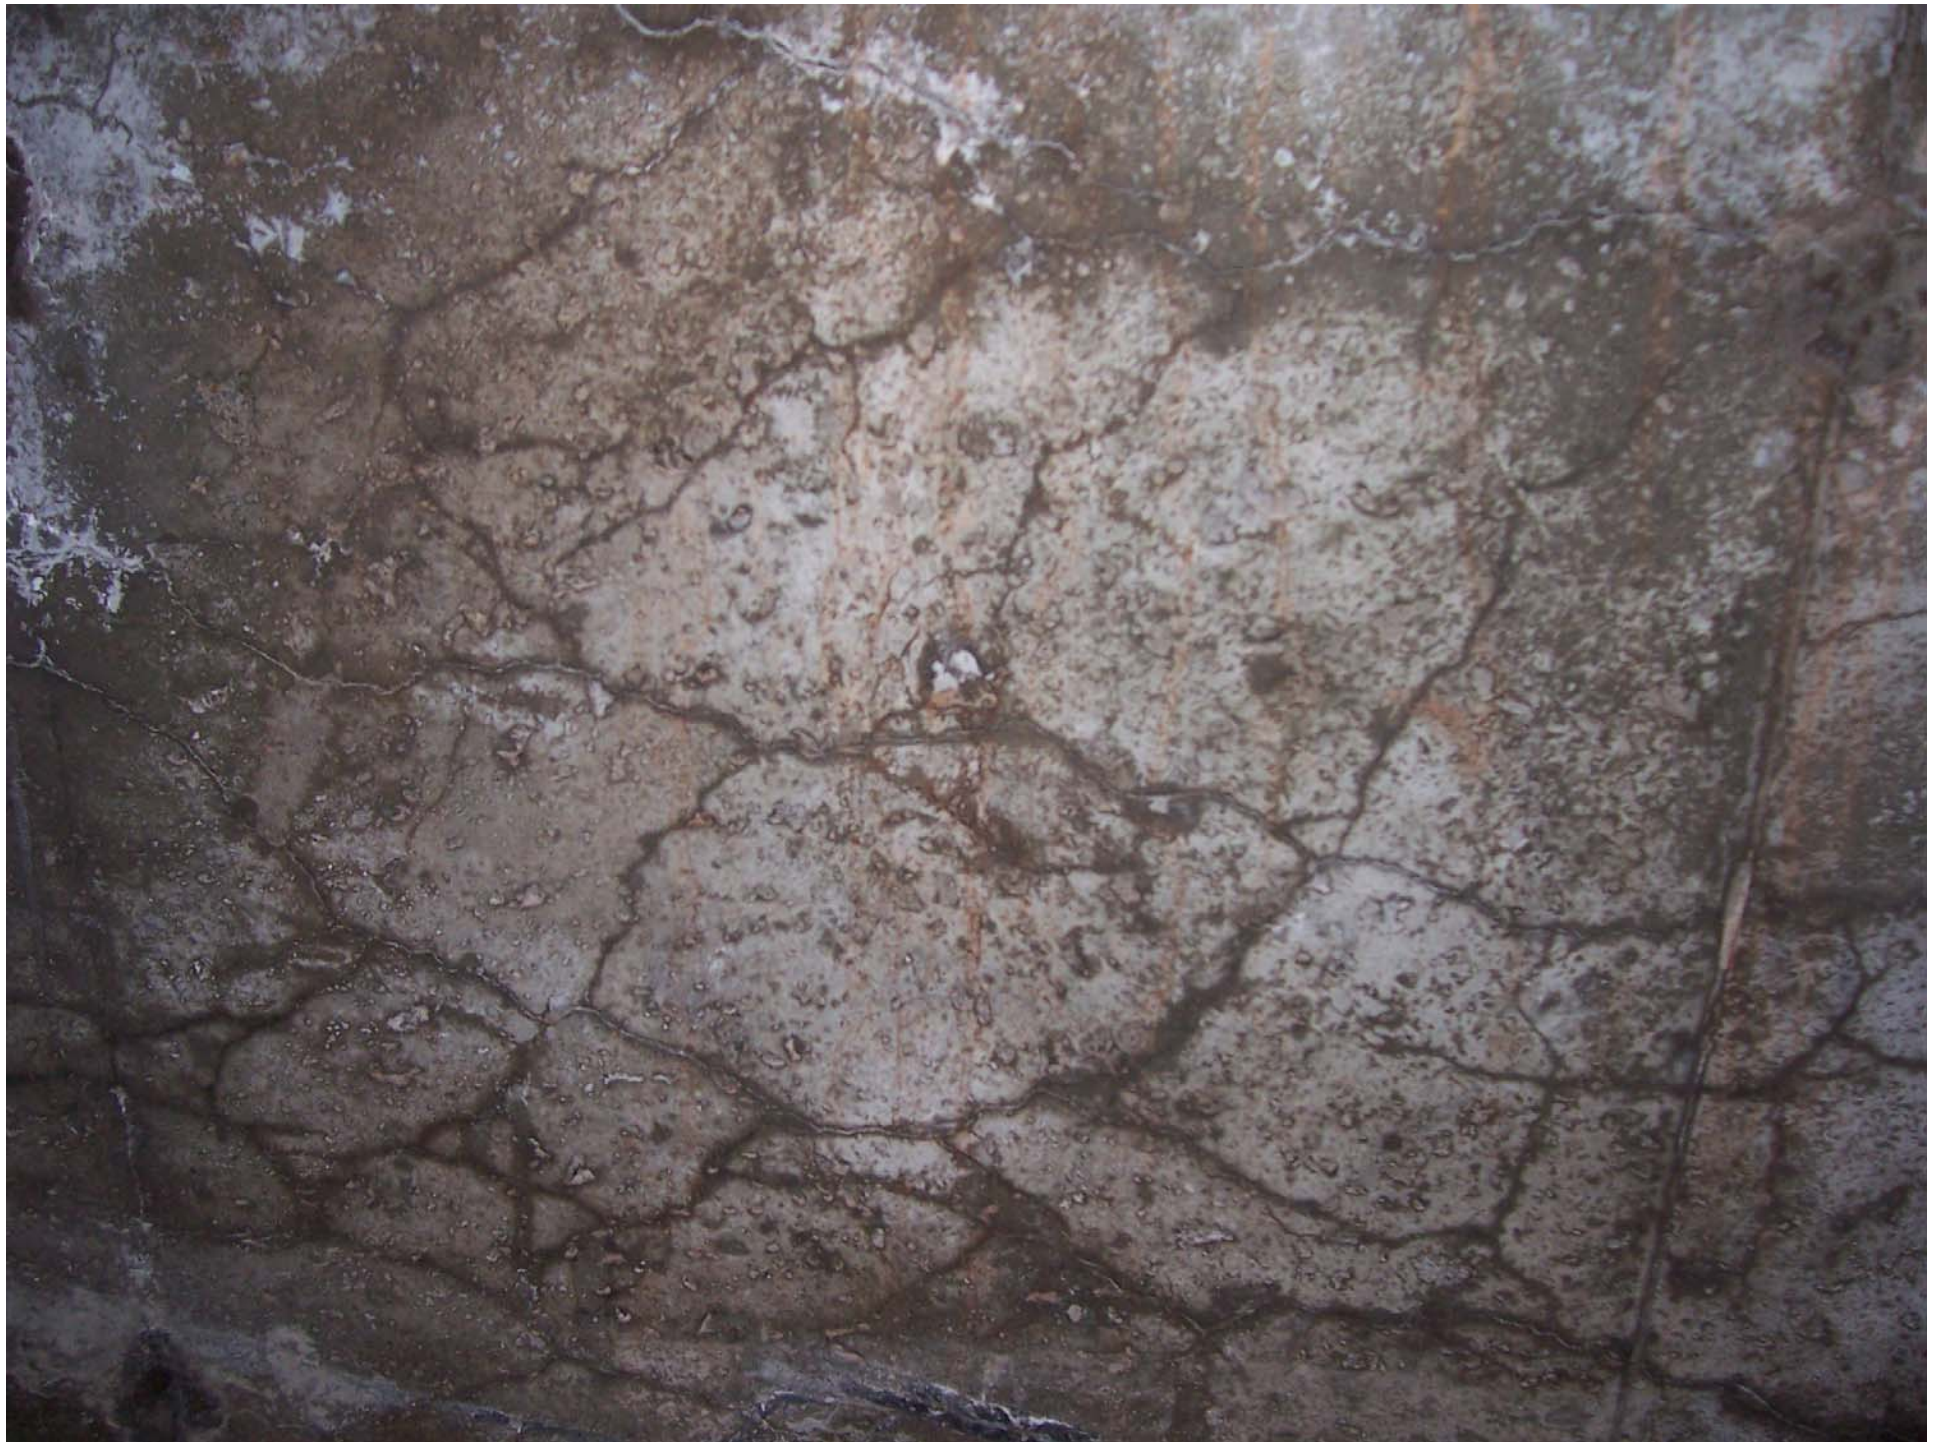
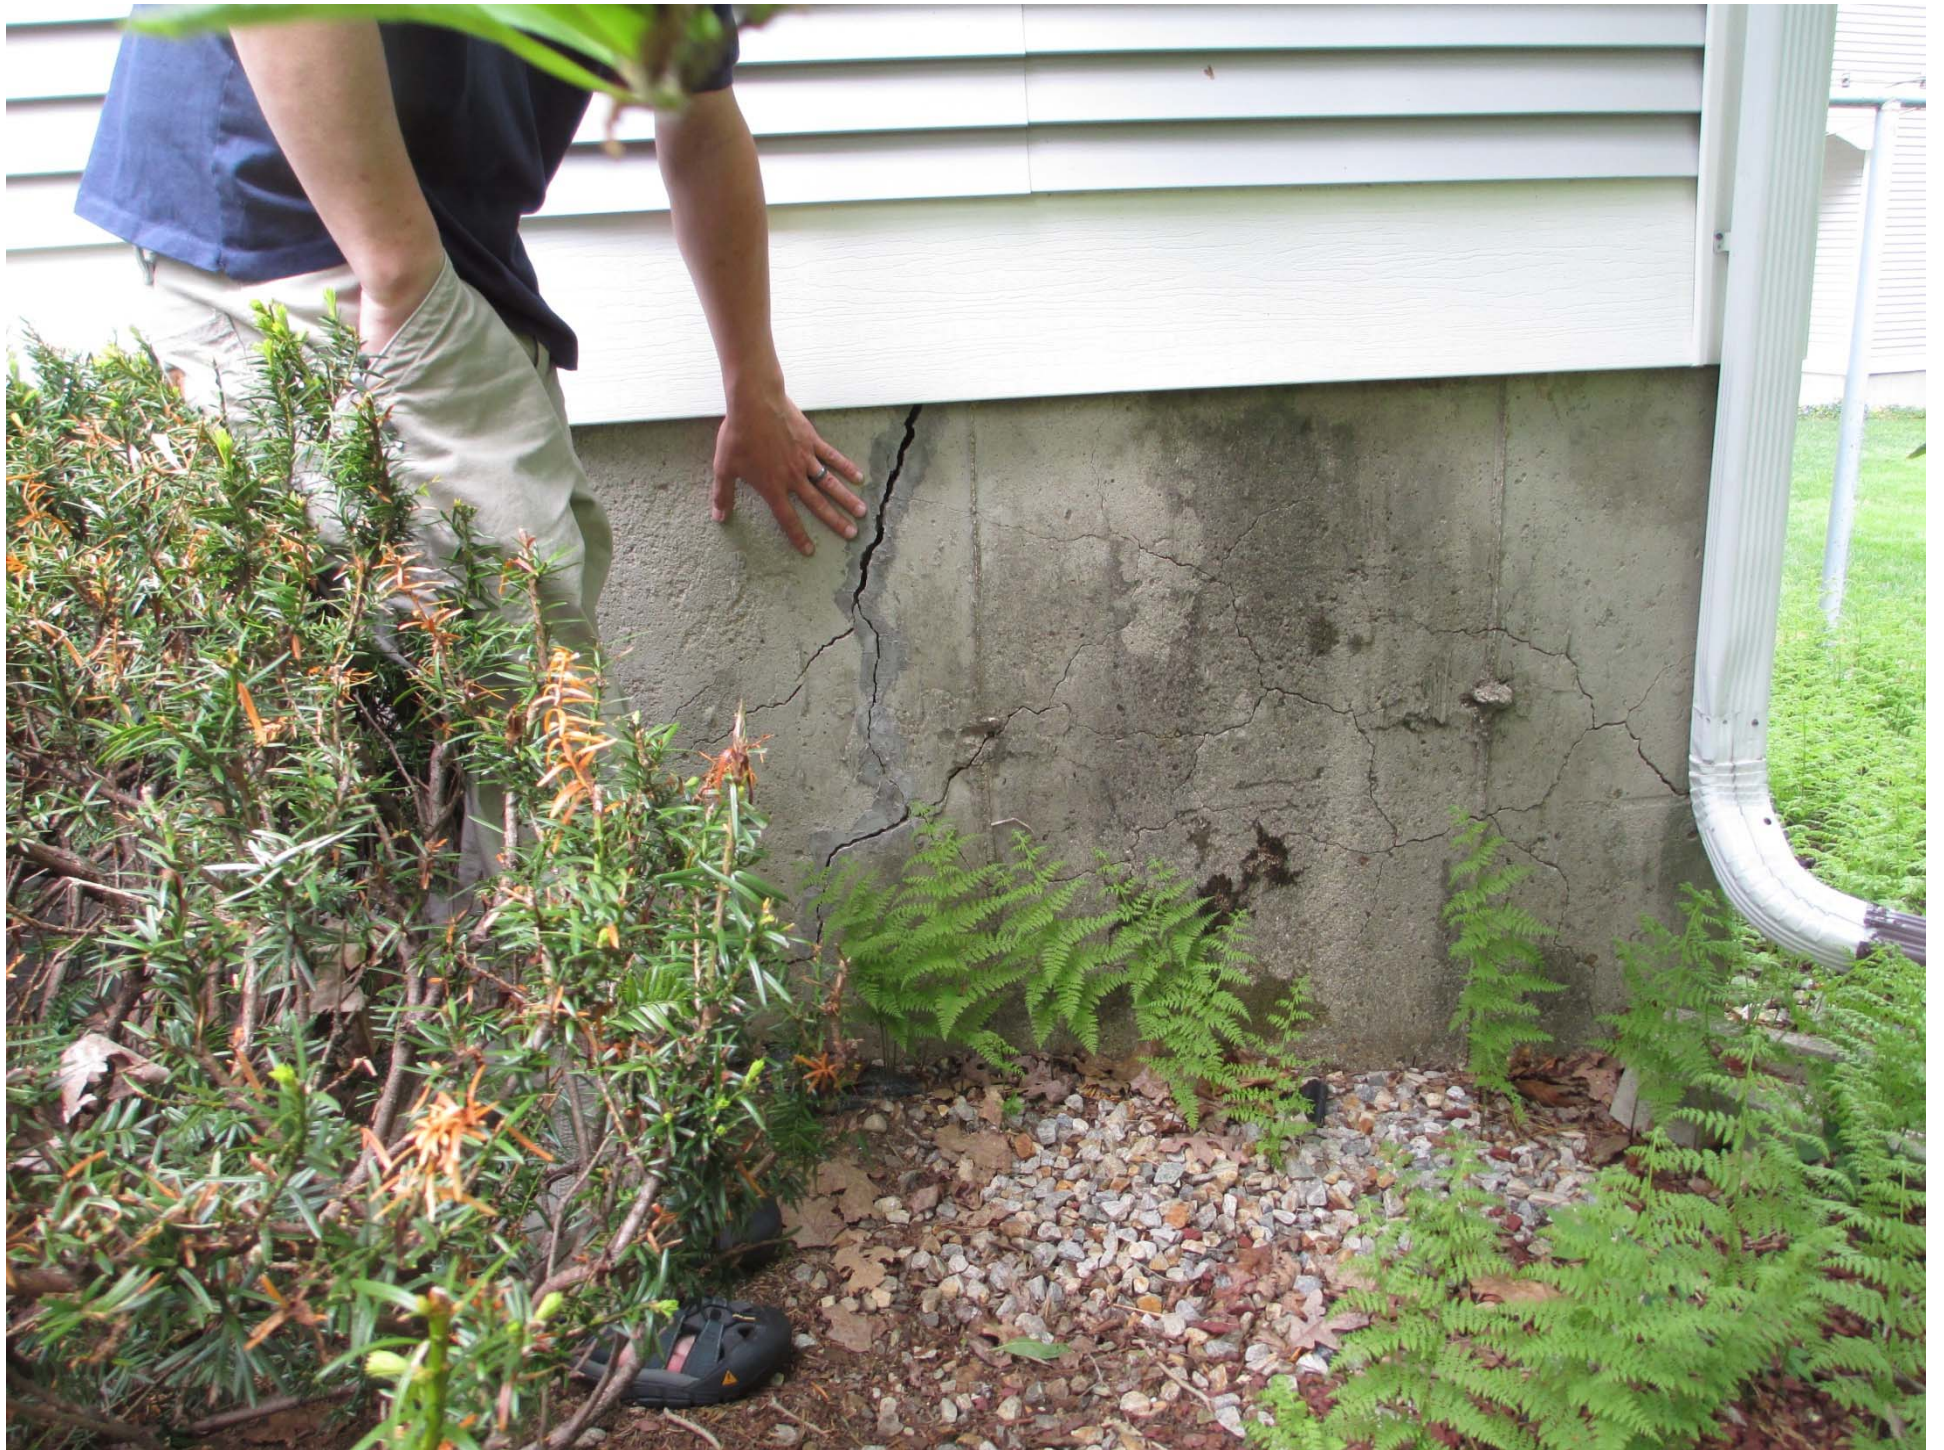
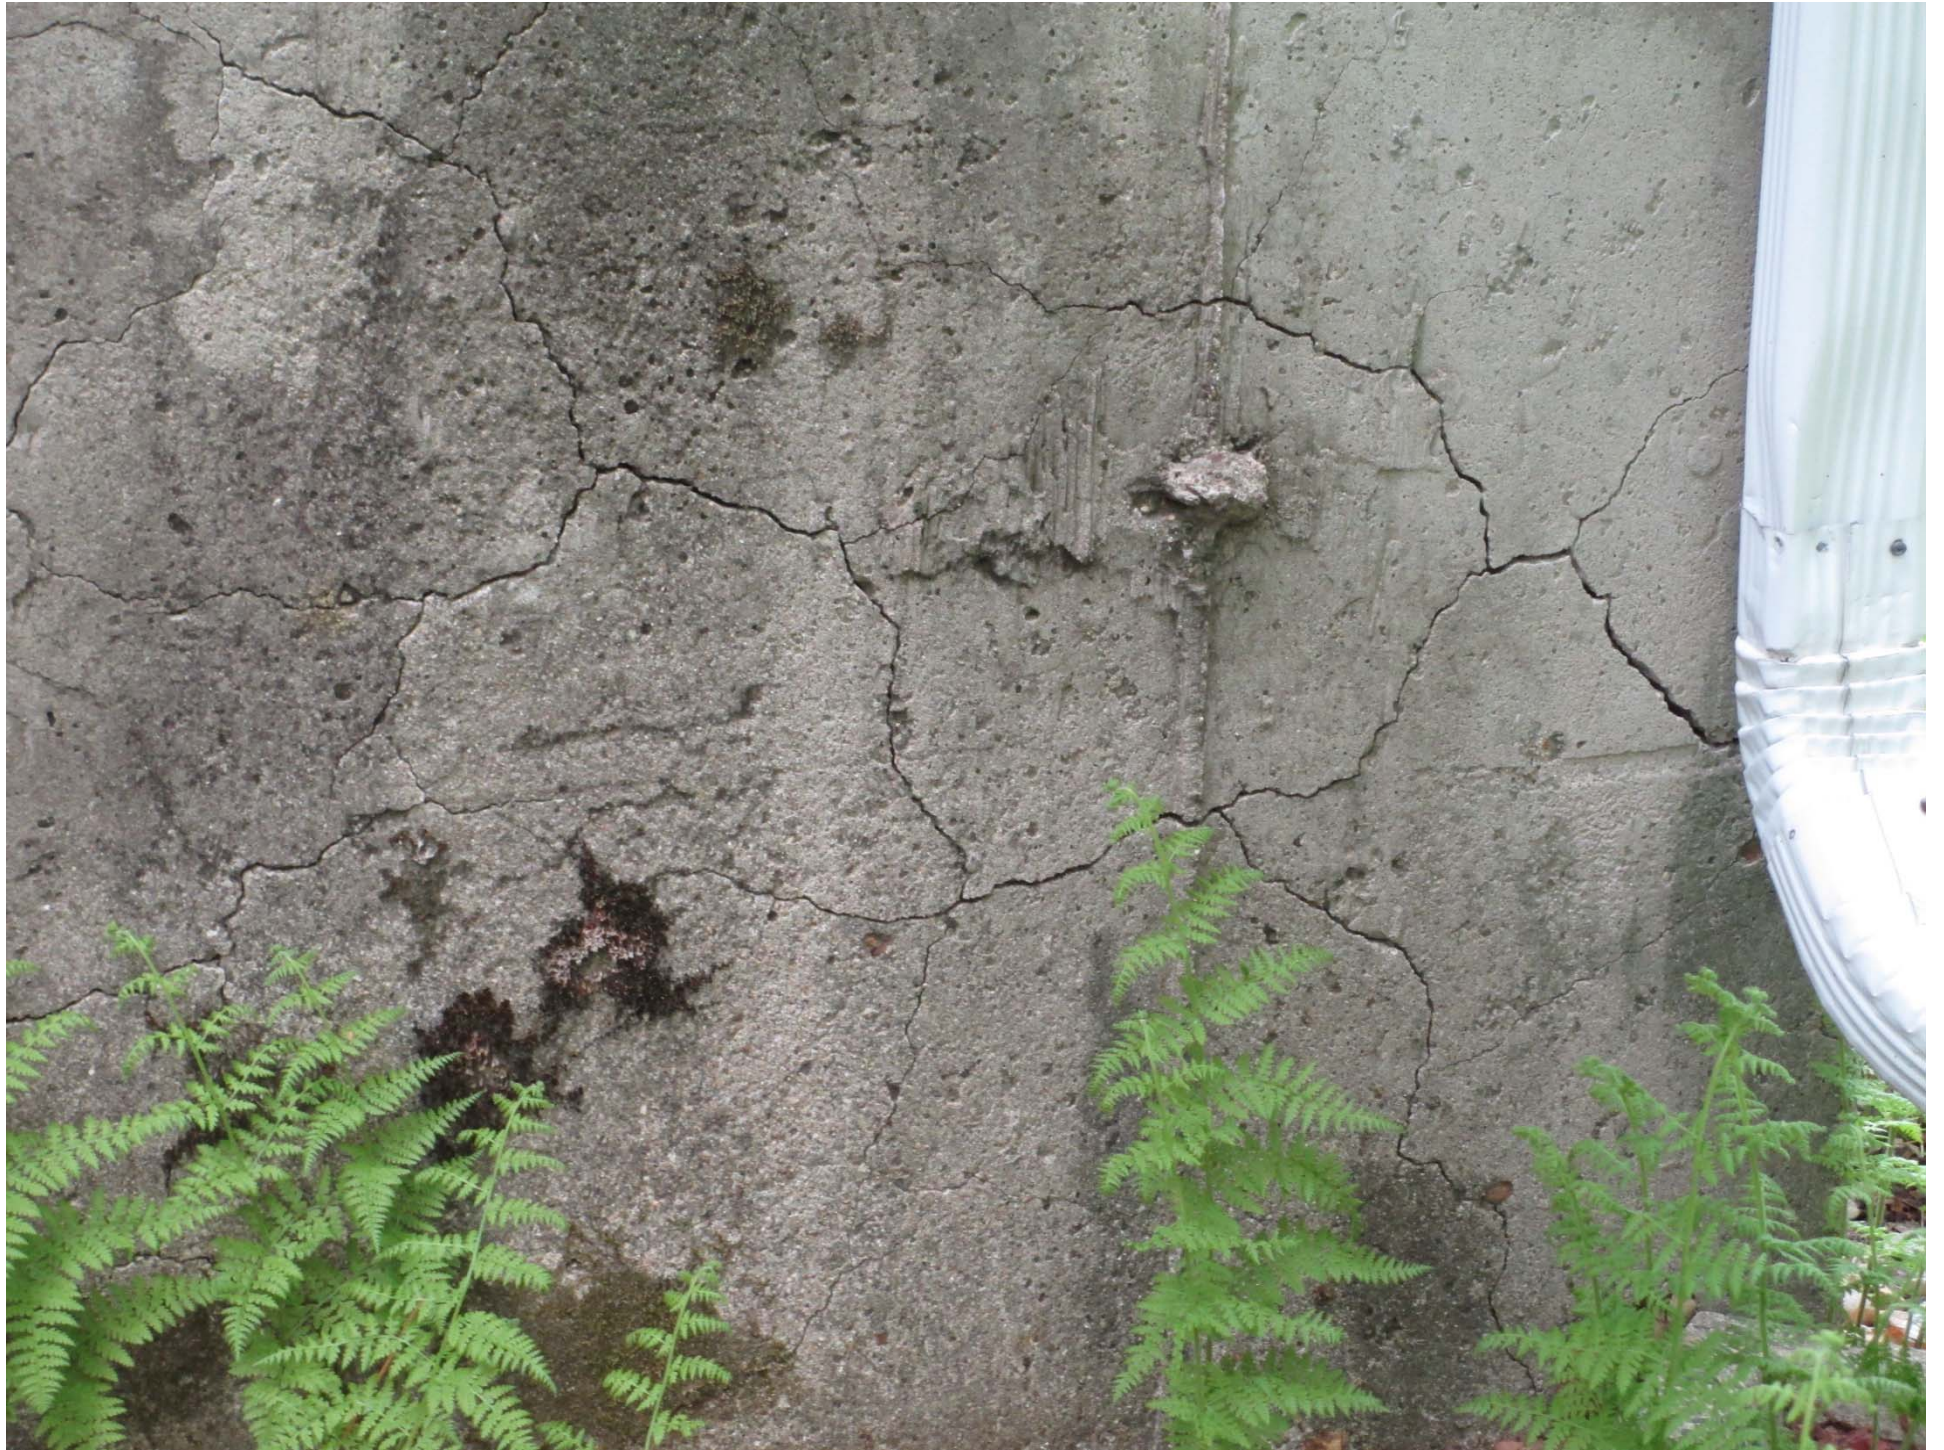
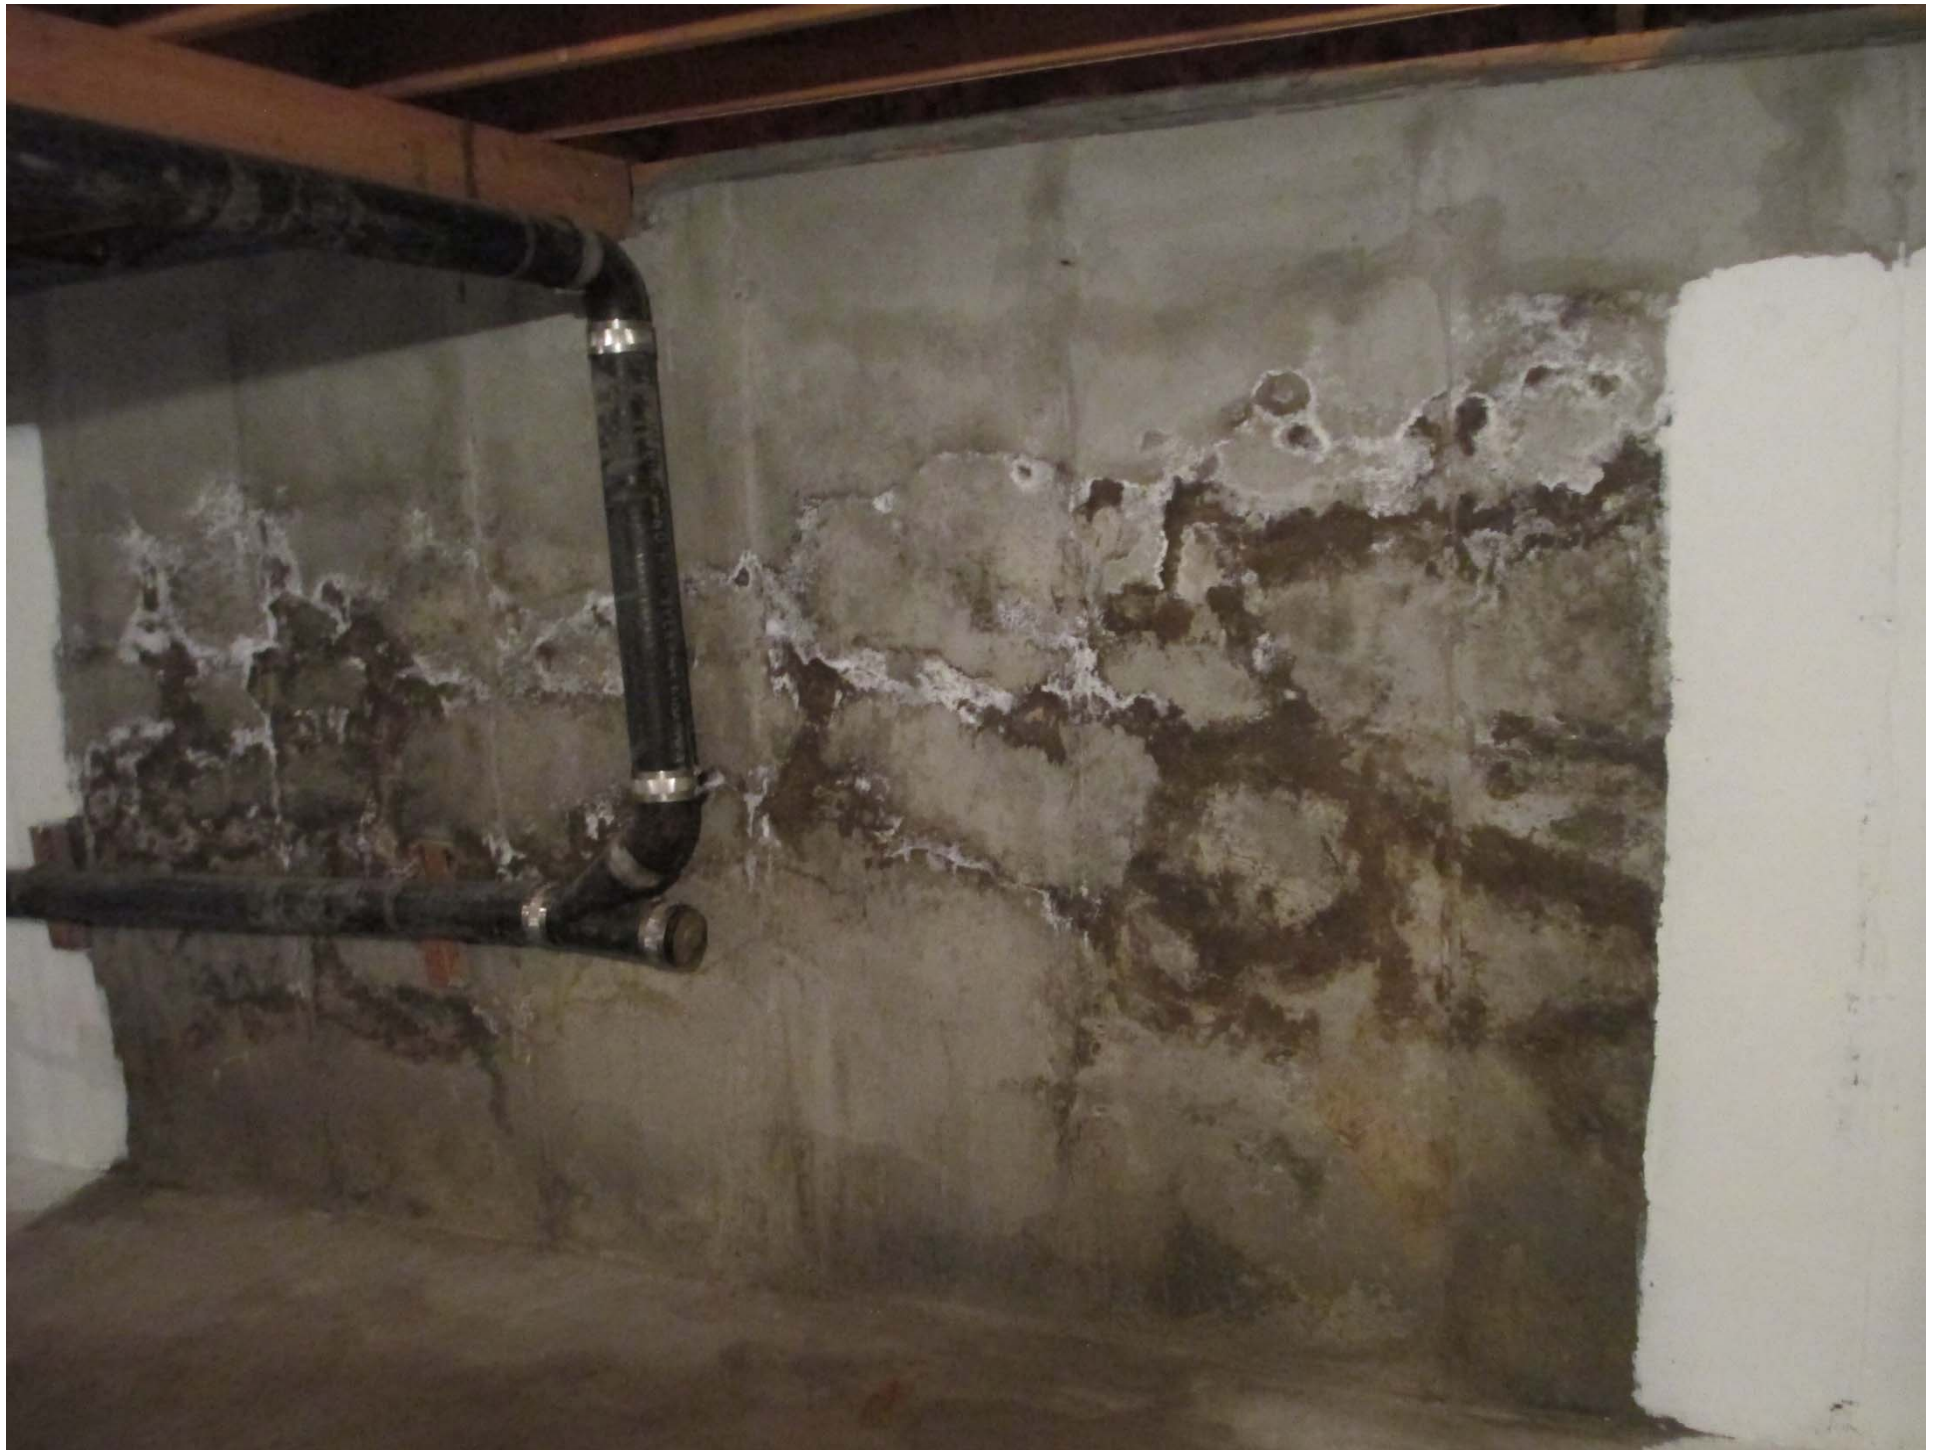
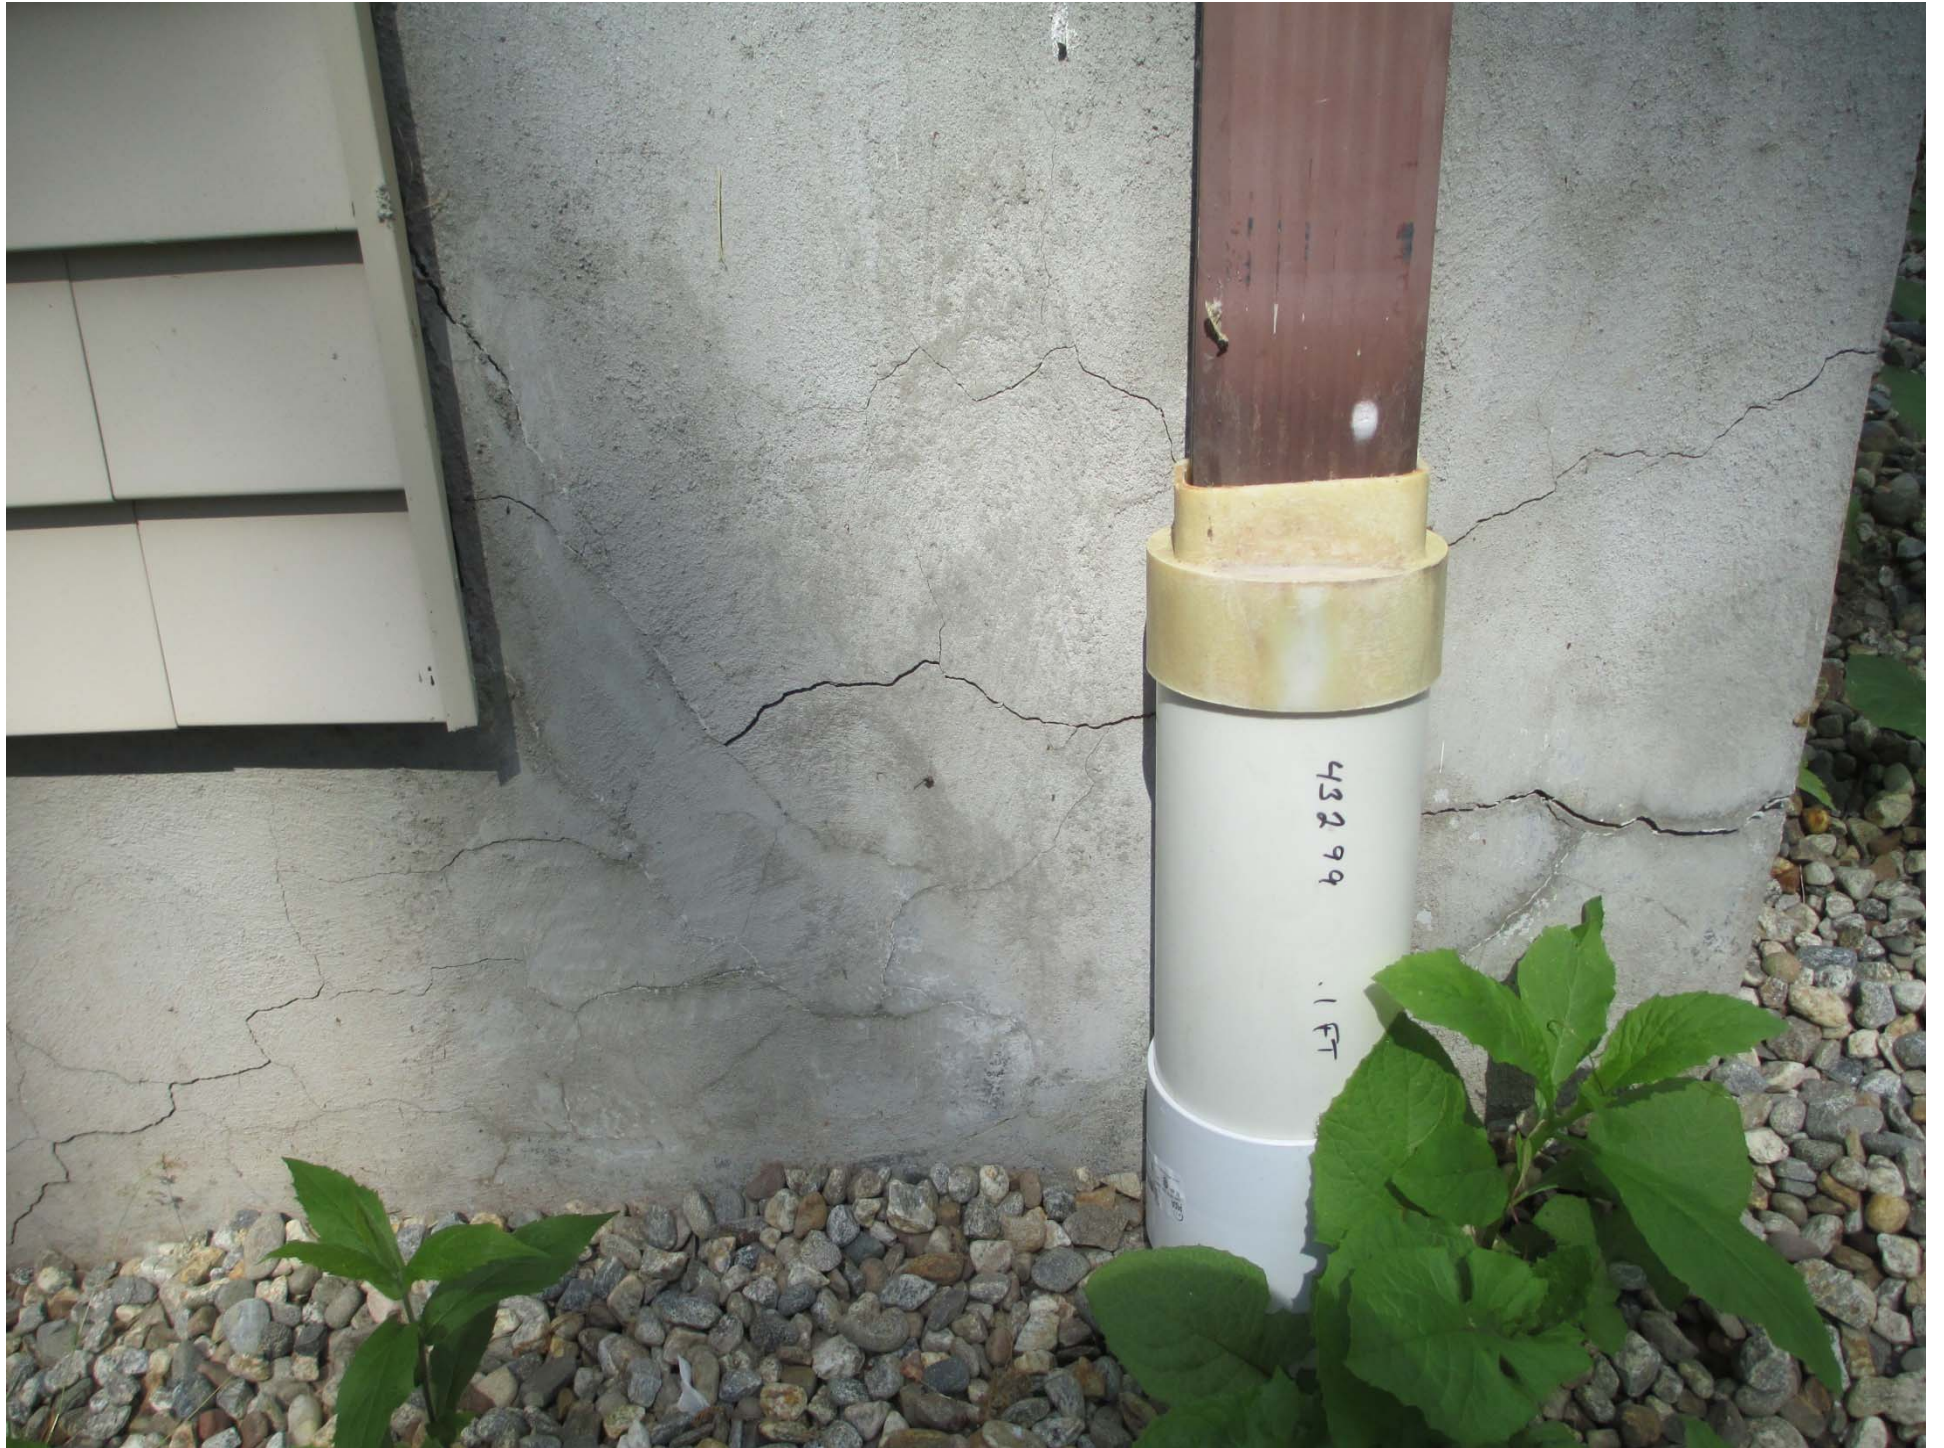
# Typical photos

- This is what we see in advanced deterioration
